Inventory & Check In

AVINTO
PROPERTY SERVICES

Example
Inventory
Report

May
1st 2026

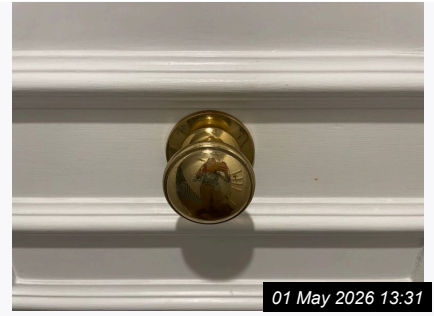
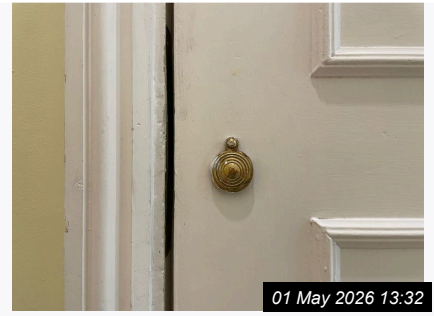
Ref #6.2

6.2	Door Fixtures	Brass Banham locks brass door knobs small brass door viewers and escutcheons brass door number	Visible surface wear and tarnishing on all brass fixtures scratches and some scuff marks present no signs of major damage.

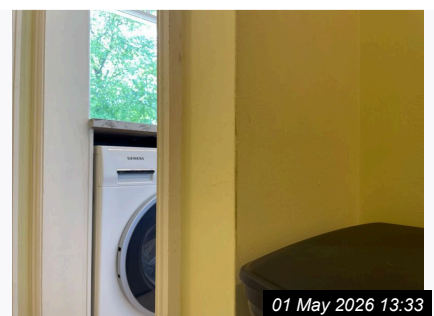
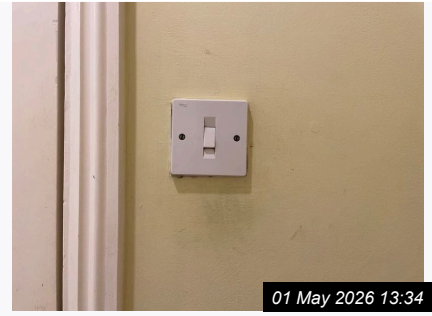
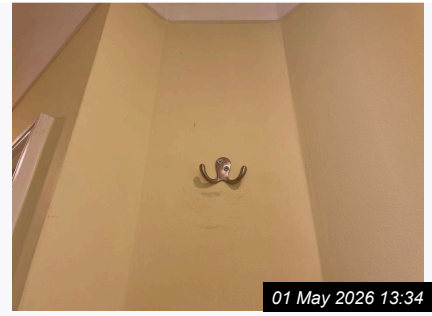
Ref #6.5

6.5	Walls	Plastered walls painted in pale yellow	Walls show multiple scuff marks and some light stains few light minor cracks near trim some areas where hooks are installed.

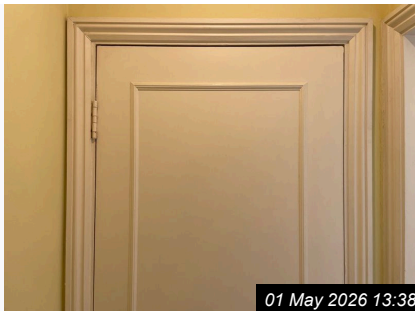
Ref #7.1

Ref	Name	Description	Condition
7.1	Door & Frame	White painted wooden door with three recessed panels and decorative trim Door frame is also white with decorative moulding.	Door and frame show scuff marks Few minor chips and cracks some paint wear, surface scratches, and light damage near the lock area.

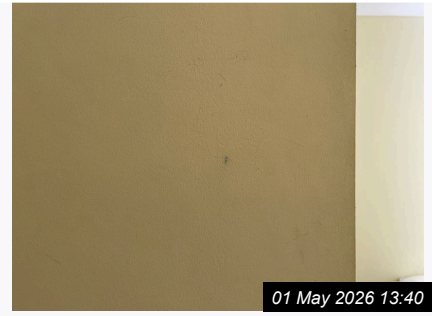
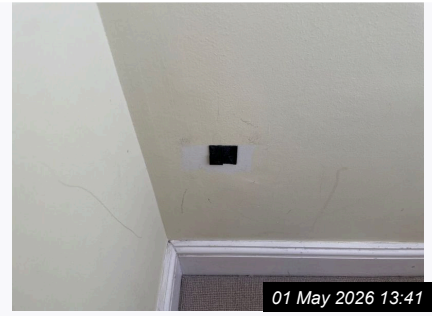
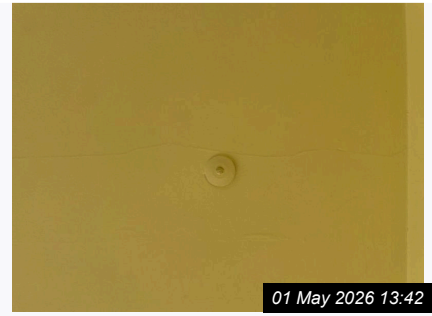
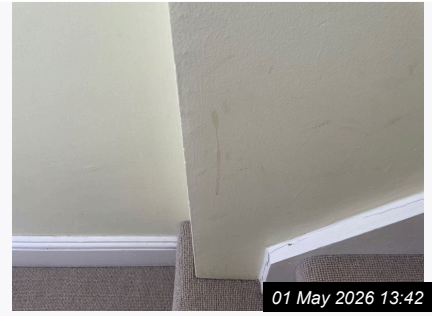
Ref #7.5

7.5	Walls	Painted plaster walls in light cream and pale yellow shades	Multiple scuff marks, patches of minor soiling, areas of paint touch-up small cracks and visible holes from previous fixings throughout.

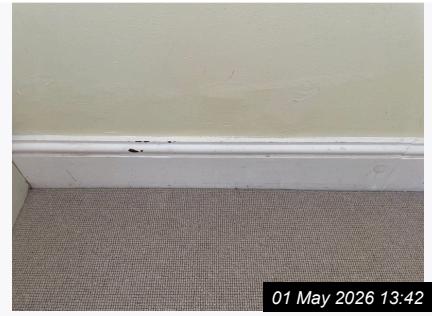
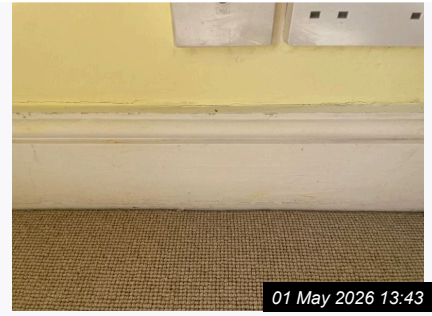
Ref #7.6

7. BEDROOM (CONT.)			
7.6	Skirting	White painted wooden	Visible paint scuffs, minor chips, cracks and some gaps at joints localised signs of wear and some areas showing paint loss

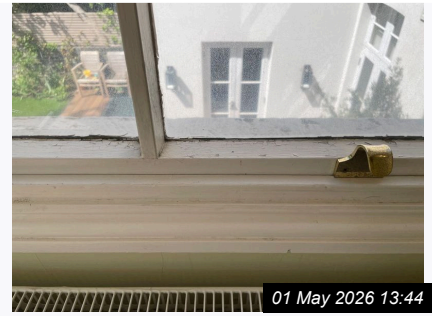
Ref #7.7

1.3	Lights	Good condition.
1.4	Walls	Bathroom - significant chip to 1x tile to RHS high level.
1.5	Windows & Sills	Bedroom - unable to close sash window fitch lock appears due to misalignment of windows

7.7	Window & Sill	White painted wooden sash window with brass catches and a matching painted sill	Window paint shows minor chips and wear visible cracks on sill and frame brass catches are tarnished some dirt and residue on glass and sill. Unable to close sash window fitch lock appears due to misalignment of windows Review - Investigate

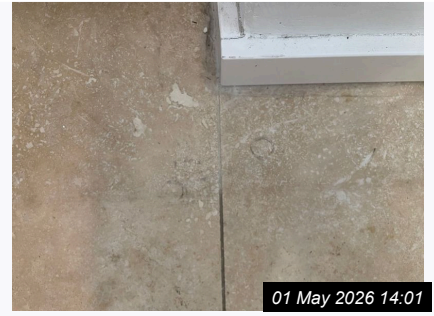
Ref #8.8

8.8	Flooring	Beige stone tiles with a matte finish	Tiles show scattered marks and scratches some ingrained dirt and minor surface wear throughout.
8.9	Wall Units	White gloss wall units with gold handles and multiple internal shelves including a vertical bottle rack and cupboards housing a boiler appliance.	Generally well-preserved with minor visible chip damage to the lower cabinet door edge some light wear inside the units.

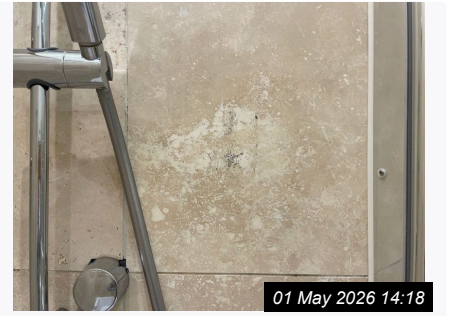
Ref #9.6

9.5	Lighting	Four round flush-mounted ceiling spotlights with metallic trim.	Spotlights appear intact
9.6	Walls	Mixture of off-white painted plaster walls and beige stone tiles	Painted walls show cracks, surface peeling, small dents, stains, and scratches; tiled surfaces show a chipped tile and discolouration in some areas.

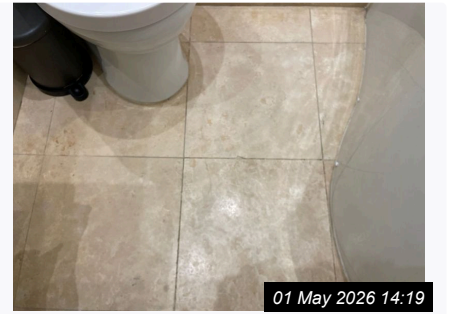
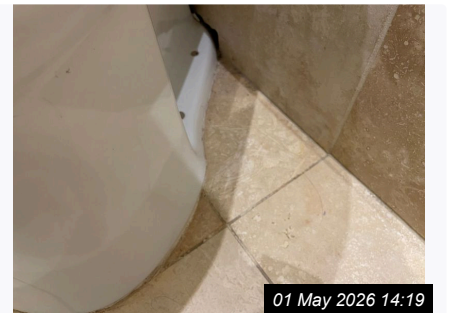
Ref #9.8

1.6	Curtains/Blinds	Bedroom, Blinds - torn fabric to Door to Balcony blind to reverse w/ visible rods.
1.7	Woodwork	Good-fair condition.
1.8	Flooring	Entrance Area - crack to 1x tile forward of entry. Further crack to 1x tile to near RHS/ corner. Kitchen Area - significant chips/indentations to 2x tiles to centre. Bathroom - crack to 1x tile to centre. Significant chip to 1x tile to same area.

9. BATHROOM (CONT.)			
9.8	Flooring	Beige marble effect ceramic tiles	Multiple tiles with visible cracks and some chipped edges minor staining and light surface marks present along grout lines.

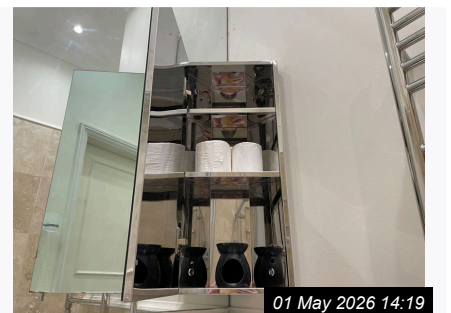
Ref #9.9

9.9	Built-In Storage	Wall-mounted mirrored cabinet with chrome frame featuring three internal shelves	Mirror edges show signs of corrosion and some rusting internal shelves and structure appear intact.
Sanitaryware

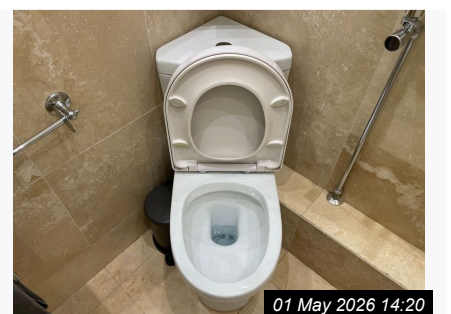
Ref #9.10

1.9	Kitchen & Appliances	Appliances, incl. Quooker tap to sink, appear brand new/newly installed. Extractor Hood - indentation to 1x filter.
1.10	Bathroom & Sanitaryware	Toilet - toilet flush weak. Requires force for full flush. Minor chip to cistern to centre high level. Basin - tap base loose from basin. Bath - multiple chips to bathtub interior to RHS. Further chip to bathtub to RHS.

9.10	Toilet	White ceramic corner toilet with dual-flush chrome button and plastic seat and lid.	No visible cracks or chips minor discolouration on seat cover, flush button intact overall appears well maintained. Toilet flush weak. Requires force for full flush Review - Investigate
