# Inventory & Check In

**AVINTO**  
PROPERTY SERVICES

Example  
Inventory  
Report

**April**  
**22nd 2026**  
09:00

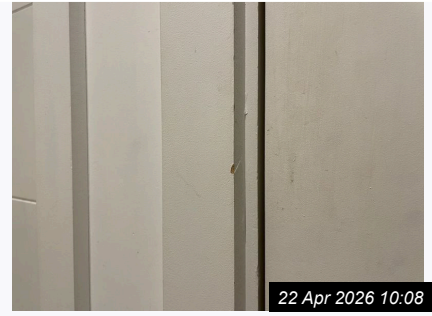
Ref #6.9

6.8	Flooring	Light oak wood	Surface scratches and a small chip with minor signs of wear. Appears clean
6.9	Built-In Storage	White built-in storage cupboard with shelving	Multiple scuff marks, scratches, small holes on the door front, minor chips to the edge, and wall interior shows heavy marking and general wear.

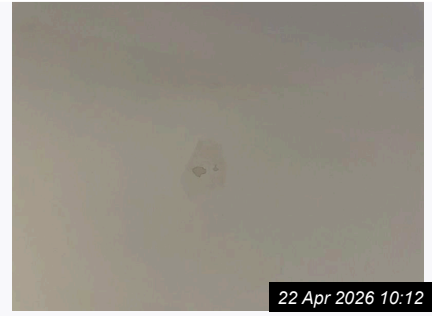
Ref #7.3

7.3	Walls	Painted plastered walls in white exposed yellow, black and brown brickwork.	Painted walls show multiple visible screw holes patch repairs and surface scuff marks; exposed brickwork is in good condition

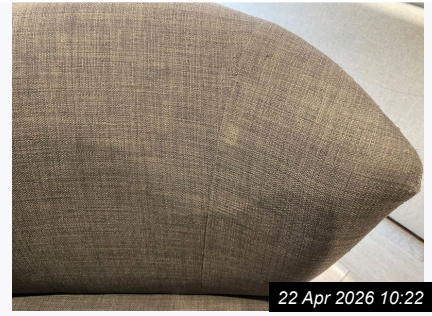
Ref #7.13

7.13	Table and chairs	Set of two grey upholstered chairs with wooden legs positioned next to a rectangular light oak dining table	Dining table surface shows a light circular mark Chairs show fraying on the back edges and a small stain on upholstery

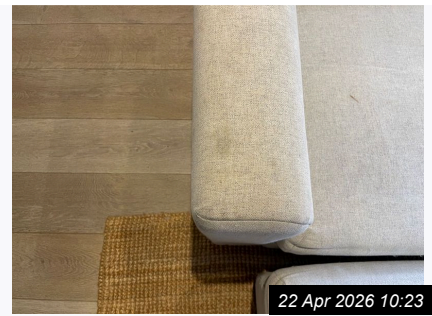
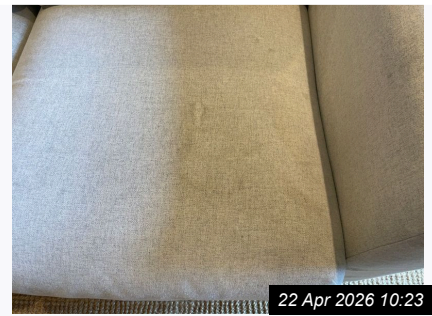
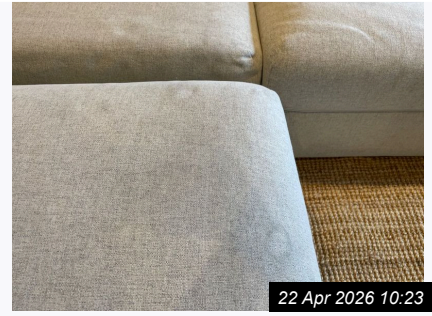
Ref #7.14

7.14	Sofa	Light beige fabric corner sofa with: Three seat cushions, three back cushions, a left chaise extension, and integrated storage compartment under the chaise.	Multiple seat and arm stains, light scuff marks, general wear to cushions, and light scratches on the rear panel.

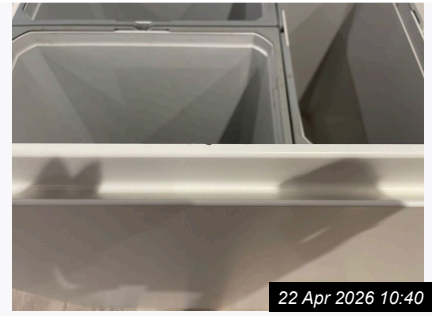
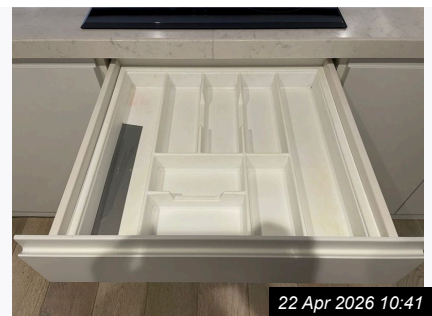
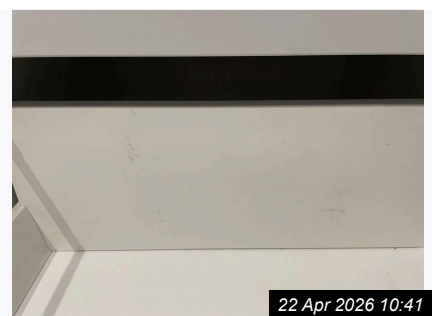
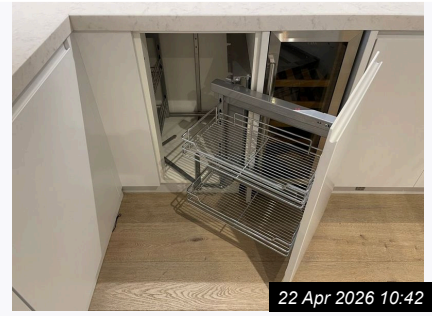
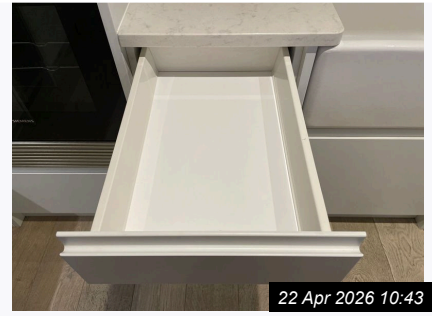
Ref #8.9

8.8	Wall Units	White laminated open shelving with copper brackets	Minor discolouration to shelf edges
8.9	Base Units	Matte white flat-panel base units with; integrated handles, internal shelving, pull-out wire baskets, soft-close drawers & built-in waste bins	General minor marks and scuffs some chipped edges on drawers and cabinets scratched and stained areas inside sink unit and drawers Corner door sections detached from unit interior sections <a href="#">Review - Investigate</a>

Actions Required			
Ref	Action Required	Responsibility	Comments
<a href="#">6.2</a> ENTRANCE & HALLWAY » Door Fixtures	Review	Investigate	Mortise lock escutcheon to exterior loose/partially detached from door
<a href="#">6.4</a> ENTRANCE & HALLWAY » Lighting	Review	Investigate	1x spotlight lightbulb not working
<a href="#">6.11</a> ENTRANCE & HALLWAY » Washing Machine	Review	Investigate	Black mould-type marks to door seal/gasket
<a href="#">6.16</a> ENTRANCE & HALLWAY » Thermostat	Review	Investigate	Tested, power not seen
<a href="#">7.5</a> RECEPTION ROOM » Window & Sill	Review	Investigate	Unable to fully open and close and lock window
<a href="#">7.12</a> RECEPTION ROOM » Thermostat	Review	Investigate	Tested, power not seen
<a href="#">8.6</a> KITCHEN AREA » Kitchen Units	Review	Investigate	Kickboard-integrated lighting not working
<a href="#">8.9</a> KITCHEN AREA » Base Units	Review	Investigate	Corner door sections detached from unit interior sections

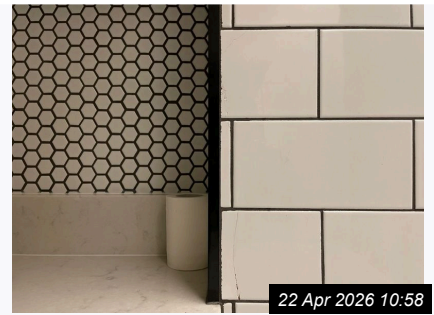
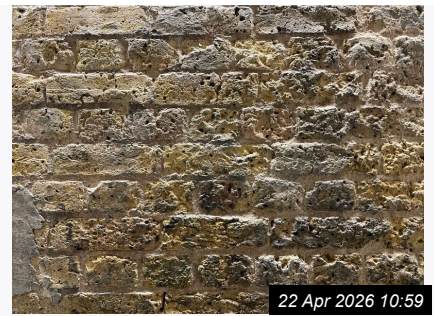
Ref #9.6

9. BATHROOM (CONT.)			
9.6	Walls	Bathroom walls consist of: exposed brick, painted plaster in white, white rectangular ceramic tiles, white hexagonal tiles with dark grout	Exposed brick possibly shows plaster and patch repairs painted plaster displays a visible crack at one joint ceramic tiles have some light marks and minor cracking to 3x tiles hexagonal tiles appear intact.

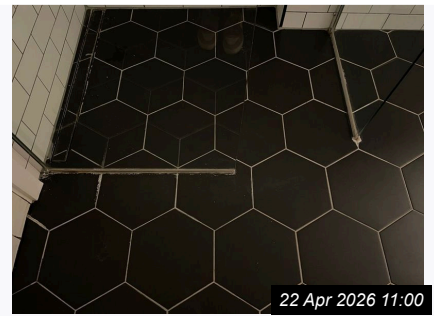
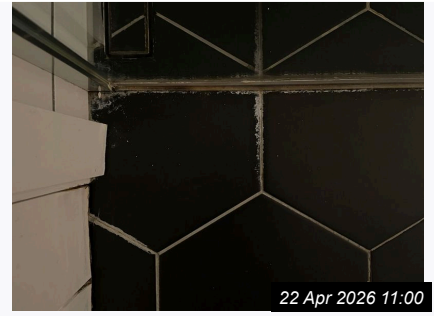
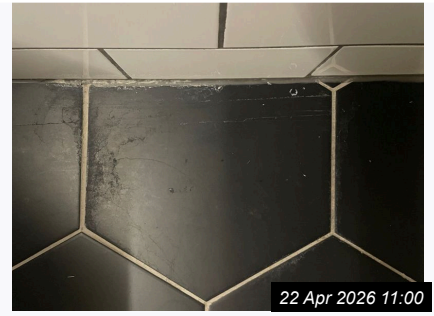
Ref #9.7

9.7	Flooring	Large format hexagonal ceramic tiles in matte black with contrasting light grout lines.	White scaling and appears some staining to surface Few white paint marks

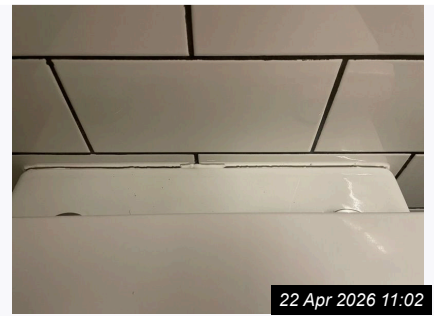
Ref #9.9

9.9	Toilet	Wall-hung white ceramic toilet with soft close seat and dual flush chrome actuator.	Minor limescale staining inside the bowl Seat is slightly loose and lopsided <a href="#">Review - Investigate</a>

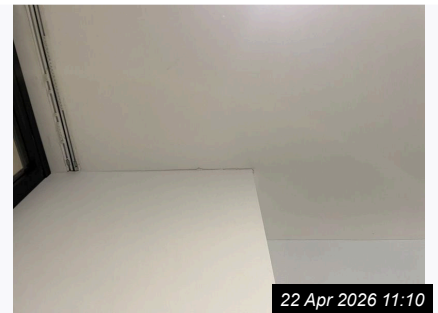
Ref #10.3

10.3	Ceiling	Smooth white ceiling	Ceiling is generally clean with a visible minor crack
10.4	Lighting	Lighting consists of recessed ceiling downlights with metallic trim contemporary pendant lights featuring smoked glass shades suspended from the ceiling.	2x pendant lightbulbs not working <a href="#">Review - Investigate</a>
