# Inventory & Check In

**AVINTO**  
PROPERTY SERVICES

Example  
Inventory  
Report

**May  
2nd 2026**

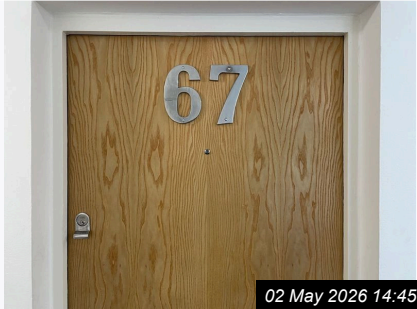
02 May 2026 14:45  
Ref #6.1

Ref	Name	Description	Condition
6.1	Door & Frame	Light brown wood veneered entrance door set in a white painted frame.	Door surface shows minor scuffs and marks with no major damage visible frame displays exposed wood and paint chips there is slight rust and wear observed on the inner side of the frame and near security fittings.

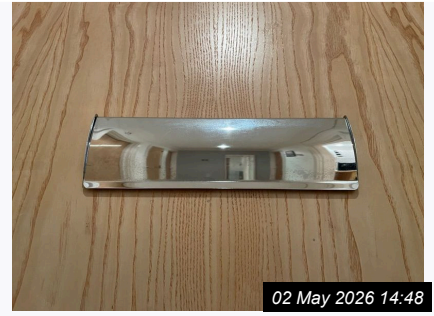
Ref #6.2

6.2	Door Fixtures	Brushed stainless steel fixtures to include: lever deadlock cylinder key lock door chain numerals spyhole letterplate inner letterplate cover metal coat hook rack	All door fixtures show light surface wear and minor scratches All secured and in general good condition

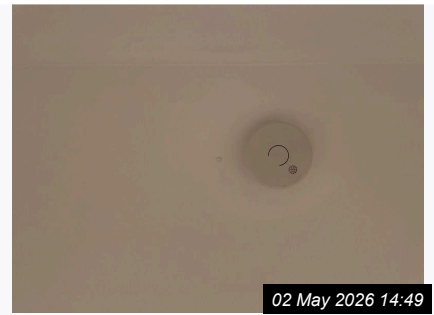
Ref #6.3

6.3	Ceiling	Smooth white painted	Ceiling appears clean with no visible signs of damage or staining.
6.4	Lighting	Recessed ceiling downlights with a circular metallic trim	Lights are operational

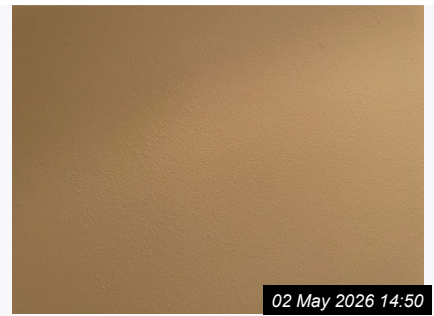
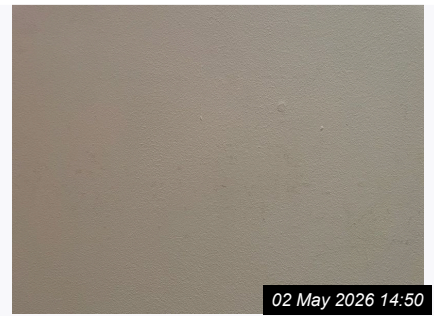
Ref #6.5

6.5	Walls	Painted plaster walls in a light beige or off-white colour	Minor scuff marks, light stains and some slight surface blemishes are visible in several areas.

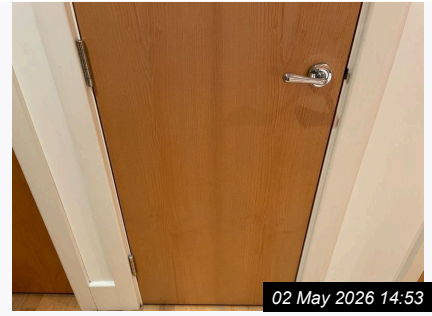
Ref #6.10

6.9	Flooring	Light oak engineered wood	Multiple scratches and scuff marks present throughout some visible dark markings and minor surface wear.
6.10	Built-In Storage	Storage cupboard with wood veneer door, chrome handle, internal shelf and housing for hot water cylinder.	Wood veneer door has scratching and paint loss at low level internal floor area is dusty with visible debris shelf and structure otherwise intact.
Contents

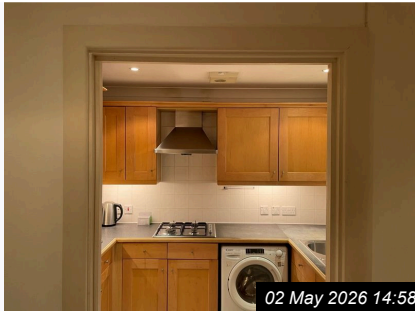
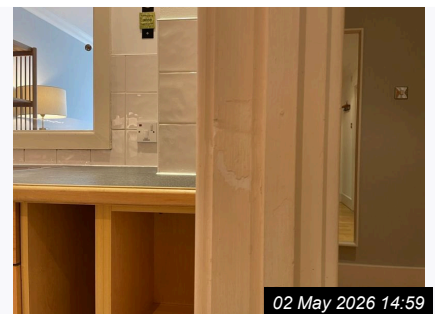
Ref #7.1

Ref	Name	Description	Condition
7.1	Door Frame	Timber door frame finished in white paint No door fitted	Minor chips and scuffs, shading or wear to low level

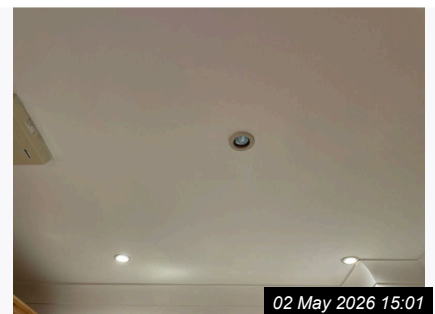
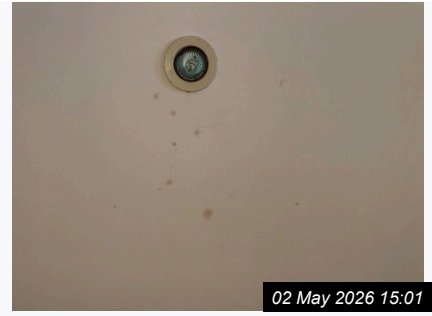
Ref #7.2

7.2	Ceiling	Smooth painted plasterboard ceiling in white	Several small stains and marks are present around some downlights otherwise ceiling appears intact.

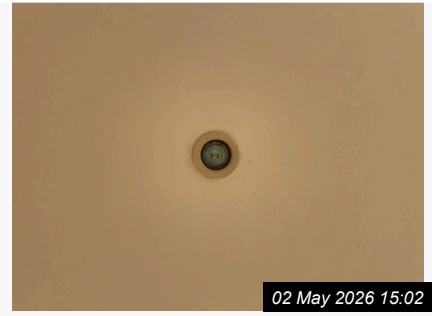
Ref #7.4

1. SCHEDULE OF CONDITION		
Ref	Name	Condition
1.1	Decorative Order	Good decorative order.
1.2	Ceilings	Good condition.
1.3	Lights	Kitchen - 1x spotlight lightbulb not working. Bedroom - black burn-type mark to ceiling surrounding 1x lighting fixture. Bathroom - mirror-mounted light not working.

7.3	Extractor Fan	Beige plastic extractor fan	Appears some light marks or stains Functional
7.4	Lighting	Ceiling recessed lights with metallic trim and three under-cabinet LED strip lights	1x spotlight lightbulb not working <a href="#">Review - Investigate</a>

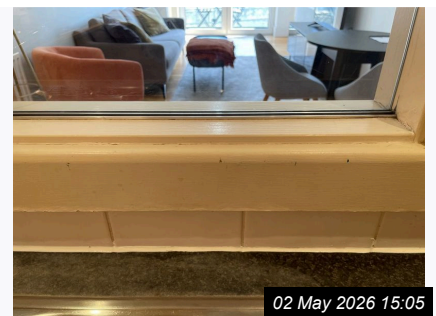
Ref #7.7

7. KITCHEN (CONT.)			
7.7	Window & Sills	Large internal window with clear glass cream-painted wooden frame decorative sunflower sticker on the pane.	Glass is clear with no visible cracks frame shows some small marks and minor paint chips overall intact.

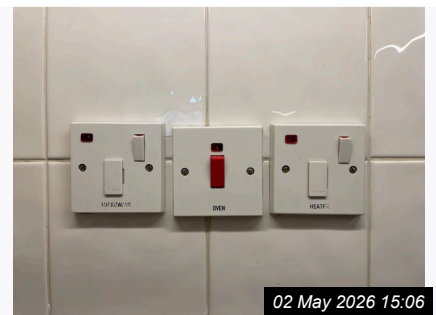
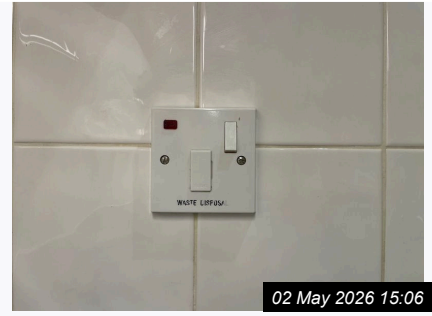
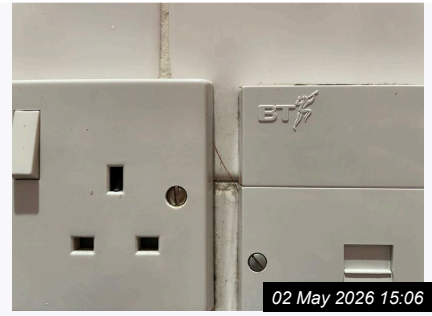
Ref #7.8

7.8	Switches/Socket	Assorted white plastic and metal switches and sockets	Slight discolouration, generally good condition
7.9	Flooring	Large rectangular ceramic tiles in a grey stone-effect finish with subtle veining and light speckling.	Flooring is overall intact with one visible hair

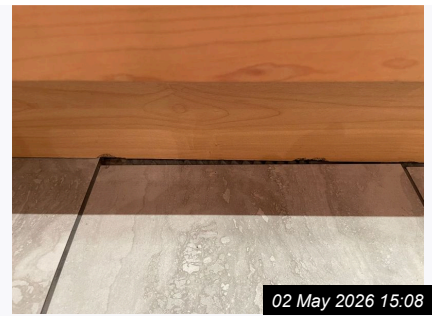
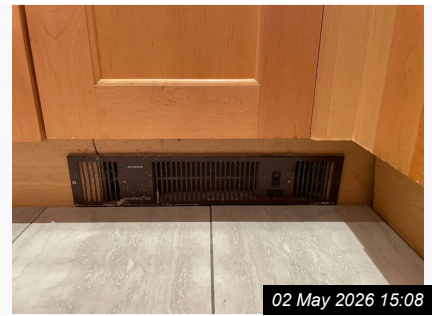
Ref #7.10

1.9	Kitchen & Appliances	Kitchen Units - significant crack to kickboard to LHS around heater area. Worktop - multiple, varied defects incl. swollen/lifting laminate, square-shape cut-out section/area of repair and visible MDF to opposite side. Sink - cracks/parts partially not seen to tap base. Fridge-Freezer - significant cracks to 1x fridge door shelf. Tear to freezer door seal/gasket to RHS/corner low level. Extractor Hood - indentation to left filter. Dishwasher - crack to trim/surround to LHS around power button area.

7.10	Kitchen Units	Light wood kitchen units with panelled doors	Plinths show multiple chips and scuffs, visible gaps and damage at joints brown kickspace heater has dirt and cobwebs overall units show wear at lower edges Kickboard not properly fitted to opposite LHS <a href="#">Review - Investigate</a>

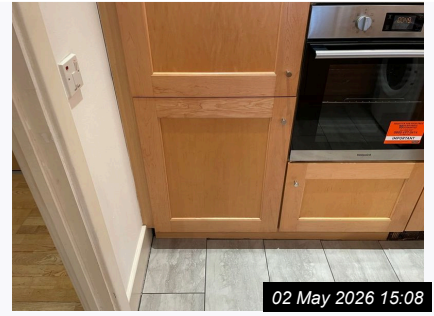
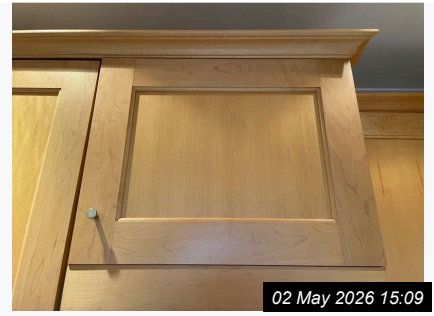
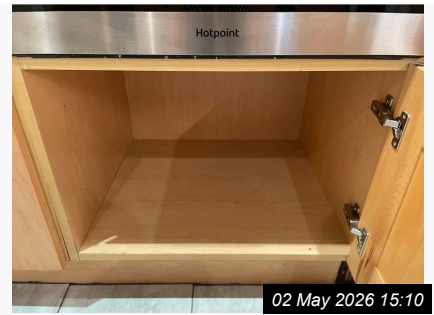
Ref #7.11

7.11	Tall Units	Tall units in the kitchen with light wood effect finish, featuring shaker style doors, integrated shelving, and built-in appliance housing.	Tall units show notable wear with visible paint and veneer damage at the bottom area minor chips and scuff marks present overall structurally intact.

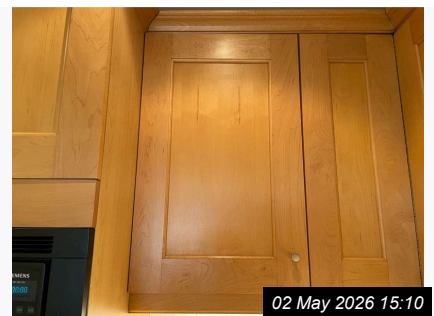
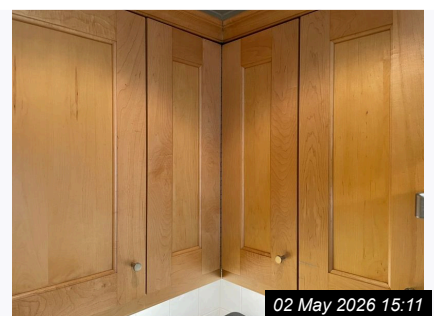
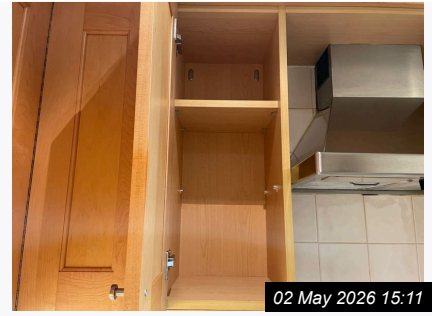
Ref #7.12

7.12	Wall Units	Wall units are constructed from light wood with a natural finish, feature panelled doors with metal knobs, and contain adjustable internal shelving.	Several units have visible scratches, scuff marks, chipped edges some panels show small surface blemishes and general wear.

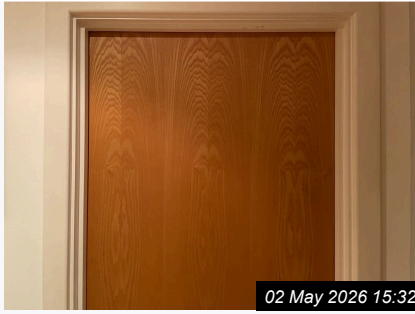
Ref #8.1

Ref	Name	Description	Condition
8.1	Door & Frame	Flush brown wood veneer door set in a white painted timber frame.	Bottom edge of door shows visible chip and wear frame has minor paint scuffs and marks hinges and handles intact and operational.

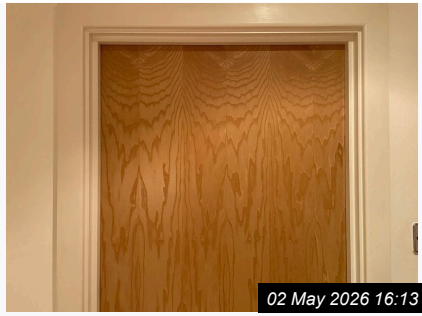
Ref #10.1

Ref	Name	Description	Condition
10.1	Door & Frame	Brown veneered timber door with a white painted wooden frame	Lower edge of door shows swelling and chipping frame has paint scuffs and damage near the base minor wear in places Door has surface staining and water damage to veneer <a href="#">Review - Investigate</a>
