Inventory & Check In

AVINTO
PROPERTY SERVICES

Example
Inventory
Report

May
1st 2026

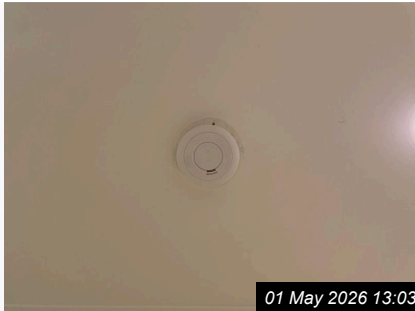
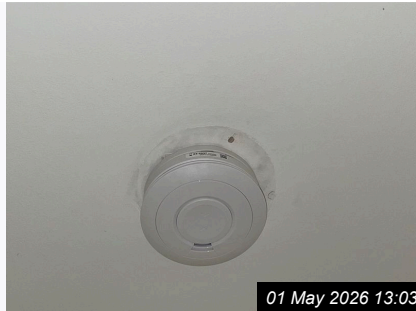
Ref #5.1

5. SMOKE AND CO ALARMS			
Ref	Name	Location Room & Floor	Test Result
5.1	Smoke Detector/Fire Alarm	Location: Entrance Area Floor: 1st Floor	Tested, power seen and heard. Replacement date March 2037.
5.2	Smoke Detector/Fire Alarm	Location: Entrance Area Floor: 1st Floor	Tested, power seen and heard. Replacement date not seen.
5.3	Carbon Monoxide Detector/Alarm	Location: not located Floor: n/a	Not located Note: CO detector/alarm required due to gas supply but not seen nor found. Review - Investigate

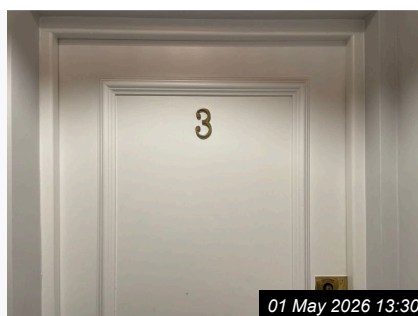
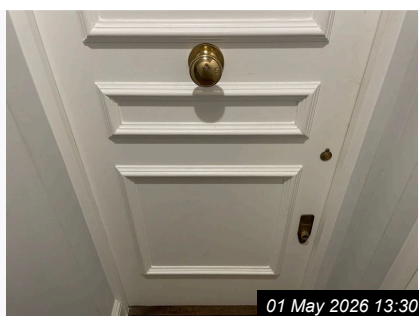
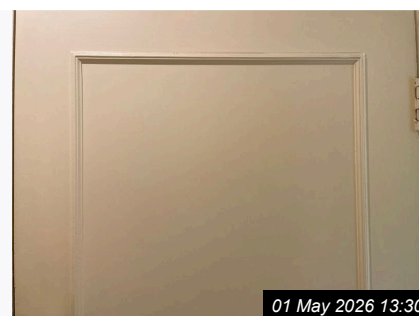
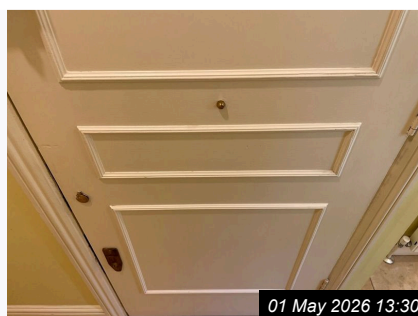
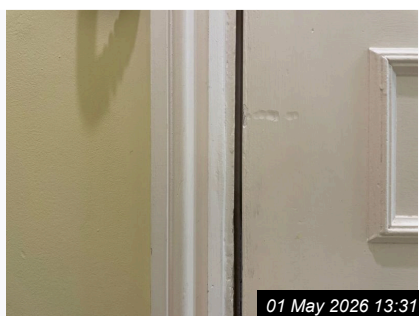
Ref #6.1

Ref	Name	Description	Condition
6.1	Door & Frame	White painted wooden door and frame with raised panel detailing	Door and frame display minor scuff marks, light scratches, small paint chips, and some general wear around edges

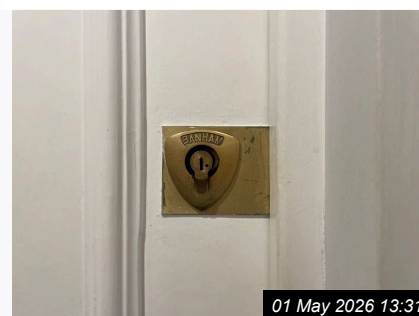
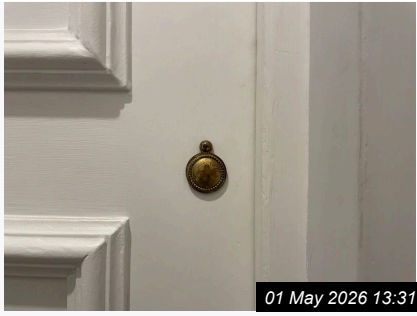
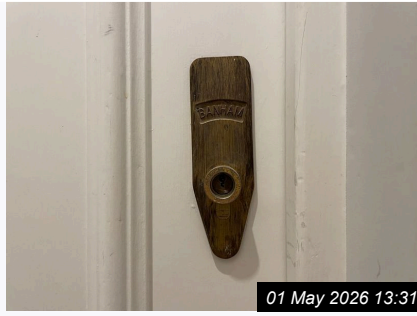
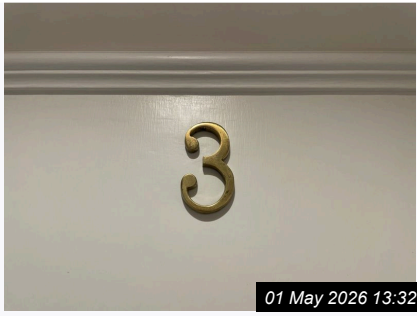
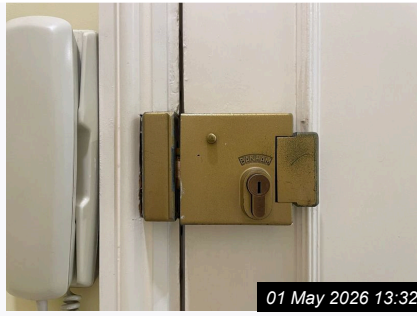
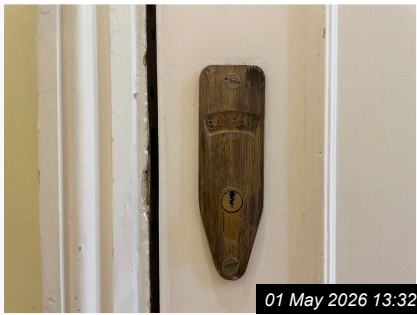
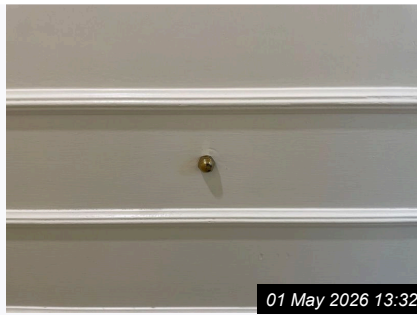
Ref #6.2

6.2	Door Fixtures	Brass Banham locks brass door knobs small brass door viewers and escutcheons brass door number	Visible surface wear and tarnishing on all brass fixtures scratches and some scuff marks present no signs of major damage.

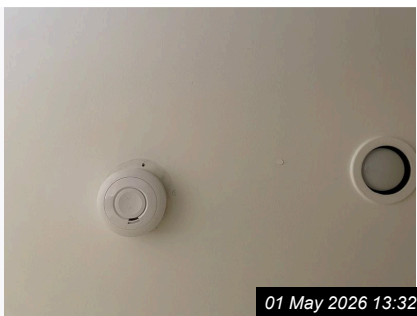
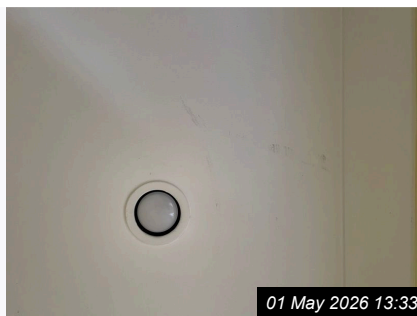
Ref #6.3

6.3	Ceiling	Smooth painted plaster ceiling in white	Ceiling has minor scuff marks some visible wear around the smoke detector and light fittings.
6.4	Lighting	Ceiling-mounted recessed round lights with white trim and frosted glass covers.	In good, working order

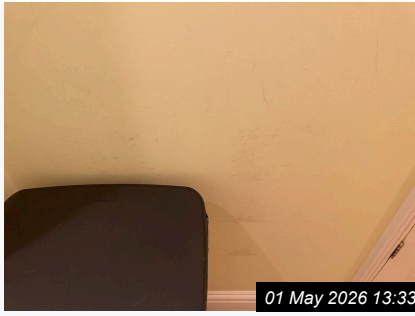
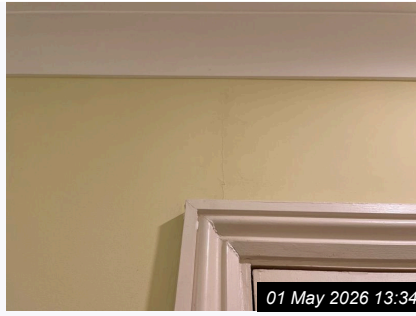
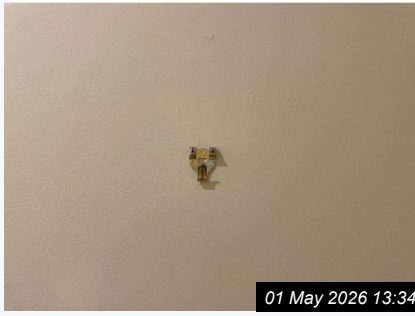
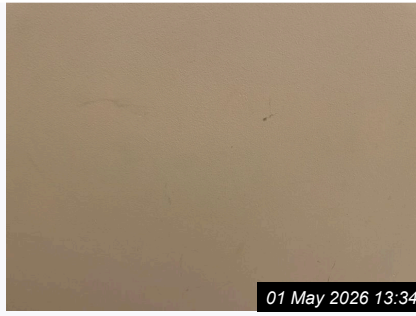
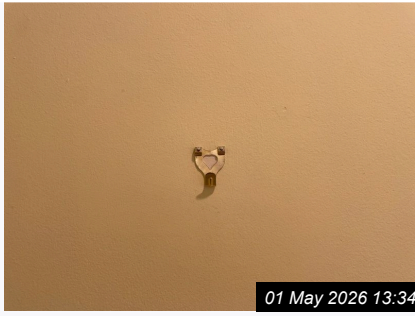
Ref #6.5

6.5	Walls	Plastered walls painted in pale yellow	Walls show multiple scuff marks and some light stains few light minor cracks near trim some areas where hooks are installed.

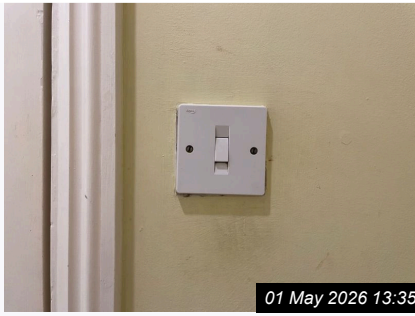
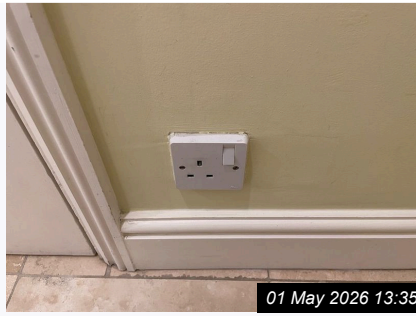
Ref #6.7

6. ENTRANCE AREA (CONT.)			
6.7	Switches/Sockets	White plastic light switches single white plastic switched power socket with standard UK configuration	All units show minor marks around the edges and light surface scuffs
6.8	Heating	White metal panel radiator featuring two visible valves and a vented top grille.	Some surface dirt and dust build-up on the top grille and external surfaces minor marks visible but no significant damage or rust observed.
6.9	Flooring	Beige stone-effect ceramic tiles	Multiple tiles show discolouration, scratches, cracks and surface staining, with worn and incomplete grouting at several edges.
6.10	Built-In-Storage	Wall-mounted white painted wooden cabinet Housing fuse box	Cabinet door and frame show no visible damage internal unit appears undamaged and clean Some paint chips to interior

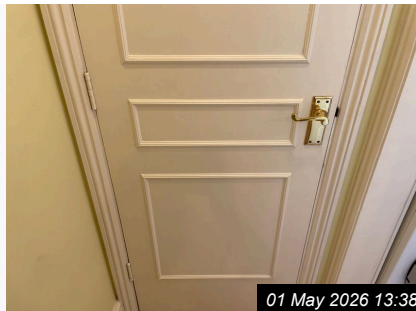
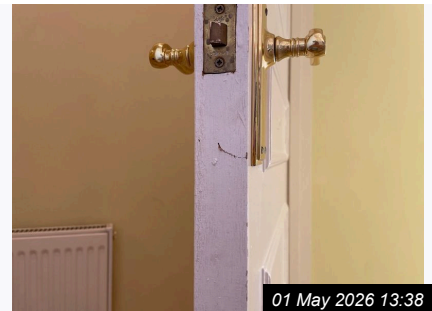
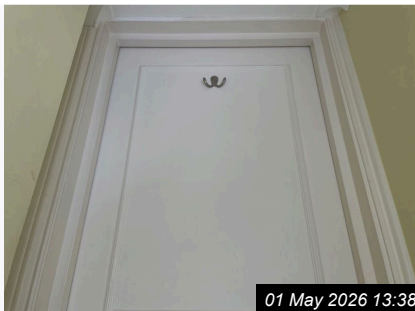
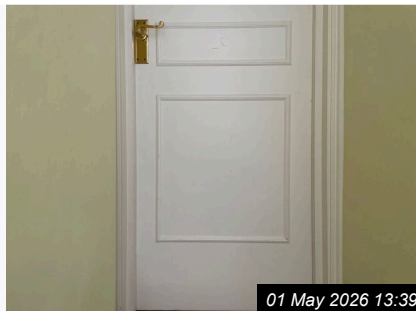
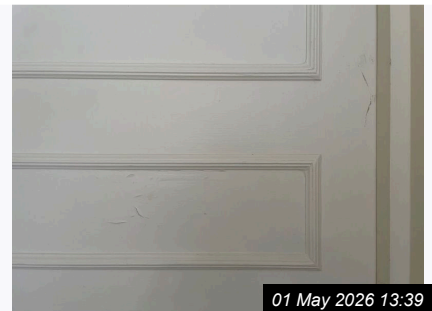
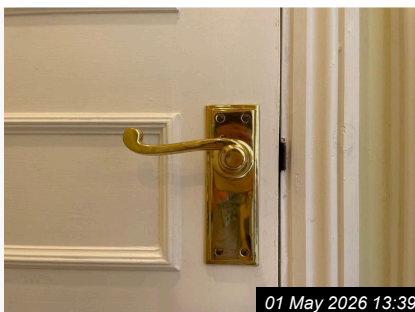
Ref	Name	Description	Condition
7.1	Door & Frame	White painted wooden door with three recessed panels and decorative trim Door frame is also white with decorative moulding.	Door and frame show scuff marks Few minor chips and cracks some paint wear, surface scratches, and light damage near the lock area.

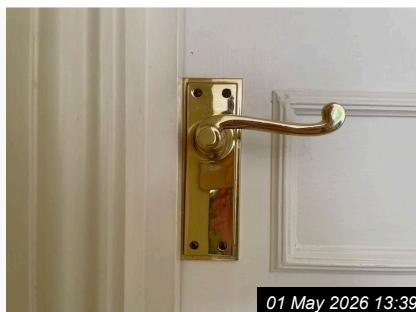
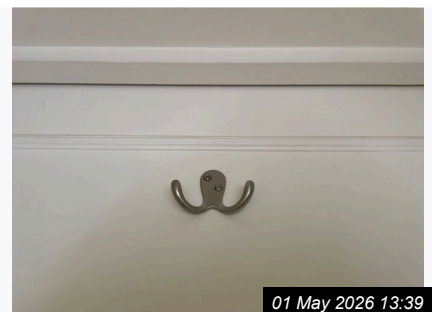
7.2	Door Fixtures	Polished brass lever handles on rectangular backplates brushed metal double coat hook fitted to a white painted door.	Handles and hook show no visible signs of damage

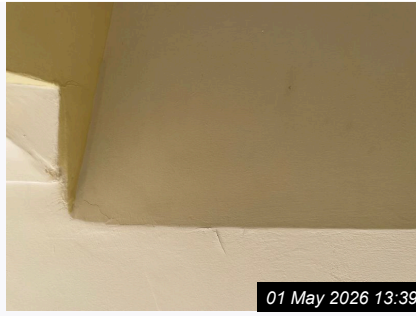
7.3	Ceiling	Painted plaster ceiling in a light cream shade with visible angled features and flat finish.	Multiple hairline cracks, minor marks, and some discolouration are present. Discolouration/staining to opposite side appears due to water damage Review - Investigate

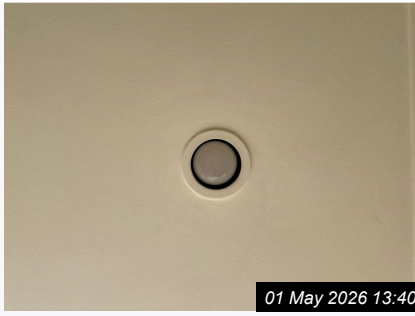
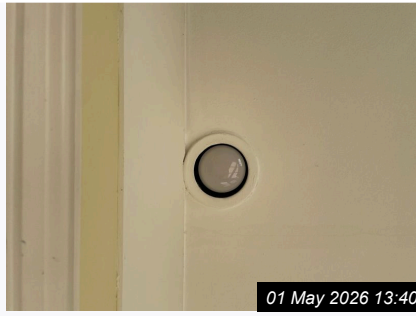
7.4	Lighting	Recessed ceiling downlights with frosted glass diffusers and white trim.	No visible damage or wear to fittings or glass minor marking around one light trim.

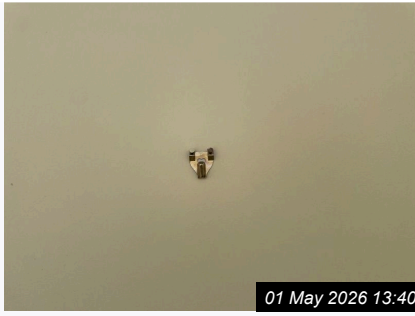
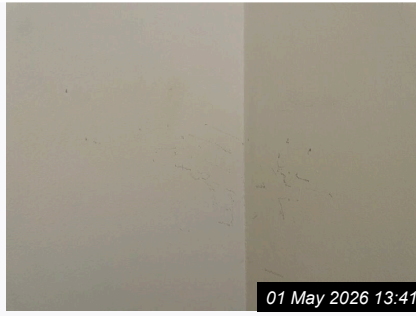
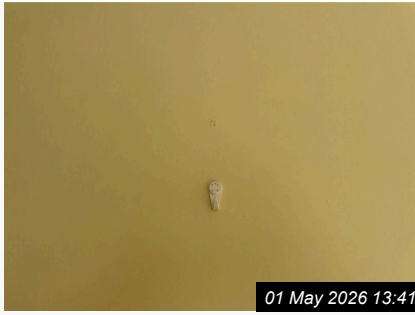
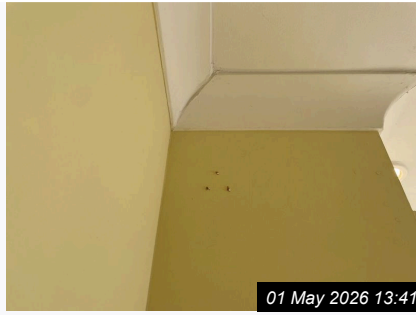
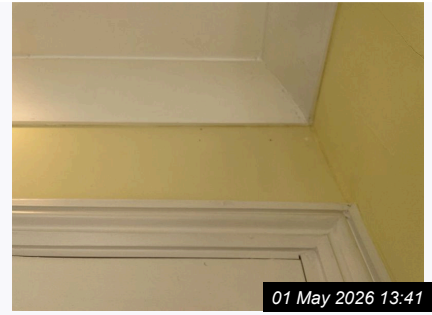
7.5	Walls	Painted plaster walls in light cream and pale yellow shades	Multiple scuff marks, patches of minor soiling, areas of paint touch-up small cracks and visible holes from previous fixings throughout.

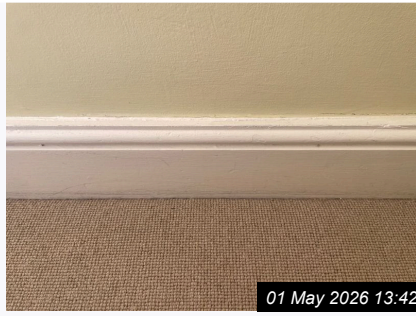
Ref #7.6

7. BEDROOM (CONT.)			
7.6	Skirting	White painted wooden	Visible paint scuffs, minor chips, cracks and some gaps at joints localised signs of wear and some areas showing paint loss

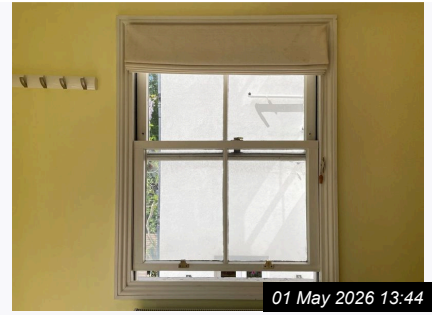
Ref #7.7

7.7	Window & Sill	White painted wooden sash window with brass catches and a matching painted sill	Window paint shows minor chips and wear visible cracks on sill and frame brass catches are tarnished some dirt and residue on glass and sill. Unable to close sash window fitch lock appears due to misalignment of windows Review - Investigate

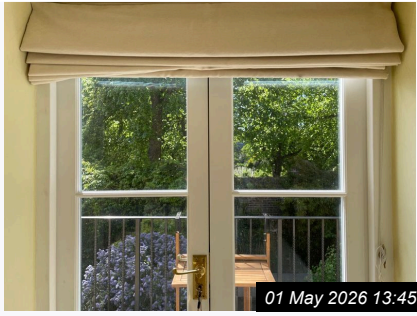
Ref #7.8

7.8	Door to Balcony	White painted timber French doors with: clear glass panels brass handle and lock brass top and bottom bolts leading to the balcony.	No visible cracks or major damage some minor surface marks and slight tarnishing on some brass fittings generally well preserved.

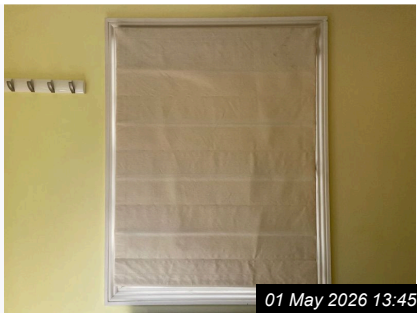
Ref #7.9

7.9	Blinds	Cream-coloured fabric Roman blinds with white pull cords and wooden pulls	Blinds show multiple marks and some staining Mild creasing, loose lower stitching, and partially detached lower edge.

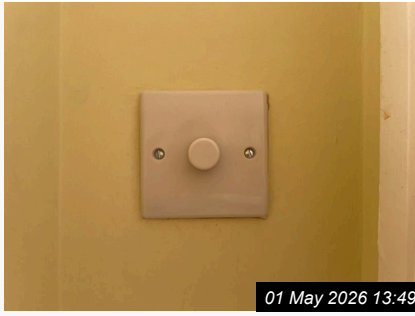
Ref #7.10

7.10	Switches/sockets	White plastic rotary dimmer switch white plastic standard rocker light switch white single switched socket white double switched socket white TV aerial socket.	Light tarnish, generally good condition

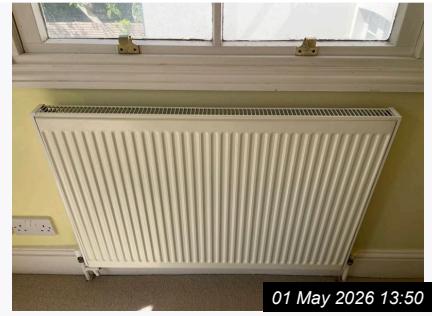
Ref #7.11

7.11	Heating	Wall-mounted white metal panel radiator	Radiator has visible dust and debris inside the top grille minor marks on the exterior but no obvious signs of damage or rust.

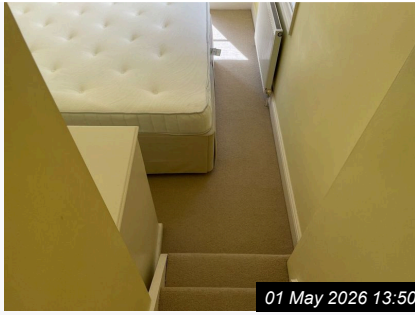
Ref #7.12

7.12	Flooring	Fitted short-pile carpet in a light beige	Carpet shows minor discolouration and light soiling in some areas with no visible tears or major damage.

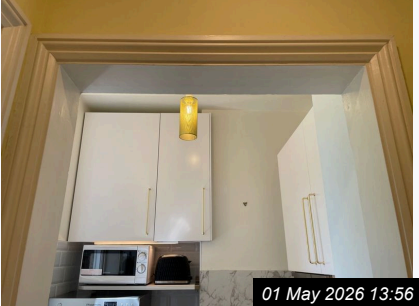
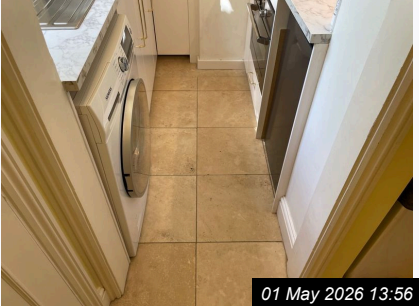
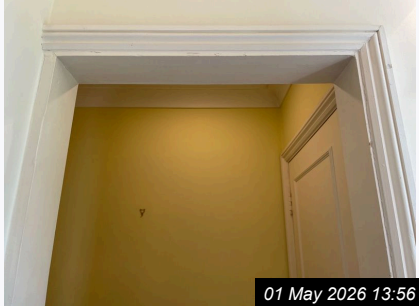
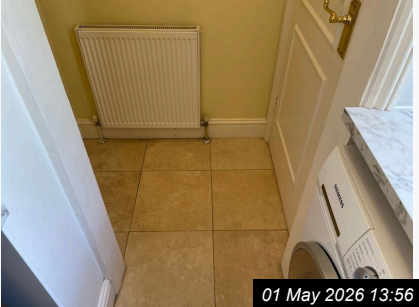
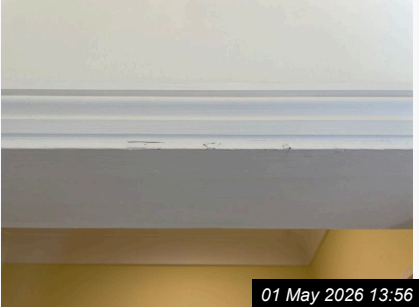
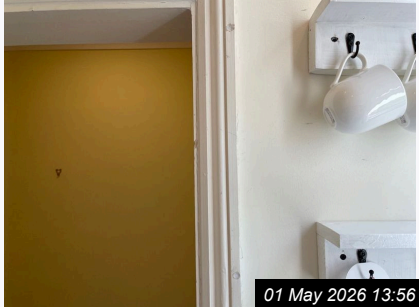
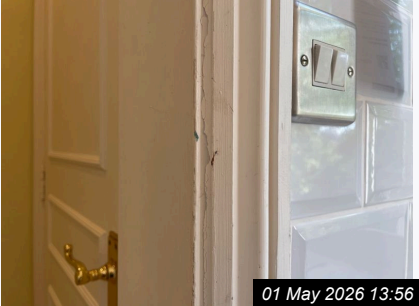
Ref	Name	Description	Condition
8.1	Door Frame	Timber door frame finished in white paint with panel detailing and standard architrave.	Frame has visible paint chips and scratches some areas of paint cracking and minor scuffs.

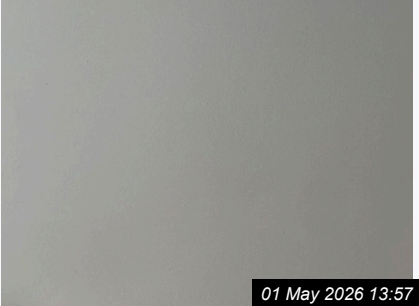
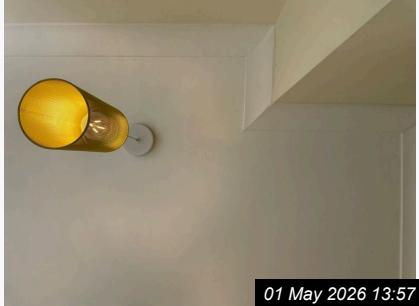
8.2	Ceiling	Smooth white painted plaster	Ceiling appears clean and intact with no visible marks, stains, or damage.
8.3	Lighting	Two ceiling pendant lights with cylindrical yellow mesh metal shades two under-cabinet strip lights one square white wall sconce with exposed bulb	All lighting appears intact and functional no visible damage or signs of wear

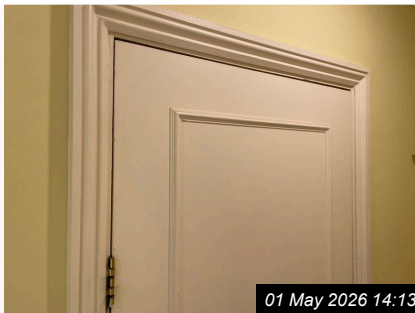
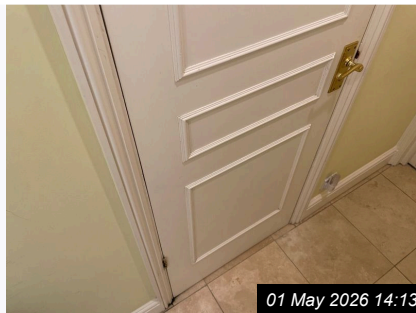
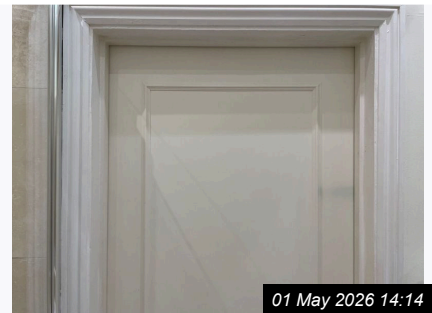
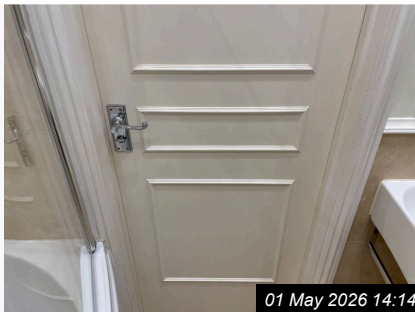
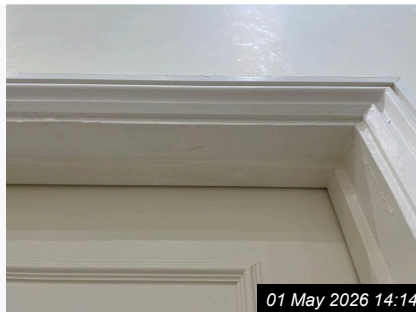
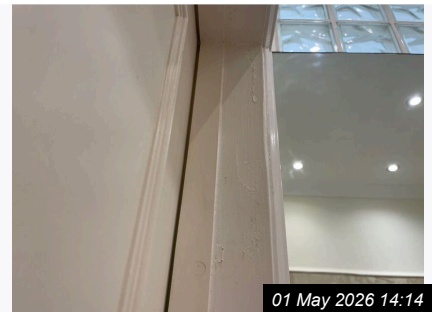
Ref #9.1

Ref	Name	Description	Condition
9.1	Door & Frame	White painted wooden panel door with matching frame featuring decorative mouldings.	Minor scuffs and paint imperfections on the frame and some edges otherwise intact with no major damage.

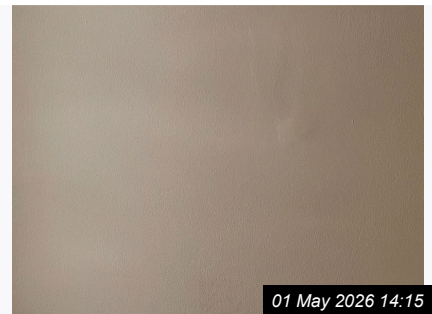
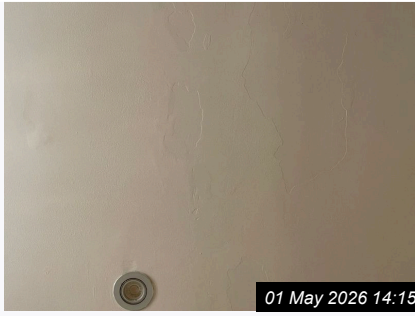
Ref #9.3

9.3	Ceiling	Painted plaster ceiling in white	Some surface unevenness Generally good condition
9.4	Extractor Fan	White plastic extractor fan	Appears in good condition

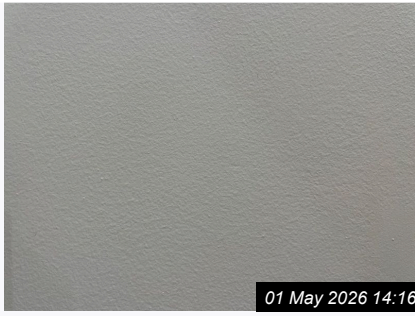
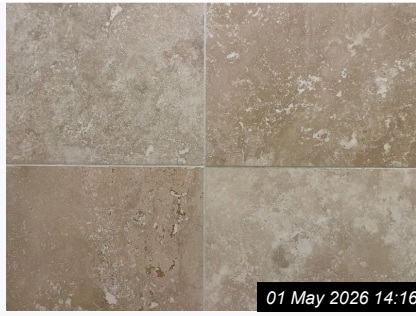
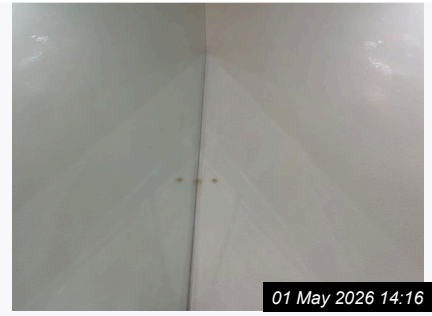
Ref #9.6

9.5	Lighting	Four round flush-mounted ceiling spotlights with metallic trim.	Spotlights appear intact
9.6	Walls	Mixture of off-white painted plaster walls and beige stone tiles	Painted walls show cracks, surface peeling, small dents, stains, and scratches; tiled surfaces show a chipped tile and discolouration in some areas.

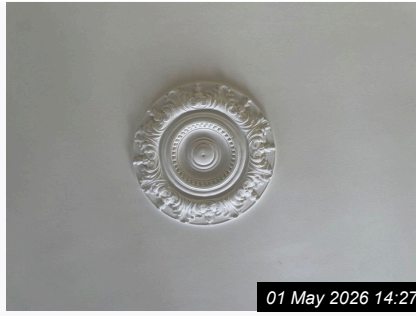
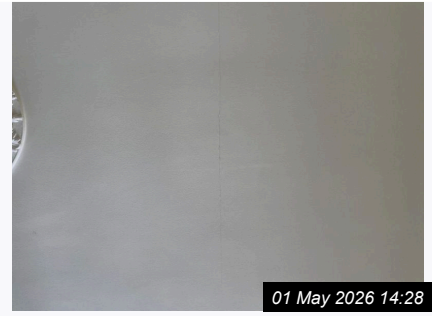
Ref #10.3

10.2	Door Fixtures	Polished brass lever handles with rectangular backplates	Handles display minor surface marks and light tarnish
10.3	Ceiling	Smooth white painted plaster ceiling with central decorative plaster ceiling rose.	Minor visible hairline crack near decorative rose

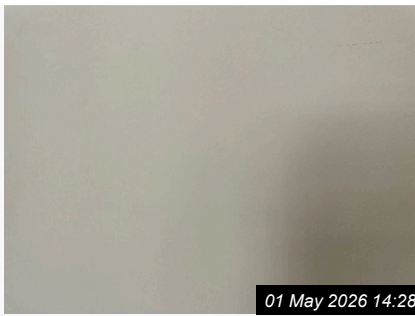
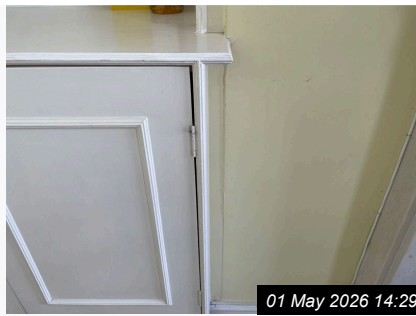
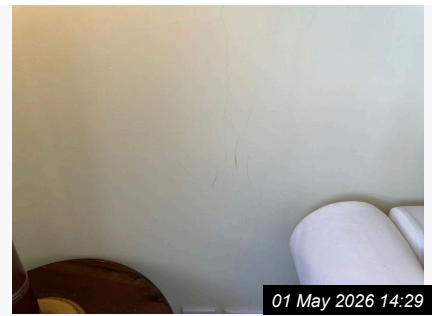
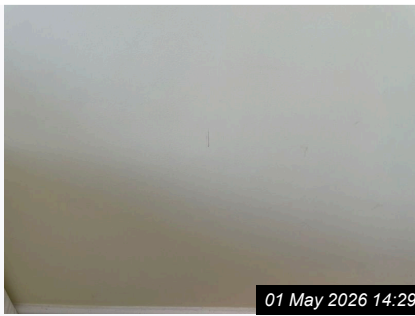
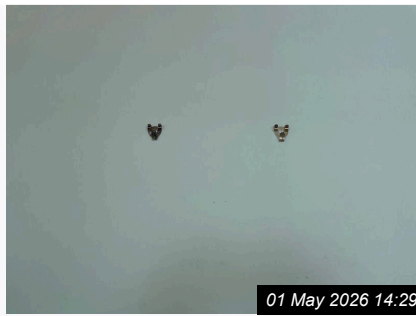
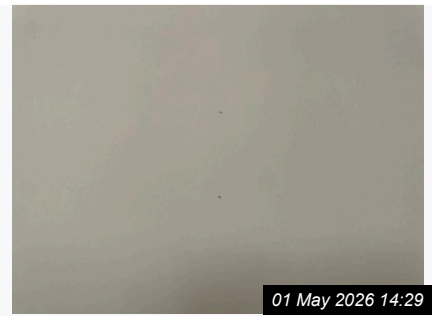
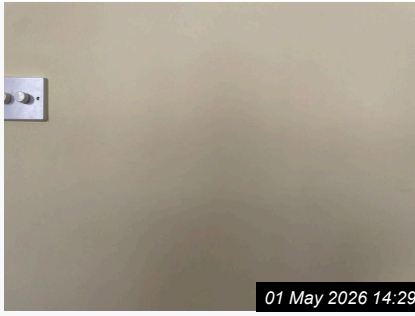
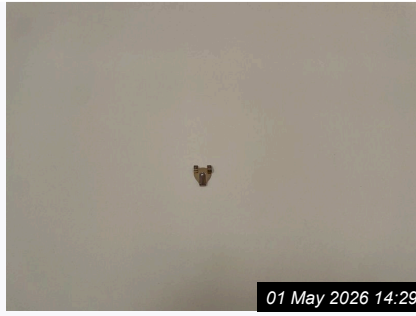
Ref #10.5

10.5	Walls	Plastered walls painted in a pale cream or off-white colour	Walls show scattered minor marks, a few small holes from wall hooks, visible cracks, and some signs of wear near edges.

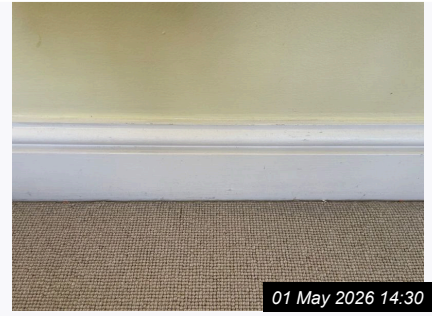
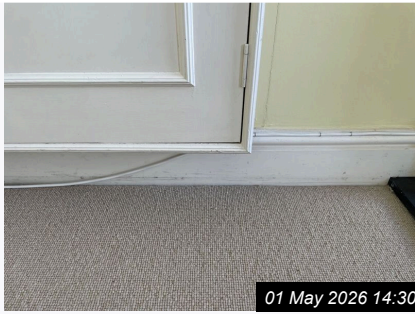
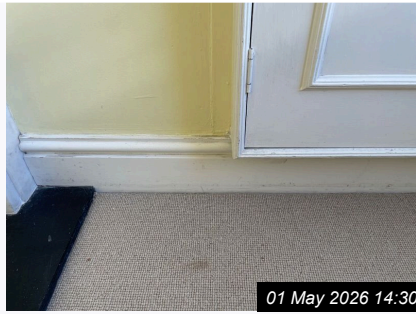
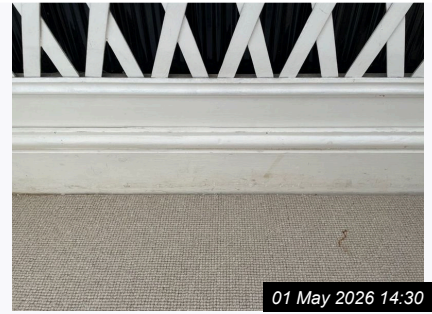
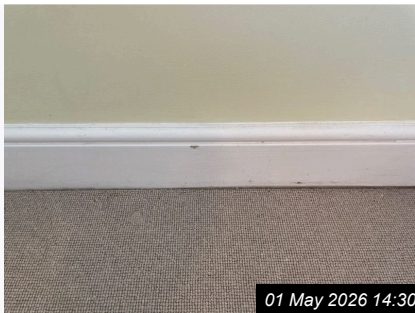
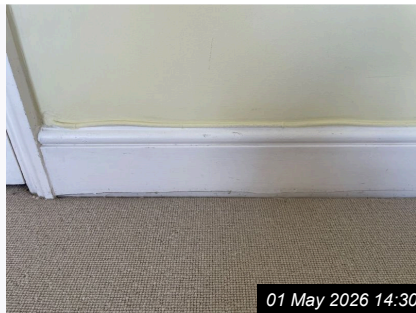
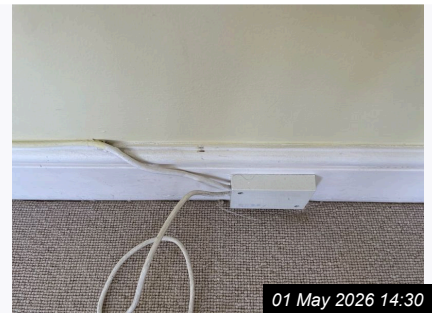
Ref #10.6

10.6	Skirting	White painted wooden	Multiple scuff marks, minor chips, paint wear, and some dirt visible along various sections.
10.7	Windows & Sills	White painted timber sash windows with brass fixtures and deep sills fitted with a window-mounted air vent.	Timber sills and frames show surface cracks and minor paint wear glass panels and metalwork have visible dust and smudges all hardware is intact.

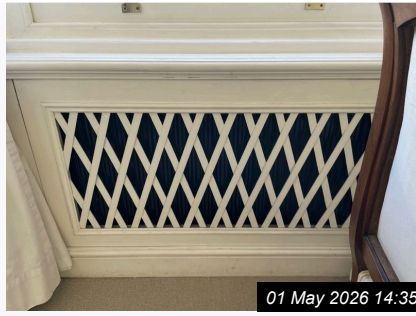
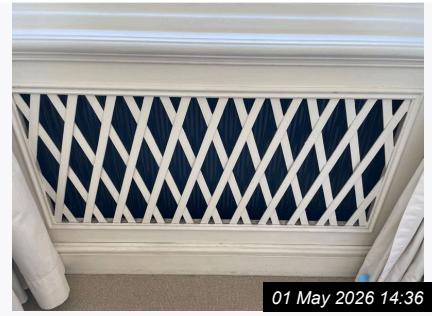
10.10	Heating	White painted wooden radiator	Both covers show minor scuff marks and light dirt near the base no visible major damage or deterioration.
10.11	Flooring	Beige loop-pile carpet	Carpet shows signs of use including: visible indentation marks several light and dark stains areas of discolouration.

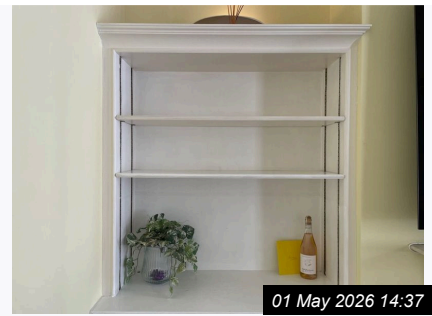
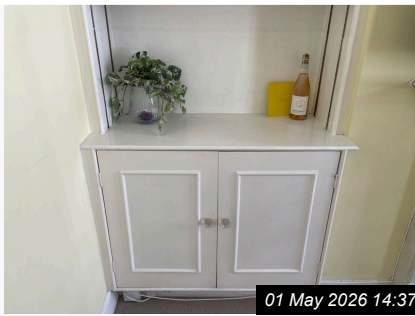
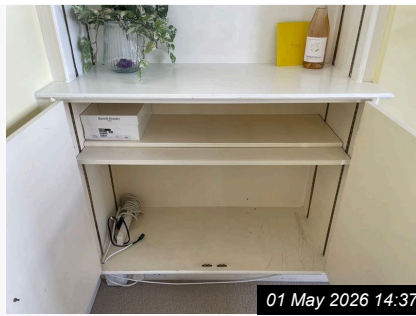
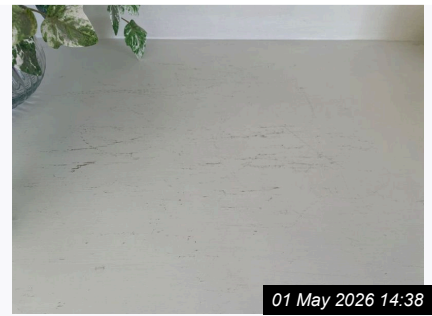
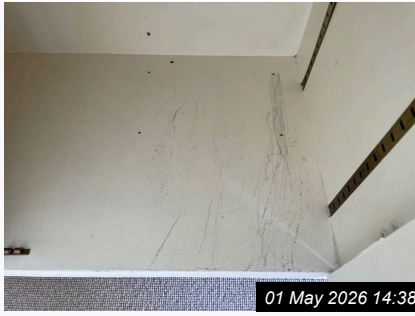
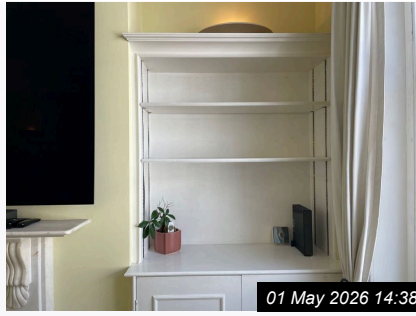
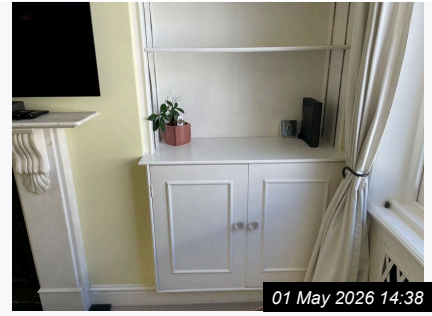
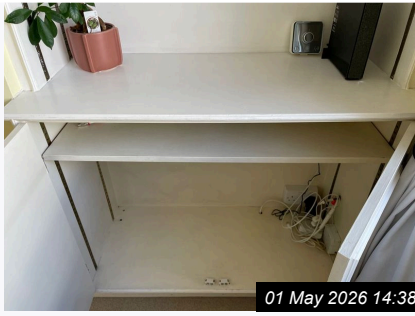
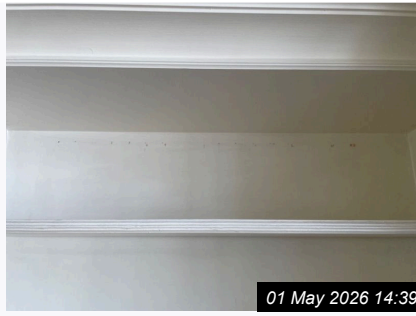
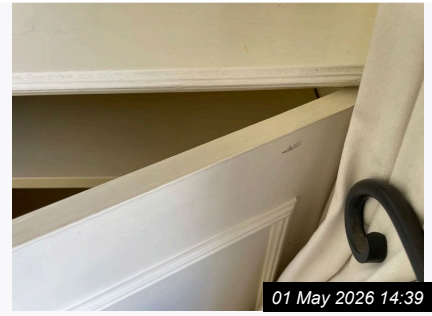
10.12	Built-In Storage	Painted white built-in shelving and cupboard unit with adjustable shelves and panelled doors	Visible scratches and scuff marks on shelves and cupboards minor paint chips on doors general signs of wear throughout.
Contents

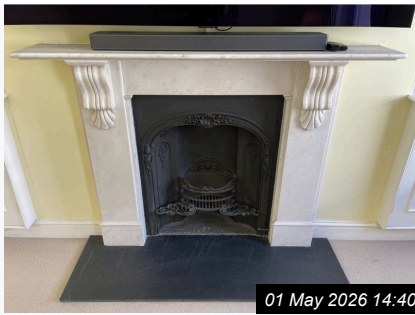
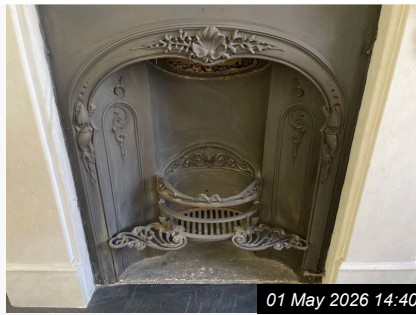
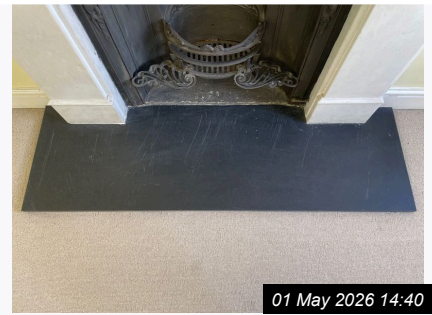
10. LIVING ROOM (CONT.)			
10.13	Fireplace	Marble surround with detailed corbels ornate black cast iron insert, and black hearth slab.	Some scuffing and scratches on the hearth minor soot deposits light surface rust inside the firebox no visible cracks or structural damage.

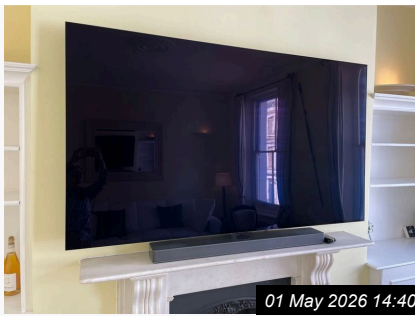
Ref #10.14

10.14	Television, Sound Bar and Remote Controls	Large flat-screen television wall-mounted above a white marble fireplace black LG sound bar and two LG remote controls placed on the mantelpiece.	Television, sound bar and remotes appear in good visual condition

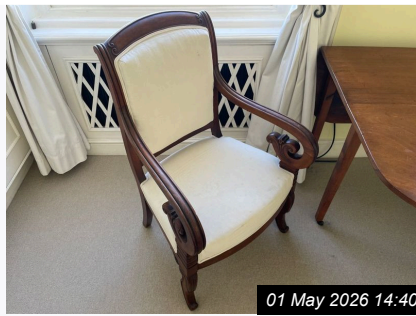
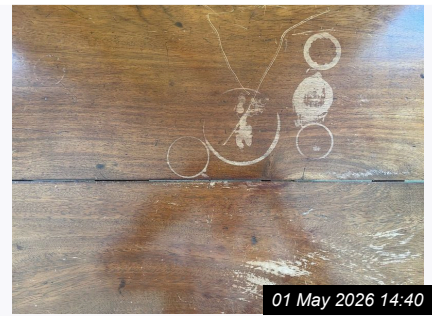
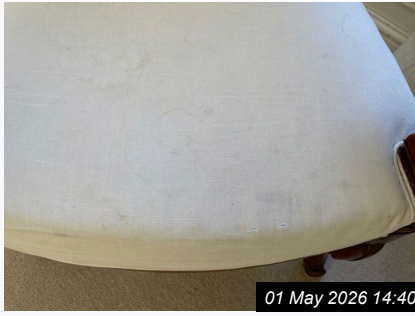
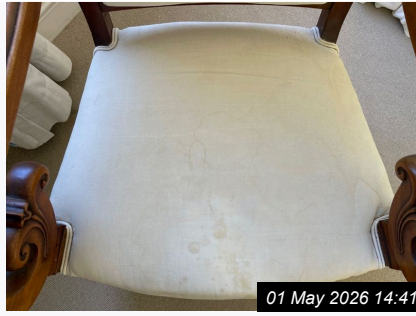
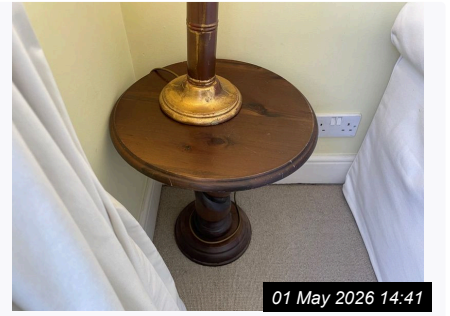
Ref #10.15

10.15	Table and Chairs	Wooden rectangular table with rounded edges and two matching wood-framed chairs with cream upholstered seats and backs.	Table has noticeable surface scratches and ring marks chairs have visible stains and some minor fabric wear on seats.

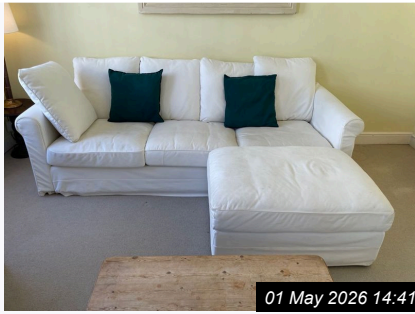
Ref #10.16

10.16	Side Table	Round wooden side table with a dark finish and a single thick pedestal base.	Tabletop and base show minor surface scratches and marks
10.17	Sofa and Footstool	Three-seat sofa and matching footstool upholstered in white fabric with two green velvet cushions included.	Minor surface stains visible on both the sofa seat cushions and the footstool

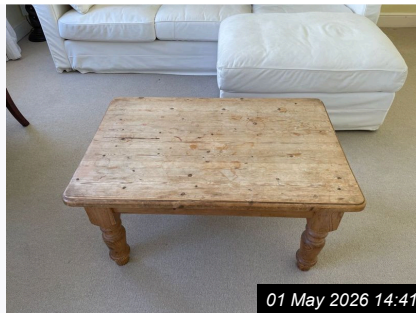
Ref #10.18

10.18	Mirror	Large rectangular wall mirror with wide light wood frame and bevelled edges.	Good condition with no visible scratches
10.19	Coffee Table	Rectangular wooden coffee table with a light natural finish and turned legs.	Tabletop shows multiple stains, ring marks, scratches, and signs of wear throughout.
Miscellaneous Items

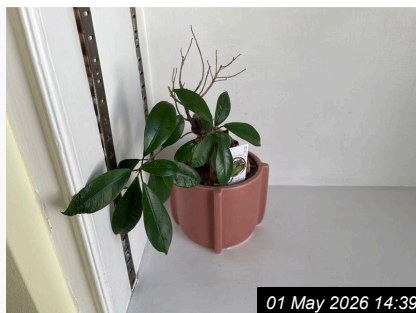
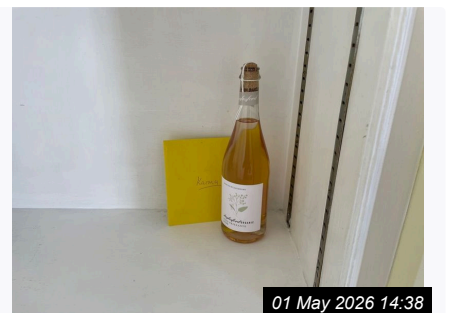
Ref #10.20

10.20	Plants	Variegated artificial trailing plant in a clear ribbed glass vase small live leafy plant with broad green leaves in a pink ceramic pot.	Artificial plant is in good condition with no visible damage live plant has healthy leaves with some bare branches present.

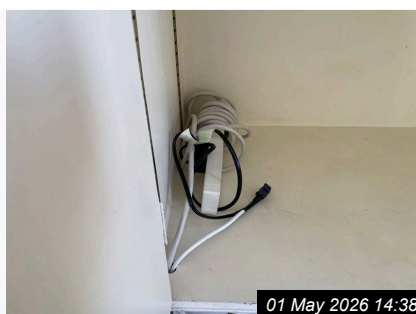
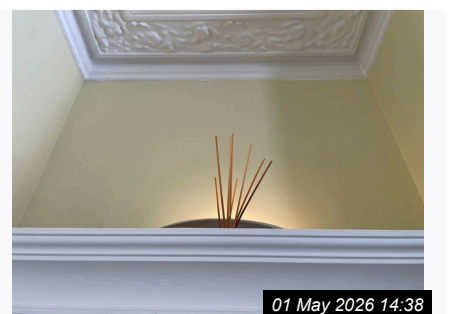
Ref #10.22

10.22	Shoebox	White Russell and Bromley branded cardboard shoebox with product labels attached	Good condition
10.23	Extension Lead	White plastic extension lead	Extension lead shows no visible damage

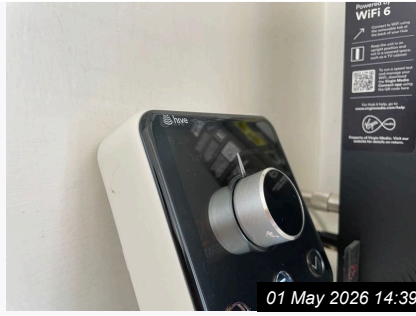
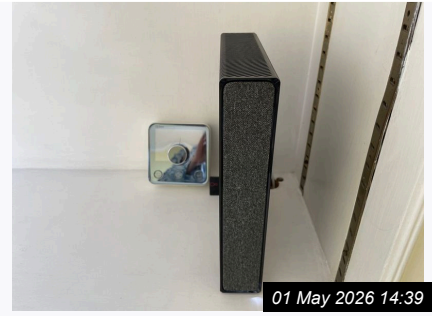
Ref #10.25

10.25	Thermostat	Digital programmable Hive thermostat with a black glass front and silver control dial	Display and dial appear intact with no visible damage minor surface marks on the white casing

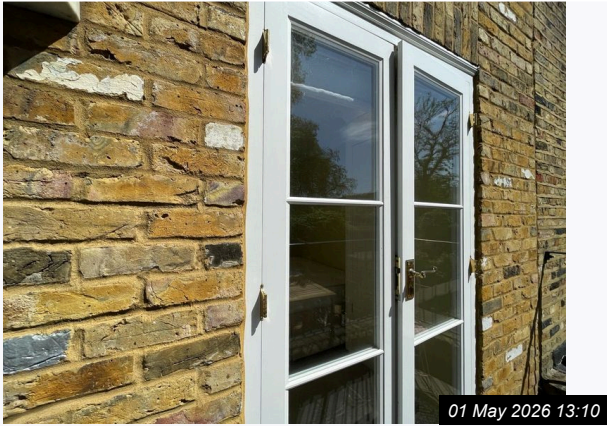
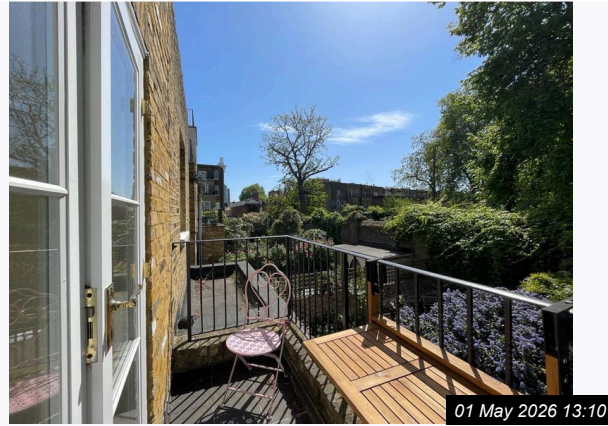
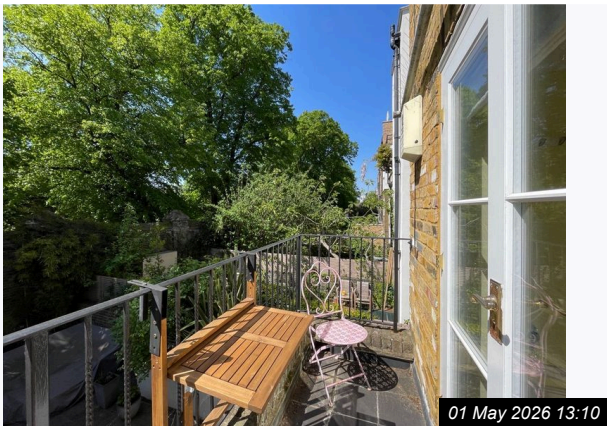
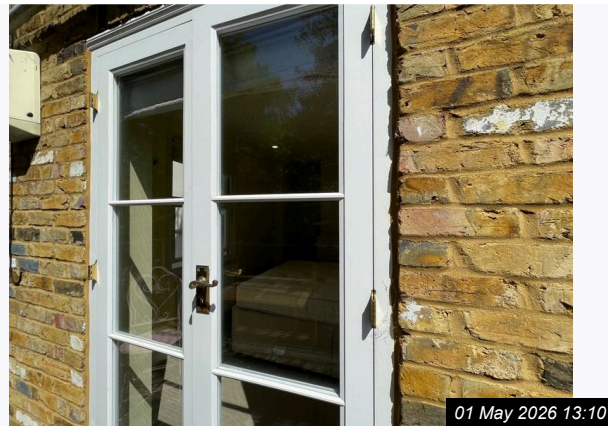
Ref #11

Ref	Name	Description	Condition
11.1	Door and Frame	White-painted wooden framed double doors with glazed panels and brass lever handle.	Some minor scuffs and wear to the paint finish and slight tarnishing to the brass handle door and frame otherwise intact and functional.
11.2	General Description	The balcony features black metal railings with twisted detailing dark stone floor tiles, a yellow brick wall, and a pink metal folding chair with a decorative back and perforated seat.	The stone floor tiles show signs of wear with cracking and surface damage some moss growth along brick edges the pink metal chair displays areas of rust and paint loss.
