# Inventory & Check In

**AVINTO**  
PROPERTY SERVICES

Example  
Inventory  
Report

**April**  
**22nd 2026**  
09:00

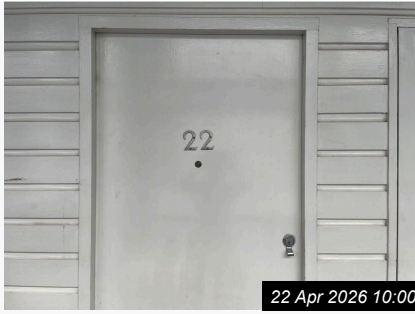
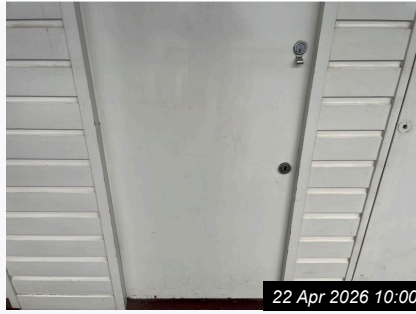
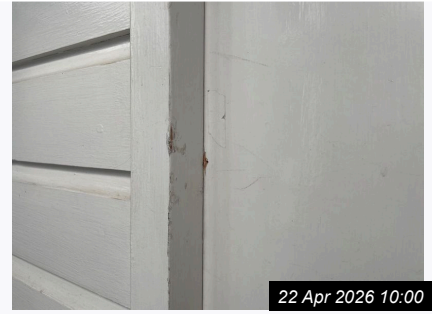
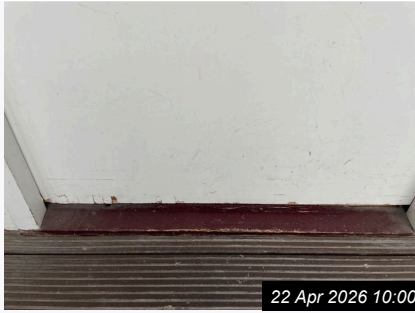
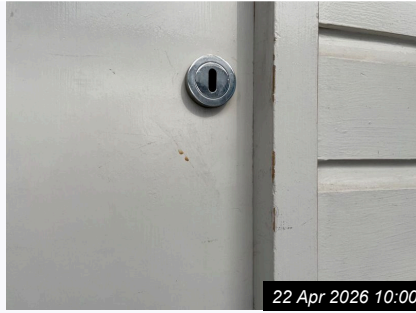
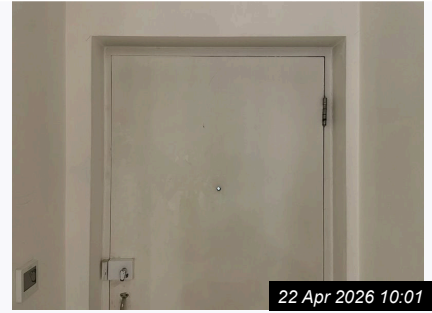
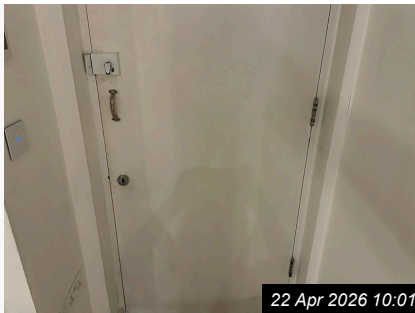
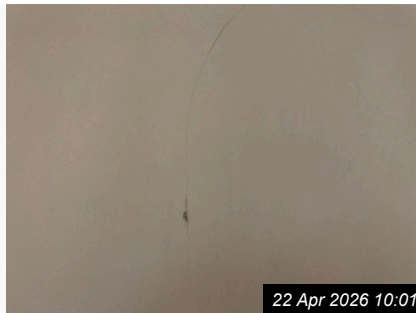
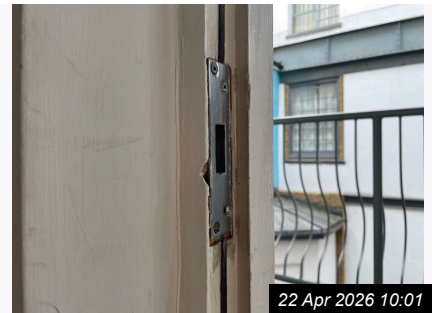
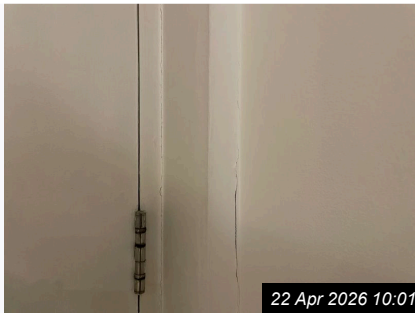
Ref #6.1

Ref	Name	Description	Condition
6.1	Door & Frame	Solid timber entrance door and frame painted white	Multiple scuff marks and scratches visible on both door and frame minor paint chipping some cracking to frame and chipped wood around lock strike plate wear to door threshold.
6.2	Door Fixtures	Chrome ERA cylinder lock chrome escutcheon chrome handle large painted turnbolt door viewer fitted metal number plate 22.	Mortise lock escutcheon to exterior loose/partially detached from door <a href="#">Review - Investigate</a>
6.3	Ceiling	Smooth white painted	Ceiling shows no visible signs of damage, stains or cracks.
6.4	Lighting	Recessed ceiling light with a silver trim	1x spotlight lightbulb not working <a href="#">Review - Investigate</a>
6.5	Walls	Painted plaster walls in white	Surface has various marks light scuffs and minor scratches visible patched or damaged sections around coat hooks.

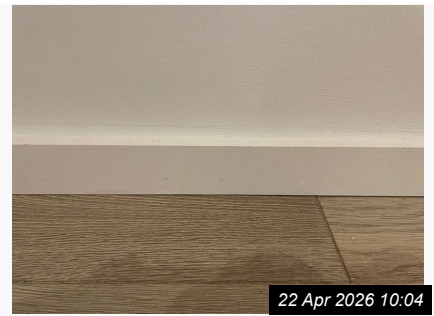
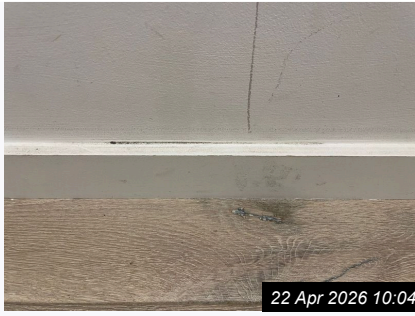
Ref #6.6

6. ENTRANCE & HALLWAY (CONT.)			
6.6	Skirting	White painted wooden	Multiple scuffs, stains, scratches and marks present some minor damage to paintwork and visible dirt in areas.

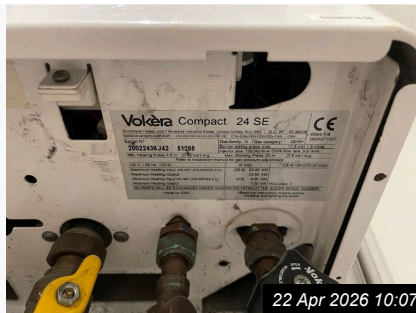
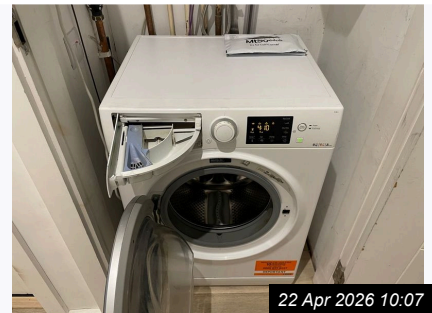
Ref #6.10

6.10	Boiler	White Vokera Compact 24 SE wall-mounted	Casing shows minor marks and surface dirt pipework visible with signs of use otherwise appears intact with no visible damage.

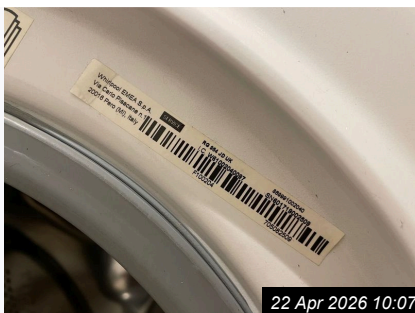
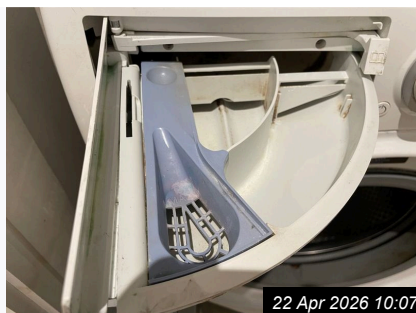
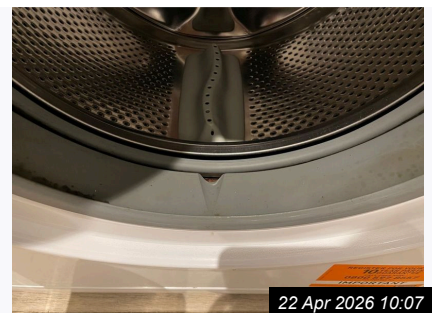
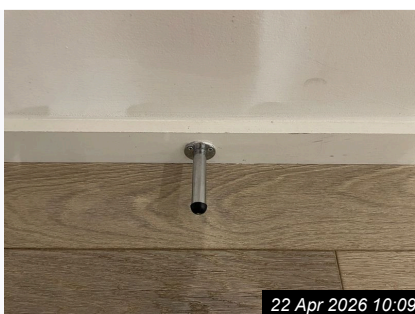
Ref #6.11

6.11	Washing Machine	Freestanding white front-loading Whirlpool washing machine with digital display	Detergent drawer shows signs of residue and rust Black marks to seal, possibly mould <a href="#">Review - Investigate</a>
Contents

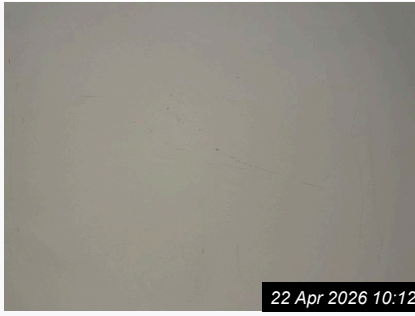
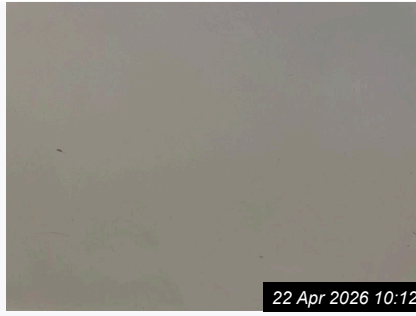
Ref #7.3

7.3	Walls	Painted plastered walls in white exposed yellow, black and brown brickwork.	Painted walls show multiple visible screw holes patch repairs and surface scuff marks; exposed brickwork is in good condition

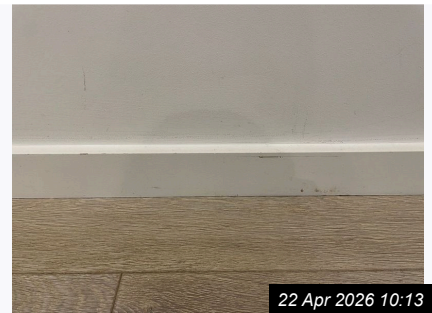
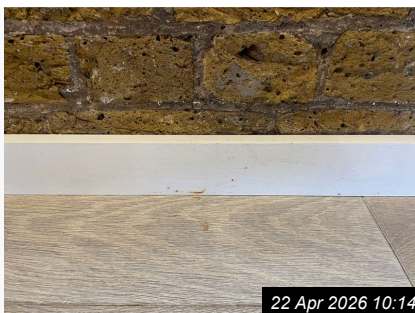
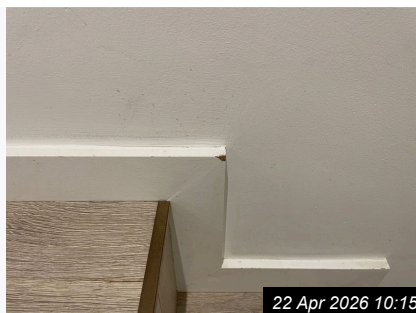
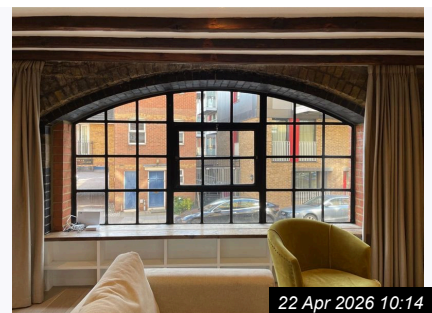
Ref #7.4

7.4	Skirting	White painted wooden	Light scuff marks slight stains and chipped paint present Generally appears in good condition
7.5	Window & Sill	Large arched industrial-style window with black metal framing and a wooden sill.	glass displays light dirt and smudges no visible cracks or major damage. Unable to fully open and close and lock window <a href="#">Review - Investigate</a>

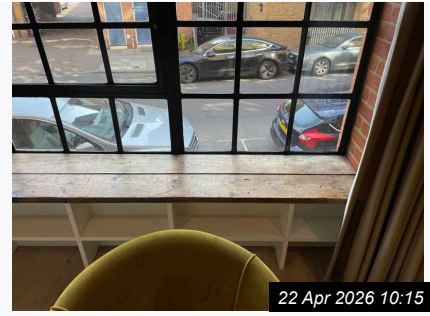
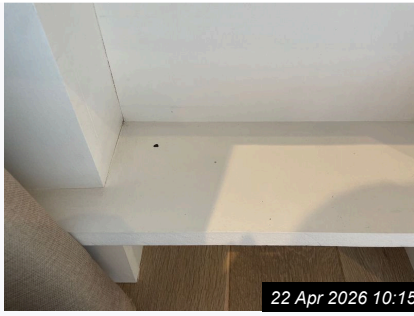
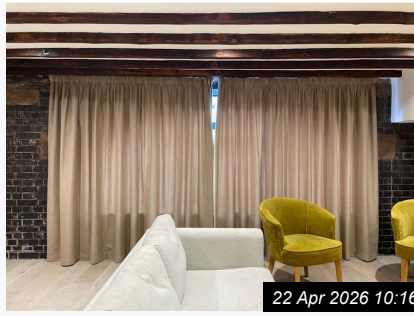
Ref #7.6

7.6	Window Sill/Built-In Storage	Timber window sill with a rustic finish and built-in white painted wooden storage shelves below.	Small chip to the paint

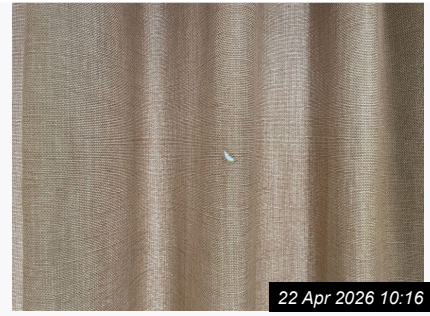
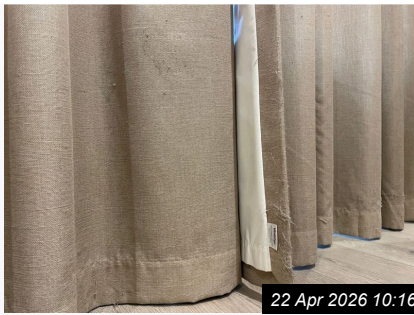
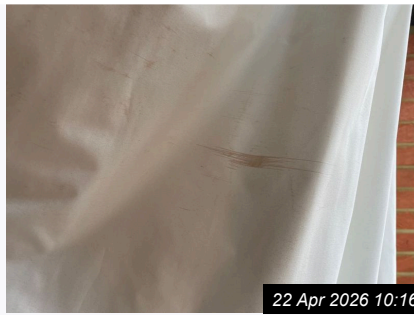
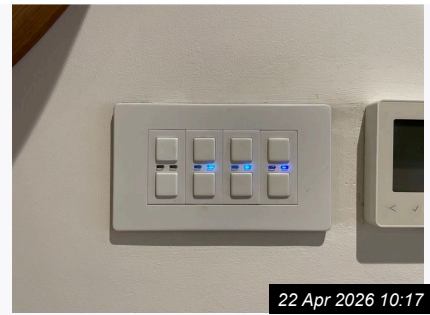
Ref #7.7

7. RECEPTION ROOM (CONT.)			
7.7	Blinds/Curtains	Pair of full-length beige fabric curtains with white lining and pleated headers	Curtains show visible stains and marks a small tear or hole fraying at the bottom edge minor discolouration and scuffing on the white lining.

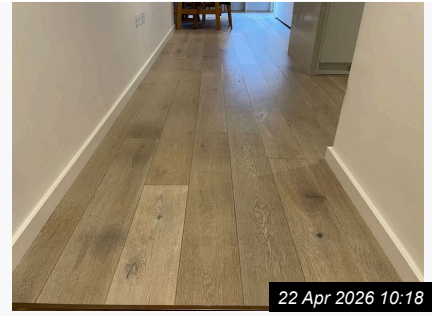
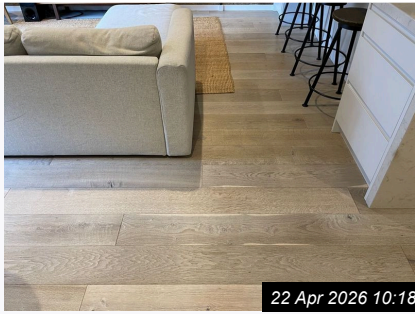
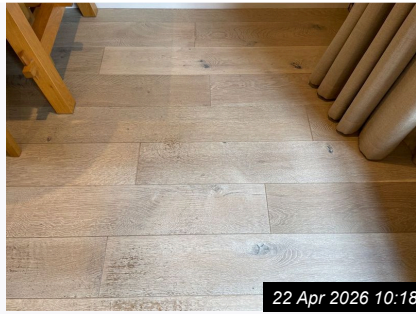
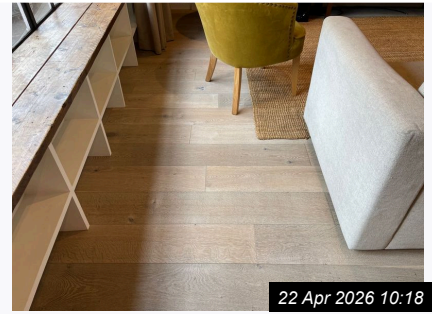
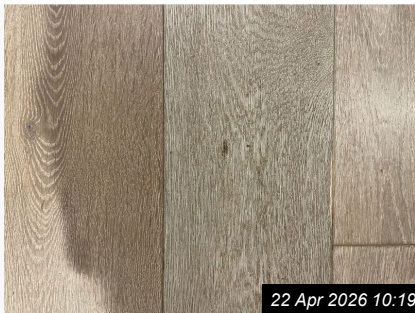
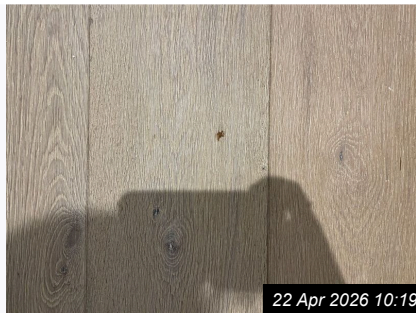
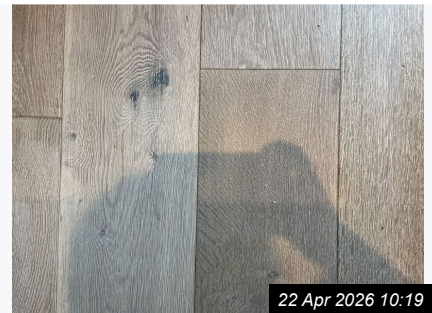
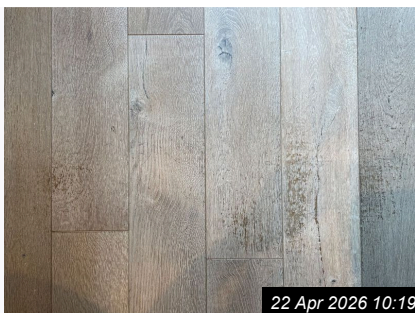
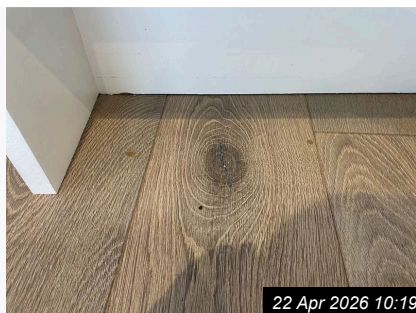
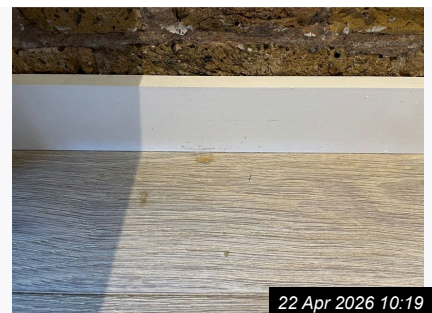
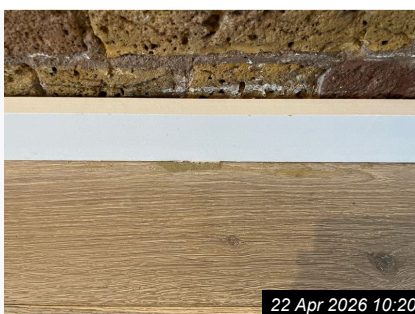
Ref #7.9

7.9	Flooring	Oak flooring with a light grey-brown tone	Very minor signs of wear including numerous small scuffs, marks, scratches and some minor staining in several areas along the room edges Generally good condition and appears clean

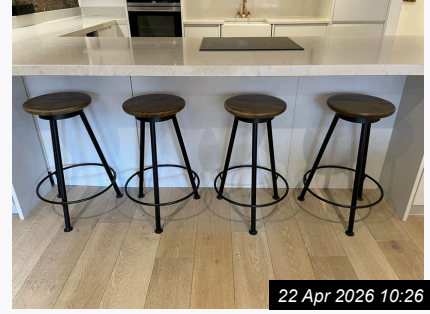
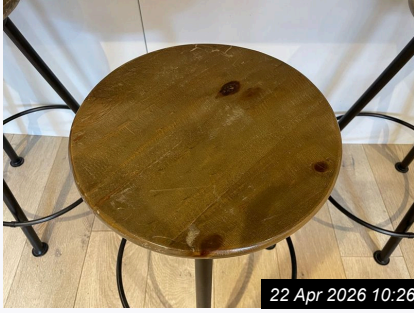
Ref #7.19

7. RECEPTION ROOM (CONT.)			
7.19	Stools	Four tall stools with circular wooden seats and black metal frames featuring footrests.	Seats show light surface scratches and scuffs frames appear intact with no visible damage.
7.20	Rug	Natural woven rectangular rug in light brown with textured weave pattern	Small dark stain and minor discolouration visible in central area with some light general wear
Miscellaneous Items			
7.21	Router	White broadband router with 'hyperoptic' branding	Minor surface marks and dust present Good condition
7.22	Vases	Set of three clear glass decorative vases with openings, one featuring a leather strap, displayed on a wooden shelf.	All three glass spheres appear intact
7.23	Components	Grey plastic components	Detached, left on shelf
Cleanliness			
7.24	Cleanliness		Generally clean to a low professional level

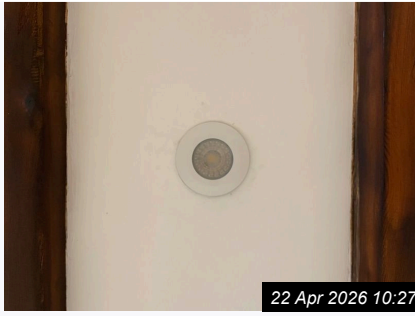
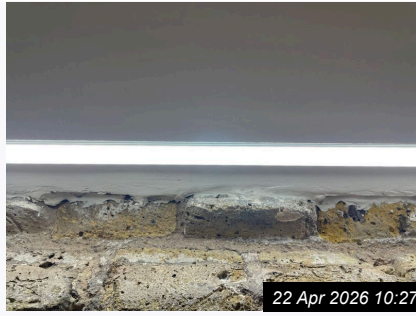
Ref #8.2

Ref	Name	Description	Condition
8.1	Ceiling	Features white painted ceiling with exposed dark wooden beams	Light settlement crack in the plaster with no other significant signs of damage. Generally good condition
8.2	Lighting	Ceiling recessed round LED lights with white trim under-cabinet linear LED strip light	Both lights are operational
8.3	Walls	Part white painted, part exposed yellow-brown brick Kitchen also features a section with a marble splash back tiled finish	Generally all in good condition
8.4	Switches/Sockets	Multiple white and black plastic switches and sockets Labelled appliance switches all flush-mounted	All switches and sockets appear intact
8.5	Flooring	Light oak wood	Multiple scratches, marks and small indentations are present

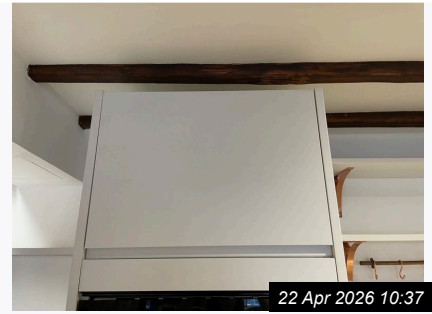
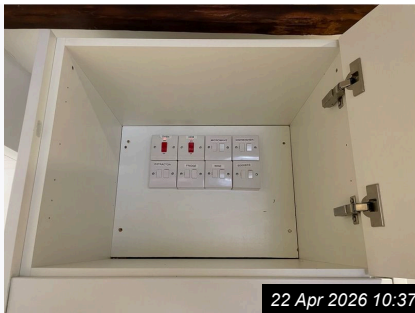
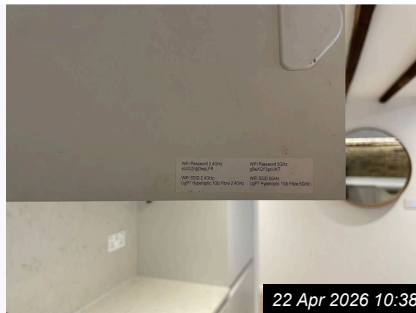
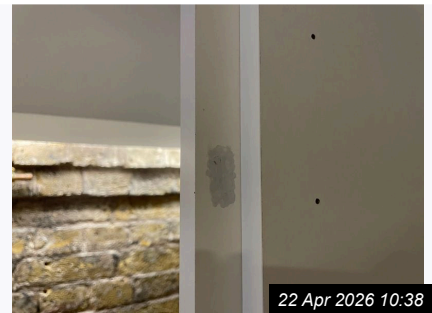
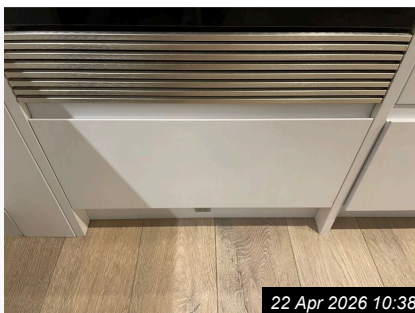
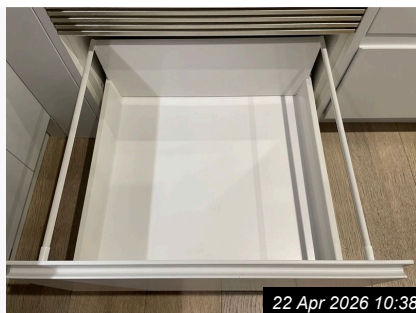
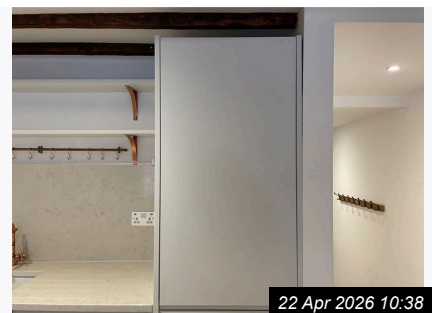
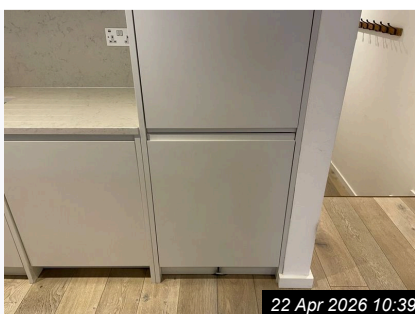
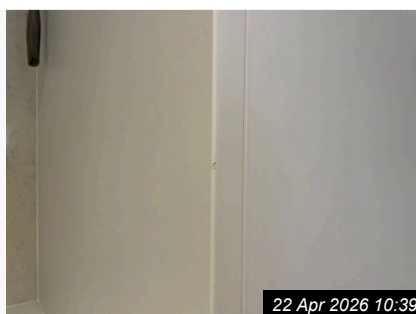
Ref #8.7

8.7	Tall Units	Tall units constructed from white laminate panels with integrated doors, soft-close fittings and internal control panel for kitchen appliances	Generally good condition with minor marks, a patched repair area and small chip to exterior

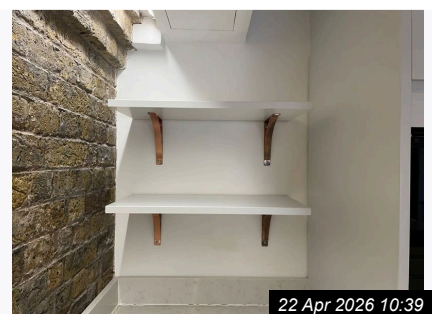
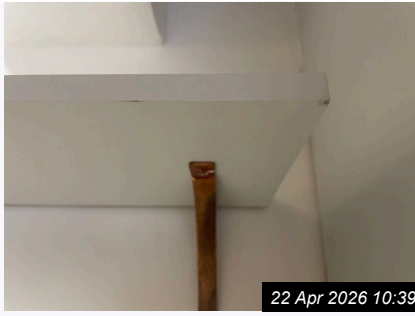
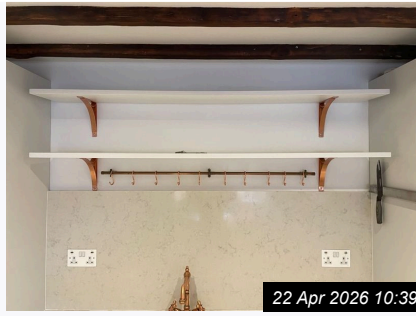
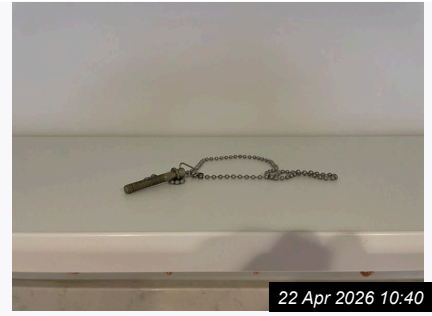
Ref #8.8

8.8	Wall Units	White laminated open shelving with copper brackets	Minor discolouration to shelf edges
8.9	Base Units	Matte white flat-panel base units with; integrated handles, internal shelving, pull-out wire baskets, soft-close drawers & built-in waste bins	General minor marks and scuffs some chipped edges on drawers and cabinets scratched and stained areas inside sink unit and drawers Corner door sections detached from unit interior sections <a href="#">Review - Investigate</a>

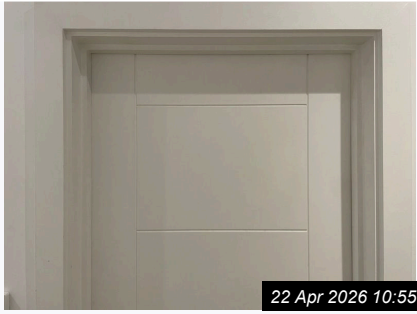
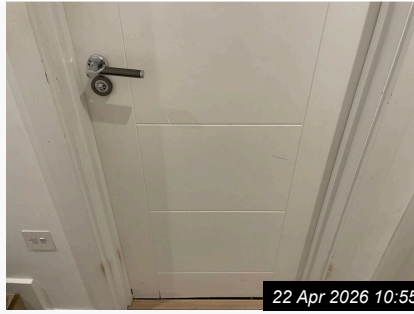
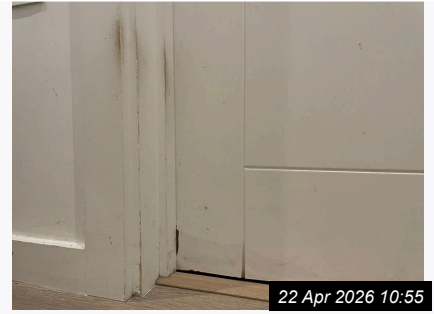
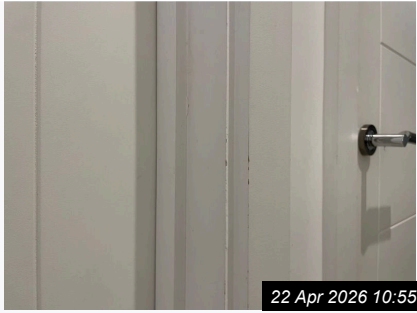
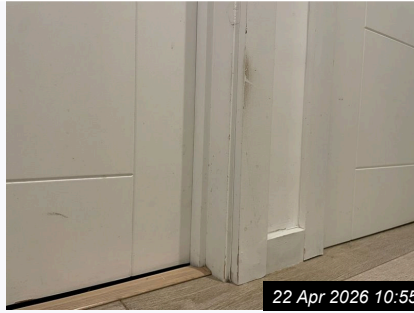
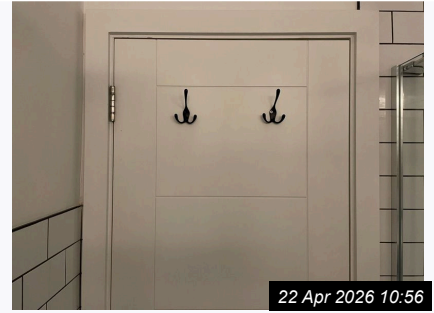
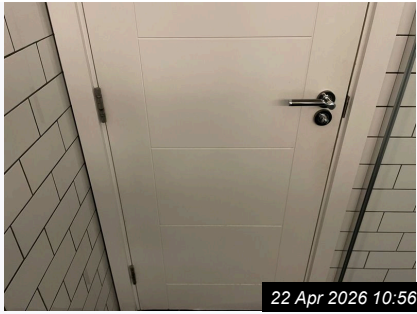
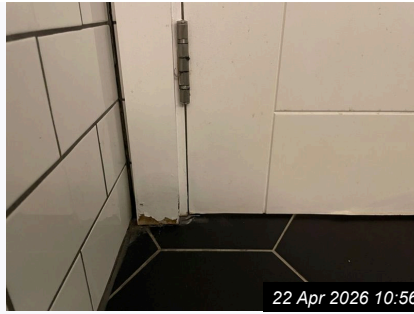
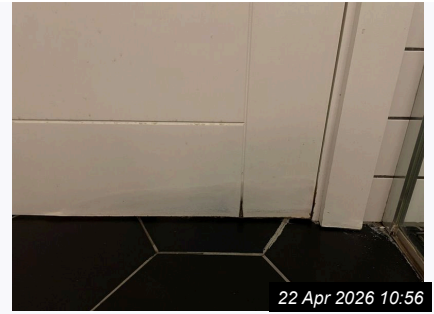
Ref #9.1

Ref	Name	Description	Condition
9.1	Door & Frame	White painted timber door and frame	<p>Lower sections of door and frame show signs of scuffing, staining, chipped paint, and water damage, particularly at the bottom edges.</p> <p>Door impacts flooring when opening and closing. Rub-marks to flooring</p> <p><a href="#">Review - Investigate</a></p>
9.2	Door Fixtures	Polished chrome lever door handle with matching thumbturn lock and black double hooks	Door handle and lock in good condition with minimal signs of wear
9.3	Ceiling	Smooth white painted	Ceiling appears intact, good condition
9.4	Extractor Fan	White circular extractor fan	Appears In good condition
9.5	Lighting	Ceiling-mounted recessed downlights	<p>Working, but slight difficulty with light switch</p> <p><a href="#">Review - Investigate</a></p>

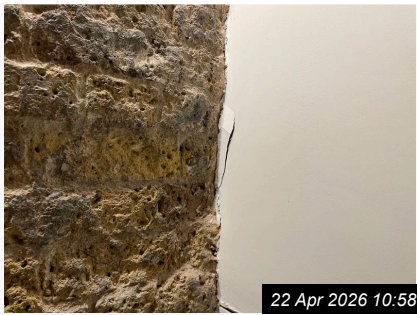
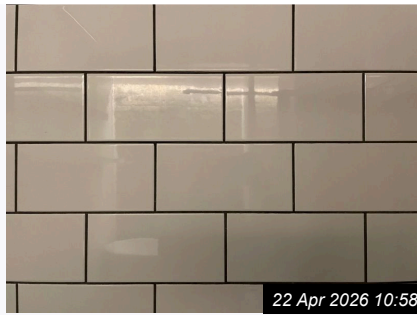
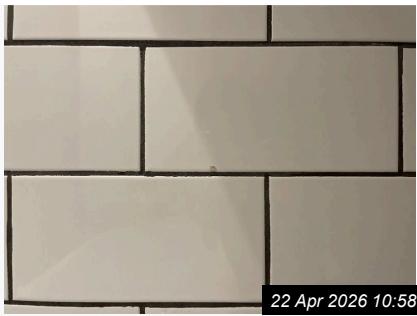
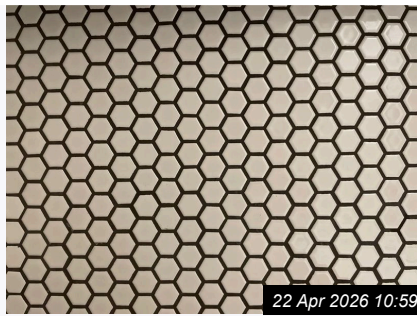
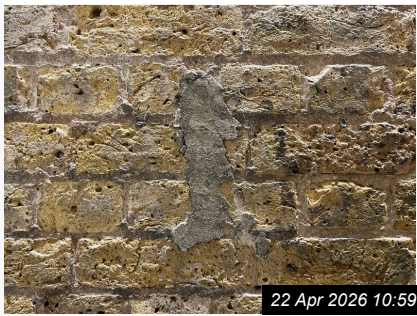
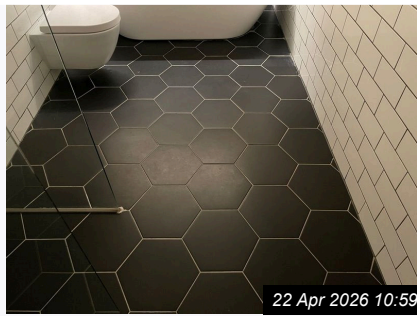
Ref #9.6

9. BATHROOM (CONT.)			
9.6	Walls	Bathroom walls consist of: exposed brick, painted plaster in white, white rectangular ceramic tiles, white hexagonal tiles with dark grout	Exposed brick possibly shows plaster and patch repairs painted plaster displays a visible crack at one joint ceramic tiles have some light marks and minor cracking to 3x tiles hexagonal tiles appear intact.

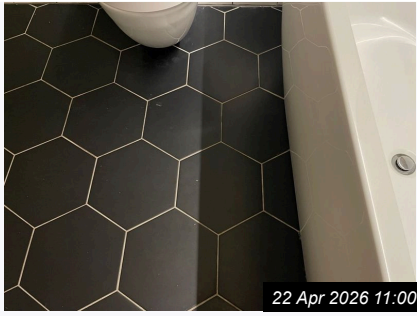
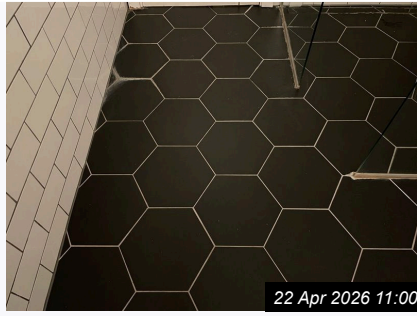
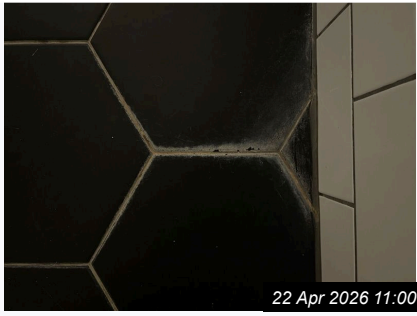
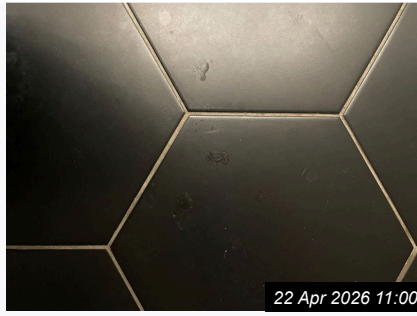
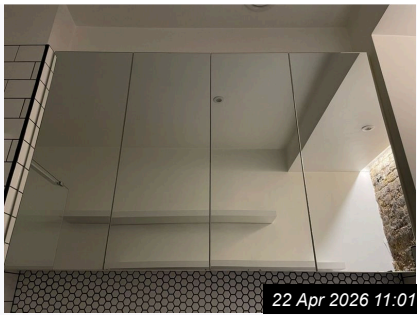
Ref #9.7

9.7	Flooring	Large format hexagonal ceramic tiles in matte black with contrasting light grout lines.	White scaling and appears some staining to surface Few white paint marks

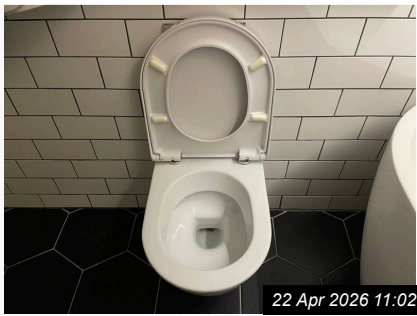
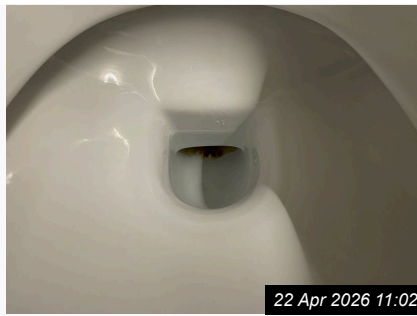
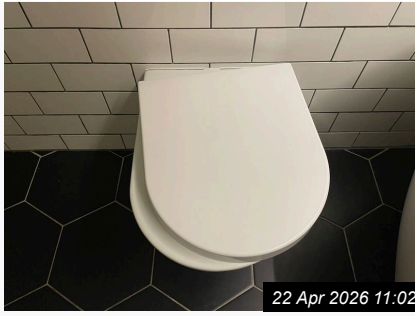
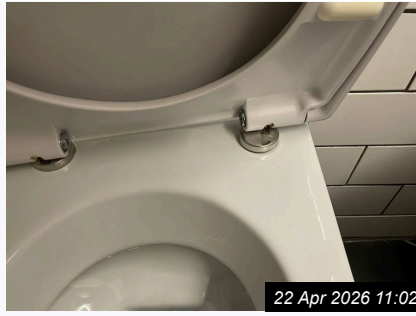
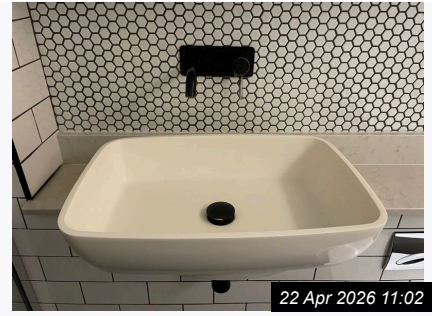
Ref #9.9

9.9	Toilet	Wall-hung white ceramic toilet with soft close seat and dual flush chrome actuator.	Minor limescale staining inside the bowl Seat is slightly loose and lopsided <a href="#">Review - Investigate</a>

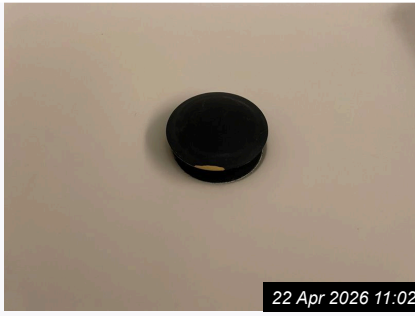
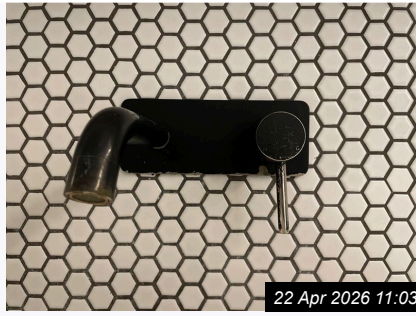
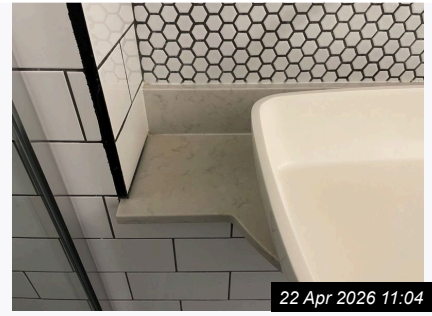
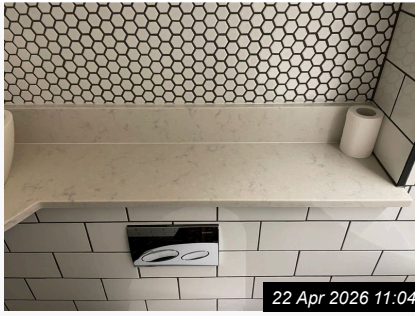
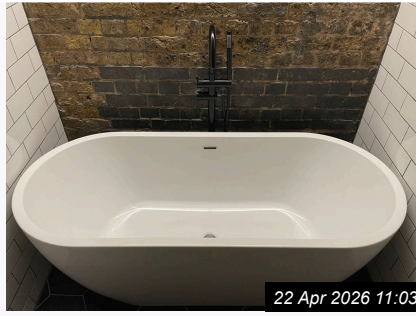
Ref #9.10

9.10	Basin	Rectangular white ceramic basin with black pop-up waste and black wall-mounted tap and control	Basin in good overall condition but waste cover shows visible chipping and surface wear tap has minor water staining.

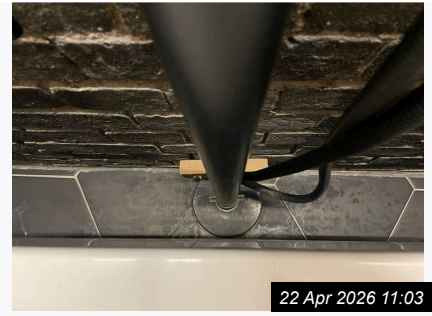
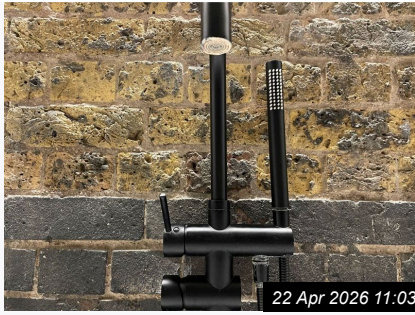
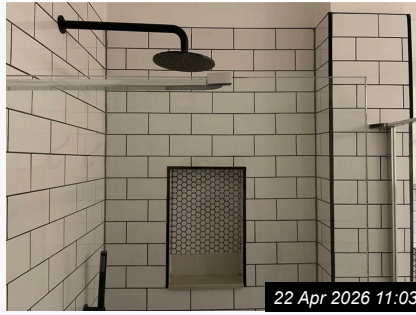
Ref #9.11

9.11	Bath & Taps	Freestanding white oval bathtub with black matte floor-mounted mixer tap and hand shower attachment.	Bath and taps show no visible signs of wear or damage surfaces appear clean and well preserved. Tap unit significantly loose from flooring <a href="#">Review - Investigate</a>

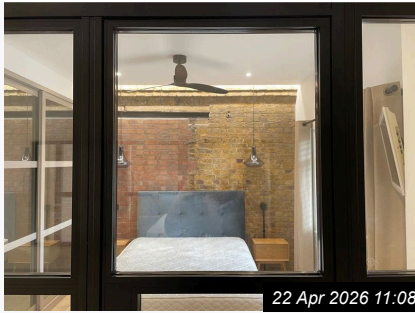
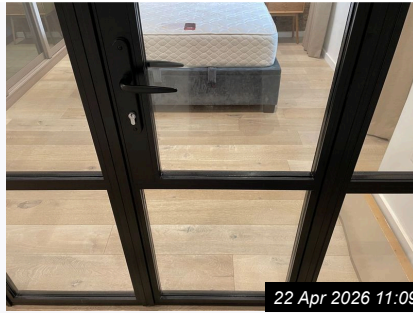
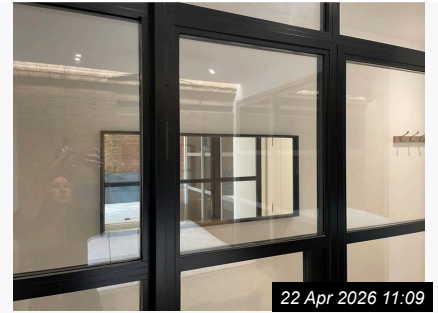
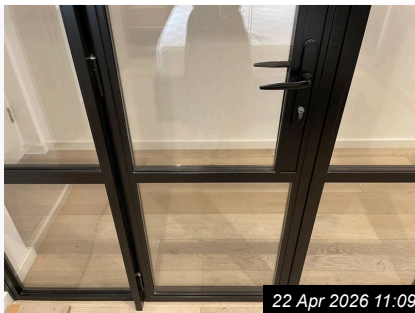
Ref	Name	Description	Condition
10.1	Door & Frame	Black metal and glass framed door and panels with clear glazing	Door and frame appear in good condition

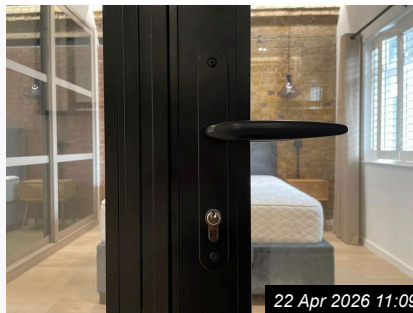
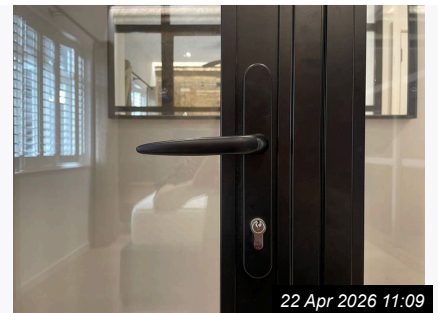
10.2	Door Fixtures	Black metal lever handles with matching backplates	No visible signs of wear or damage handles and lock barrels appear intact and clean.

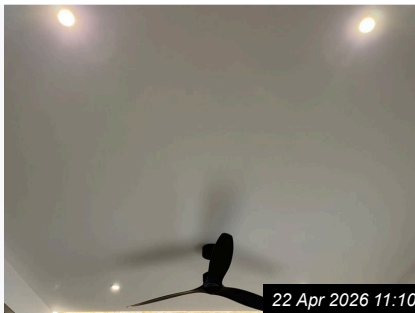
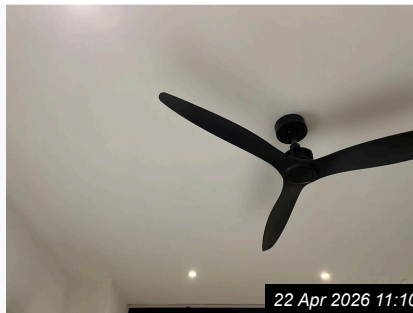
10.3	Ceiling	Smooth white ceiling	Ceiling is generally clean with a visible minor crack
10.4	Lighting	Lighting consists of recessed ceiling downlights with metallic trim contemporary pendant lights featuring smoked glass shades suspended from the ceiling.	2x pendant lightbulbs not working <a href="#">Review - Investigate</a>

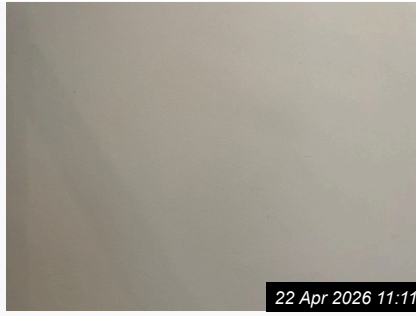
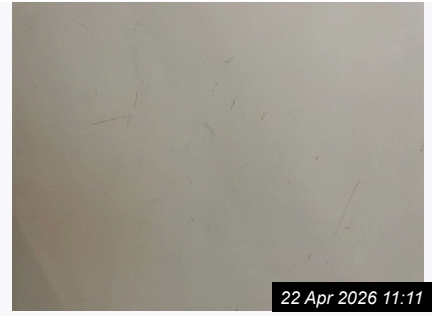
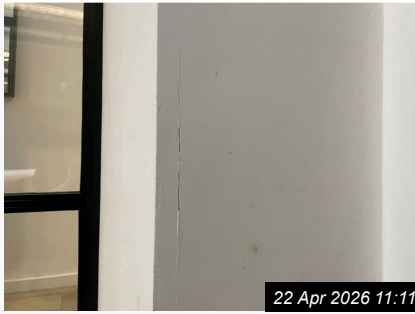
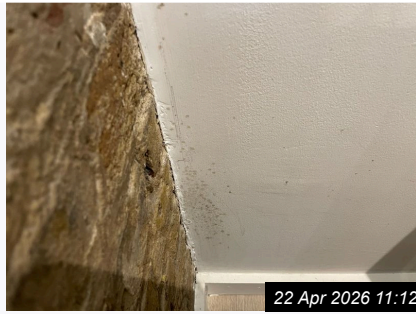
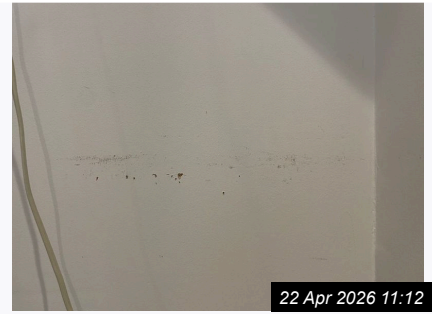
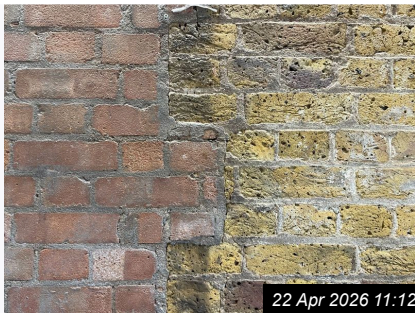
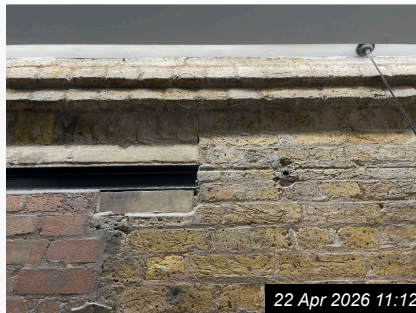
10.5	Walls	Mixture of painted plastered walls in white exposed brickwork in red and yellow tones.	Exposed brickwork is structurally intact with minor surface imperfections. Painted walls show scuffs, scratches, minor marks, a visible crack Some staining and areas of mould at the base <a href="#">Review - Investigate</a>

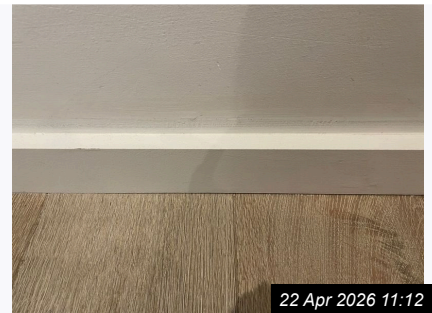
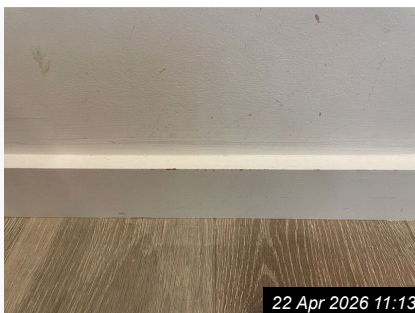
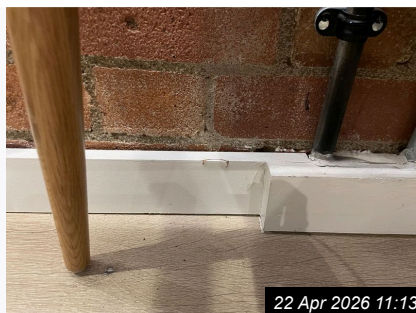
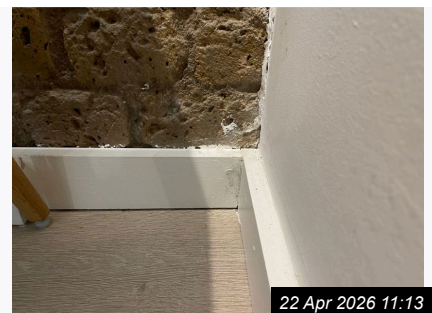
10.6	Skirting	Painted wooden skirting in white	Minor scuffs, marks, small chips, paint blemishes, and visible wear on corners and edges.

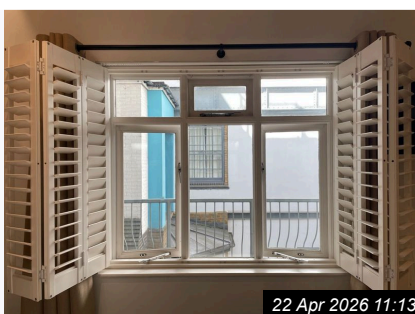
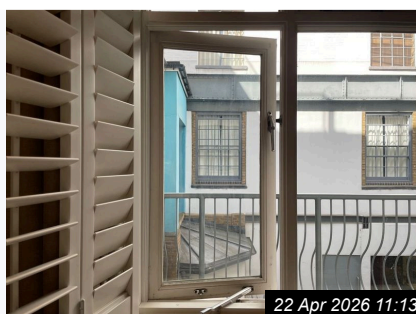
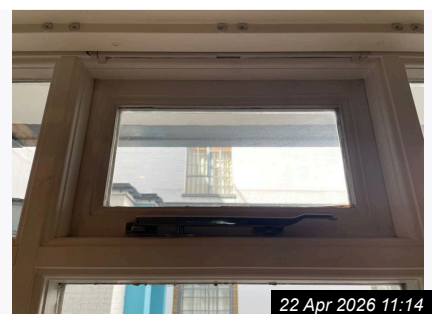
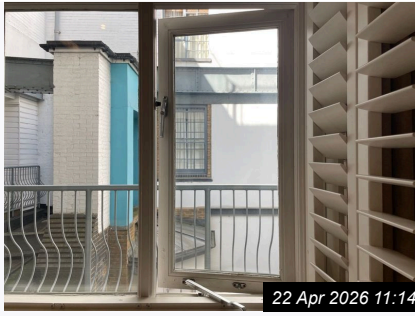
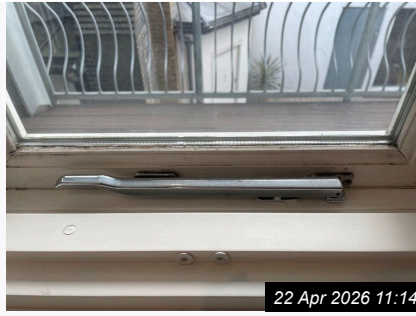
10. BEDROOM (CONT.)			
10.7	Window & Sill	Timber-framed window with white paint finish featuring multipane clear glazing and metal handles, fitted with a painted timber sill.	Minor paint wear and light scratches on the sill some discolouration and light scuffing around the handles generally good condition with no visible structural damage.

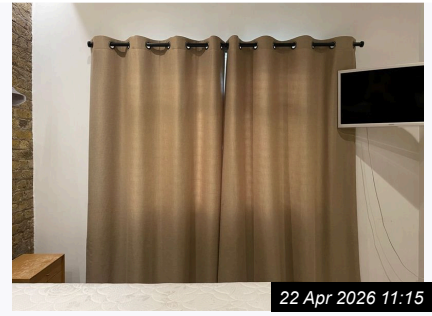
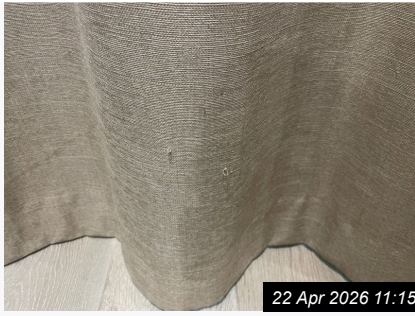
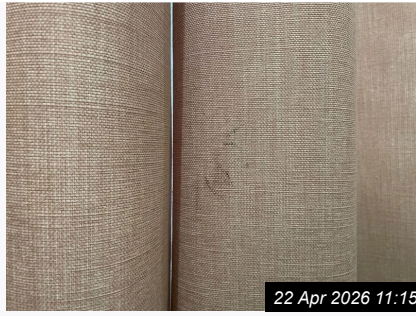
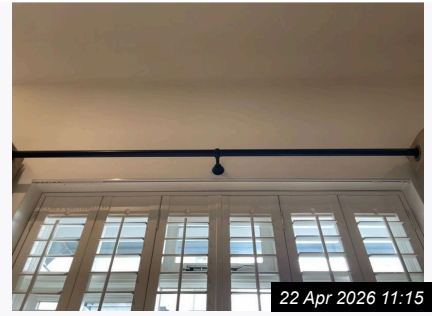
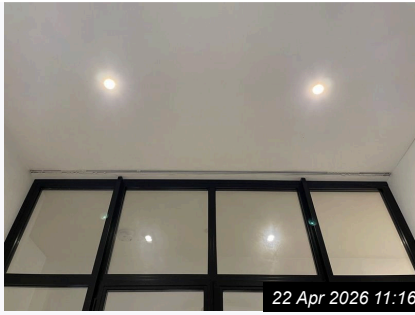
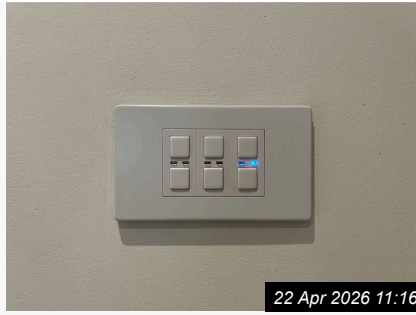
Ref #10.8

10.8	Blinds/Curtains	Beige fabric curtains with eyelet on a black metal curtain pole and white plantation shutters	Curtains present small snags and visible black marks shutters appear in good order with no visible damage.

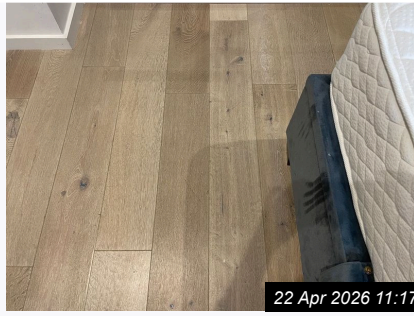
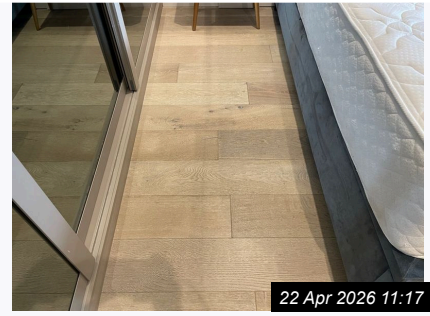
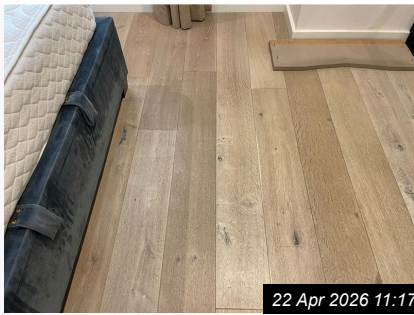
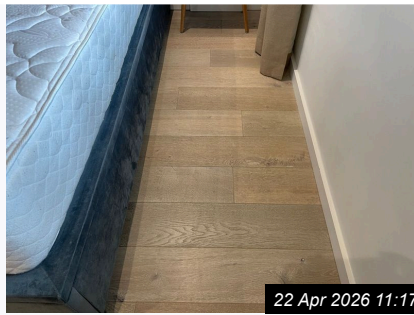
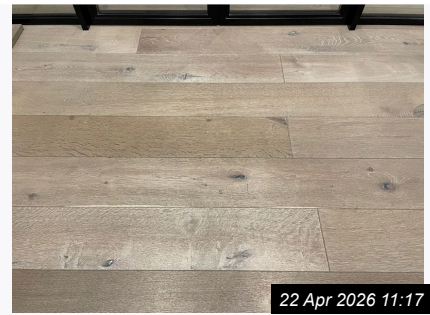
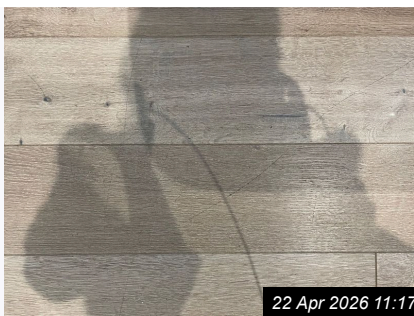
Ref #10.10

10.9	Switches/Sockets	Multiple white plastic light switch panels and double socket outlets	All switches and sockets are intact
10.10	Flooring	Oak wood flooring in light brown	Minor scratches and surface marks are visible in several areas some signs of general use but no significant damage.

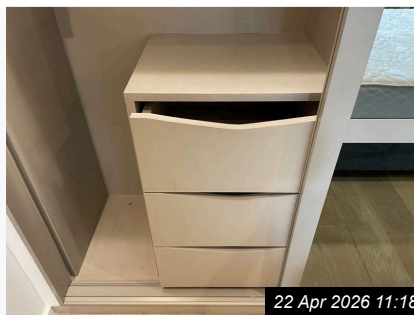
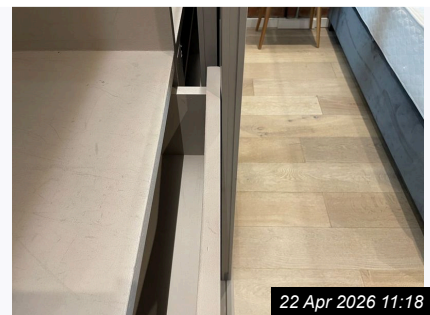
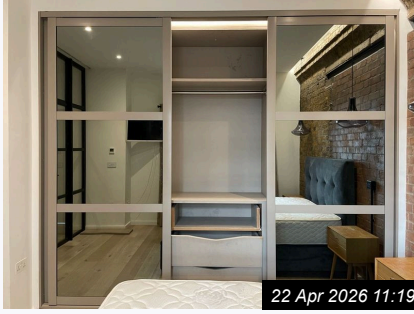
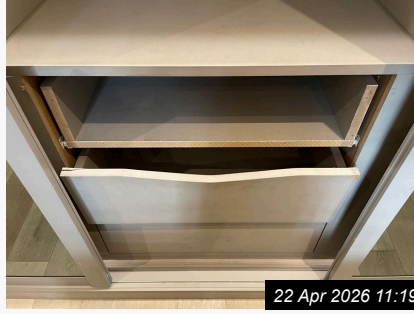
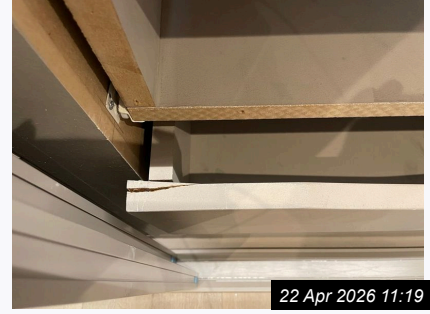
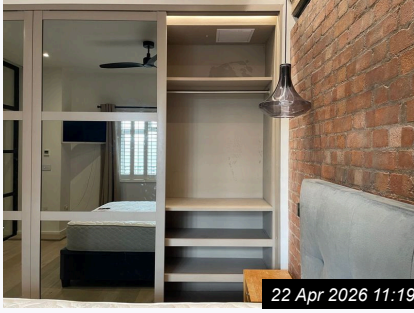
Ref #10.11

10.11	Built-In Storage	Wardrobe with beige wood finish, mirrored sliding doors, shelf, rail, and three integrated drawers.	Drawer front panel missing and 1x cracked interior shelving scratched and scuffed Stain marks to interior walls White scratches to edge of mirrored doors
Contents

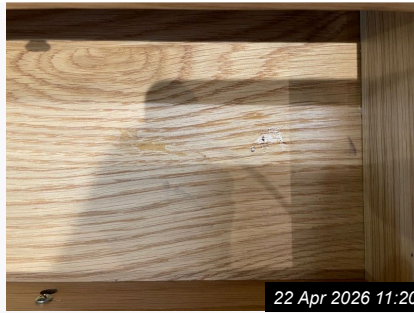
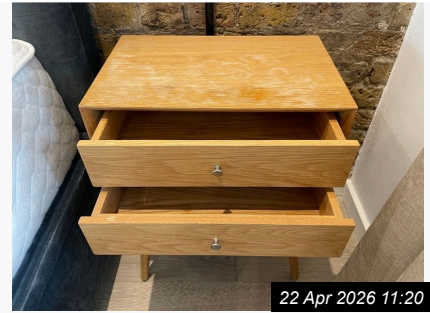
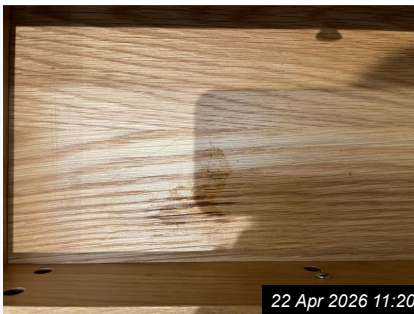
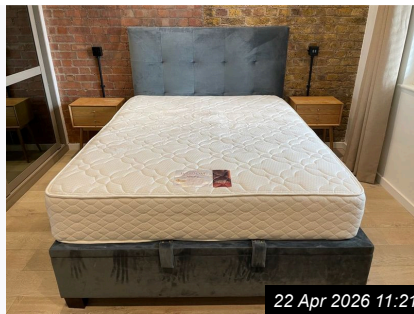
Ref #10.12

10.12	Bedside table	Light oak wood bedside table with two drawers and metal knob handles	Visible water marks and stains on the surface
10.13	Mattress	Memory foam mattress with a cream quilted cover and labelled as Inner Wisdom Mirage	Visible staining and discolouration on the fabric beneath the mattress some surface marks and minor wear on mattress sides small area of yellowing on quilted surface.

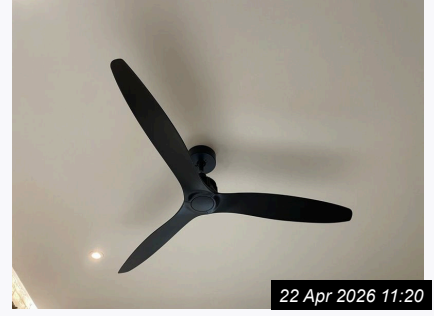
Ref #10.14

10.14	Television	Wall-mounted Samsung flat-screen	No visible damage or scratches screen and frame appear intact.
10.15	Ceiling fan	Black three-blade ceiling fan with matte finish	No visible damage or wear blades and housing appear clean and well-maintained.

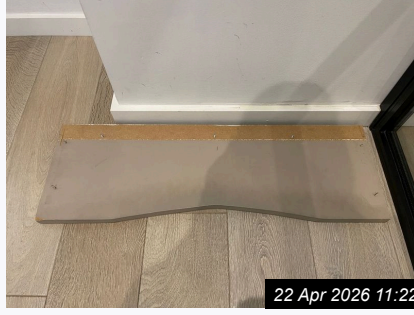
Ref #10.16

10.16	Thermostat	Digital wall-mounted thermostat with touch buttons and a white plastic casing.	Appears in good condition
10.17	Wooden panel	Rectangular wood panel with a grey painted finish and a curved bottom edge.	Appears to have been left on the floor <span style="background-color: orange; padding: 2px;">Review - Investigate</span>
Miscellaneous Items
