# Inventory & Check In

**AVINTO**  
PROPERTY SERVICES

Example  
Inventory  
Report

**May  
2nd 2026**

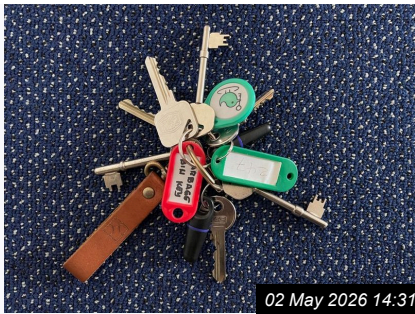
Ref #3.1

3. KEY SETS		
Ref	Name	Description
3.1	1x Set of Keys	<p>1x set of keys incl.:</p> <p>2x silver cylinder keys for property front door top lock                      2x silver mortise keys for property front door bottom lock                      1x silver mortise key for bin store                      1x silver cylinder key for purpose unknown                      1x silver cylinder key for purpose unknown                      2x black plastic fobs for building entrance and car park</p> <p>All keys and fobs tested, working except for keys/purpose unknown not tested.</p> <p>Keys collected from TT on-site.                      Keys to be returned to agent (The Chant Group, Cannon Street, EC4N).</p>

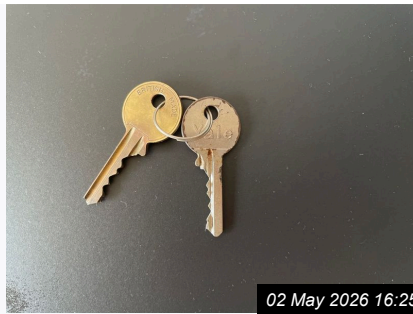
Ref #3.2

3.2	Balcony Keys	<p>1x silver cylinder key for Balcony                      1x gold cylinder key for Balcony</p> <p>Both keys tested, working.</p> <p>Keys found in-situ in property.                      Keys to remain in-situ in property.</p>

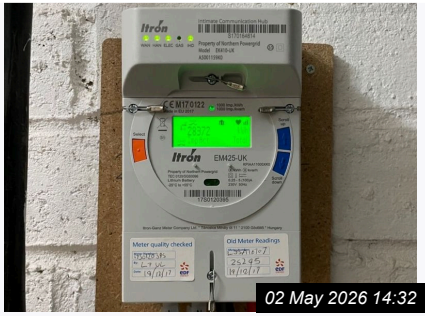
Ref #4.1

4. METER READINGS			
Ref	Name	Description	Reading
4.1	Electricity Meter	Location: communal hallway meter cupboard Access via: FB2 key Serial number: 17S0120395	28372 kWh
4.2	Gas Meter	Location: car park Access via: fob and T-bar key Serial number: G4 A6056509 17 02	004482.762 m3

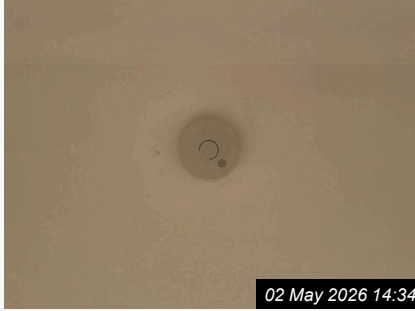
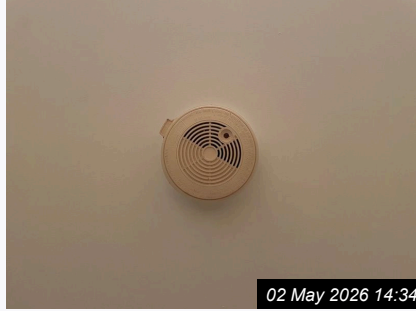
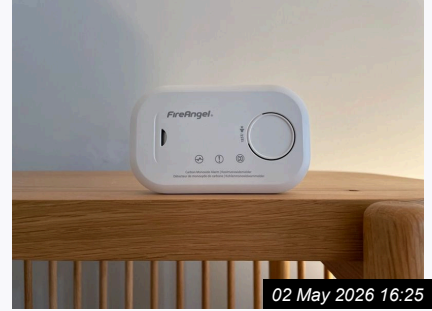
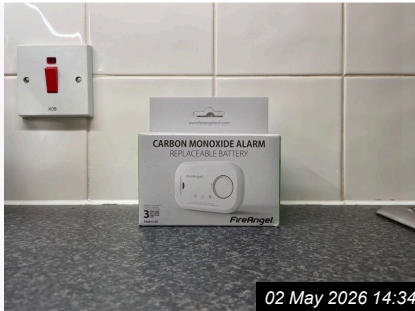
5. SMOKE AND CO ALARMS			
Ref	Name	Location Room & Floor	Test Result
5.1	Smoke Detector/Fire Alarm	Location: Entrance & Hallway Floor: 1st Floor	Tested, power seen and heard. Replacement date not seen.
5.2	Smoke Detector/Fire Alarm	Location: Entrance & Hallway Floor: 1st Floor	Tested, power not seen nor heard. Replacement date not seen.  Note: alarm loose/partially detached from ceiling fixture/fitting.
5.3	Carbon Monoxide Detector/Alarm	Location: Reception Room Floor: 1st Floor	Tested, power seen and heard. Replacement date April 2035.
5.4	Carbon Monoxide Detector/Alarm	Location: Kitchen Floor: 1st Floor	Brand new w/ original packaging (batteries included). Not tested. Replacement date April 2035.

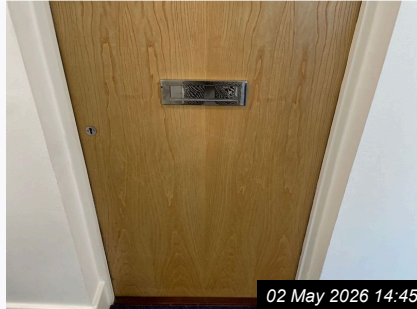
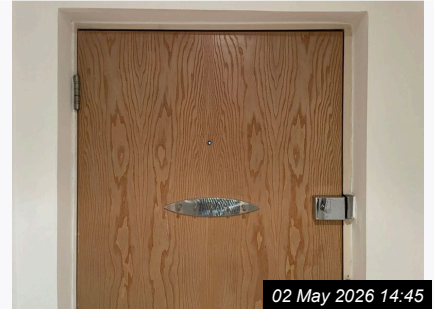
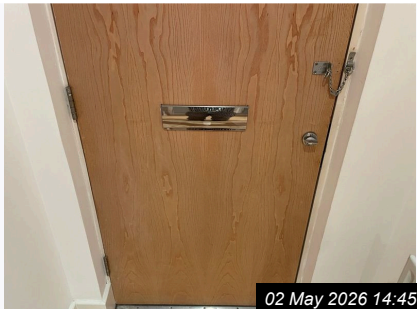
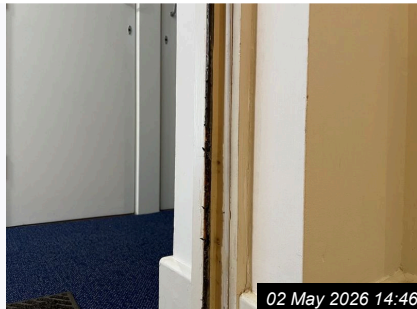
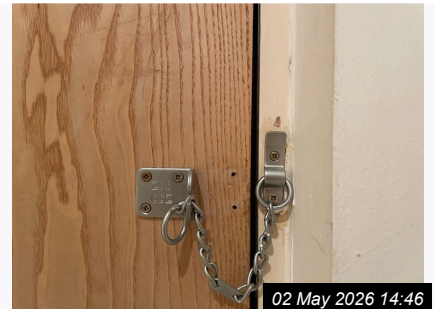
Ref	Name	Description	Condition
6.1	Door & Frame	Light brown wood veneered entrance door set in a white painted frame.	Door surface shows minor scuffs and marks with no major damage visible frame displays exposed wood and paint chips there is slight rust and wear observed on the inner side of the frame and near security fittings.

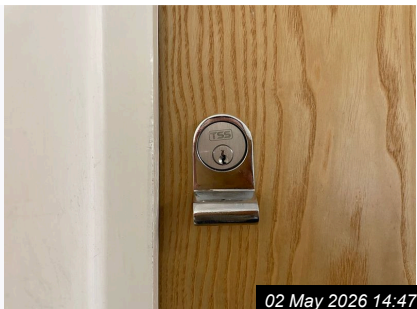
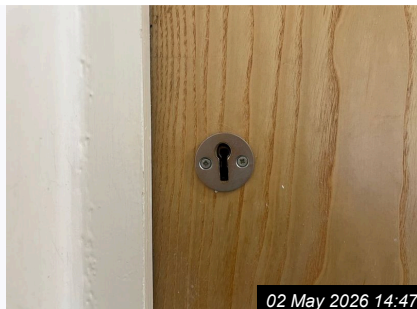
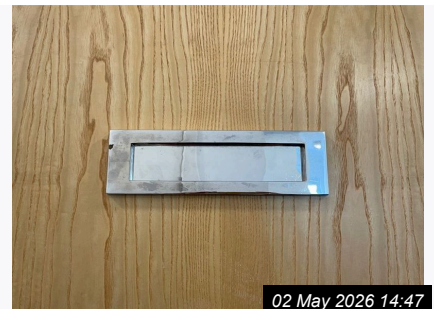
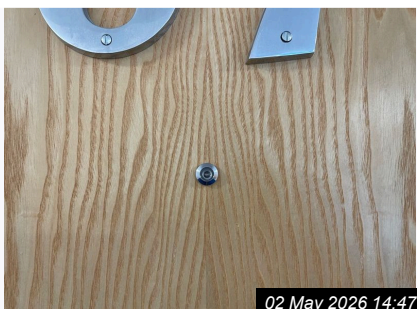
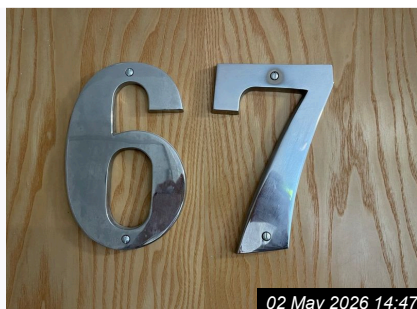
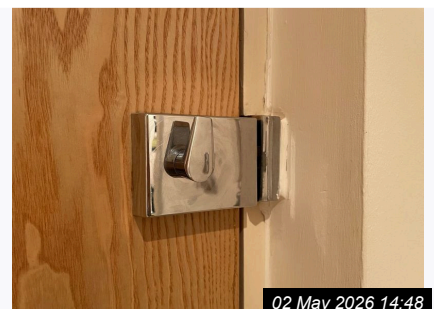
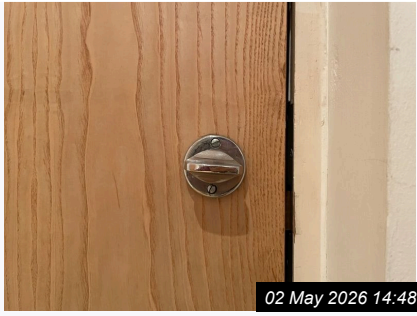
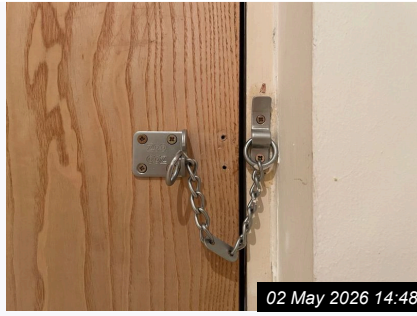
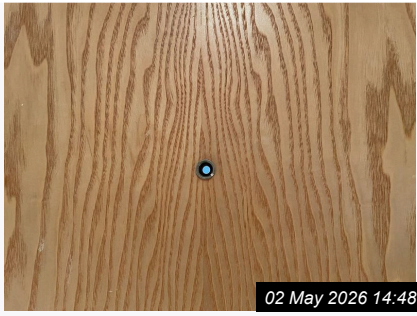
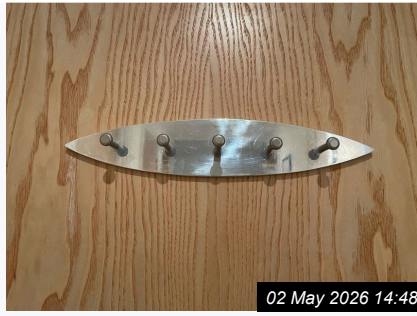
6.2	Door Fixtures	Brushed stainless steel fixtures to include: lever deadlock cylinder key lock door chain numerals spyhole letterplate inner letterplate cover metal coat hook rack	All door fixtures show light surface wear and minor scratches All secured and in general good condition

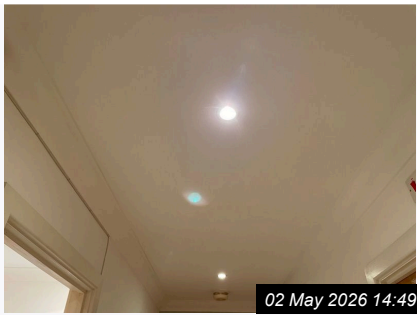
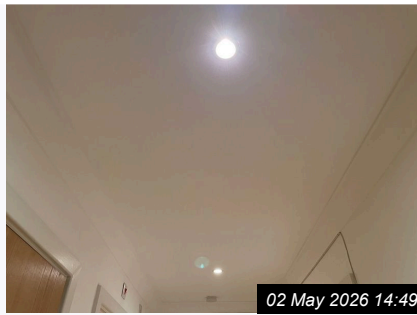
6.3	Ceiling	Smooth white painted	Ceiling appears clean with no visible signs of damage or staining.
6.4	Lighting	Recessed ceiling downlights with a circular metallic trim	Lights are operational

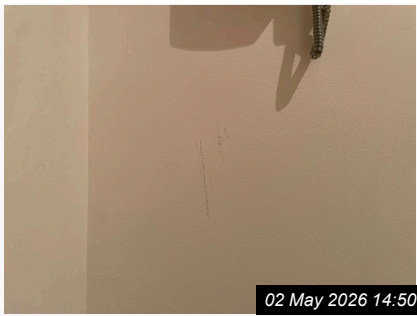
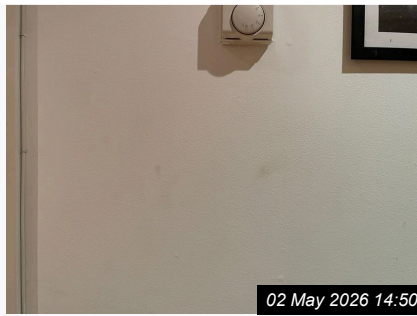
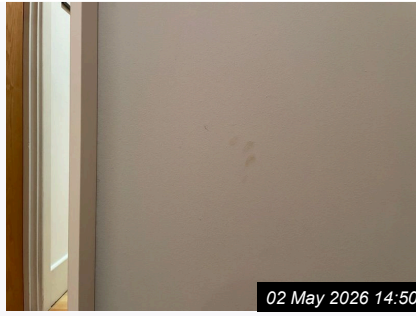
6.5	Walls	Painted plaster walls in a light beige or off-white colour	Minor scuff marks, light stains and some slight surface blemishes are visible in several areas.

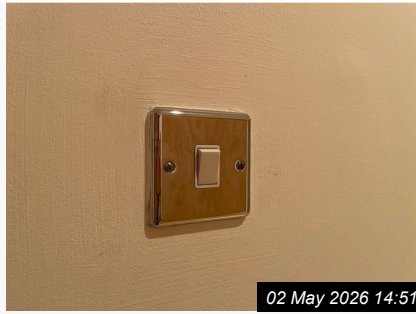
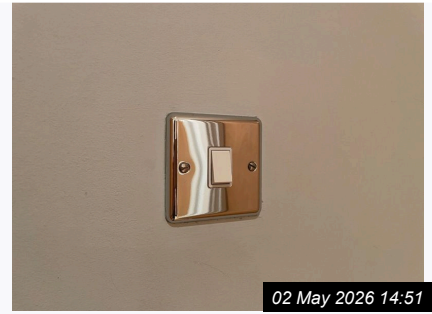
6.7	Switches/sockets	Stainless steel single light switches double white power socket with switches	Switches and sockets appear in good order
6.8	Heating	White metal panel radiator with dual valve fittings	Minor paint chips and scuff marks on top edge with no visible dents

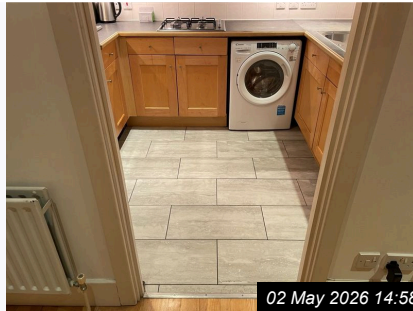
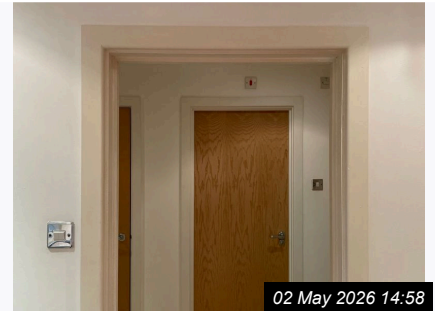
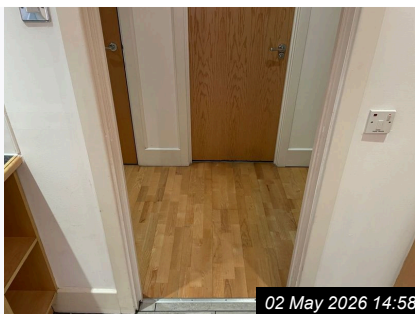
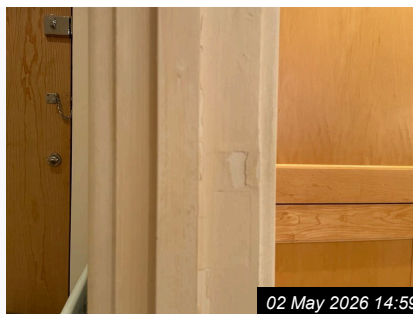
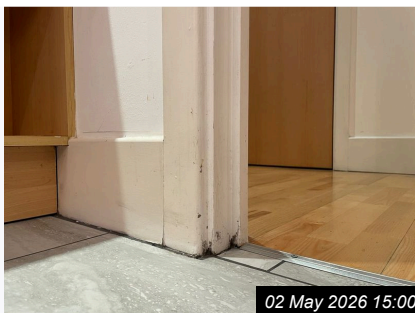
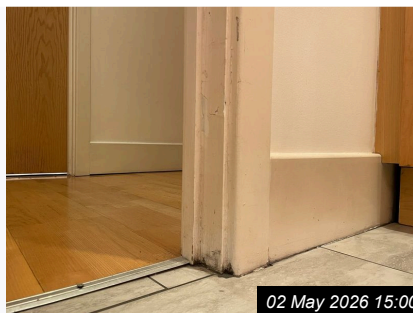
Ref	Name	Description	Condition
7.1	Door Frame	Timber door frame finished in white paint No door fitted	Minor chips and scuffs, shading or wear to low level

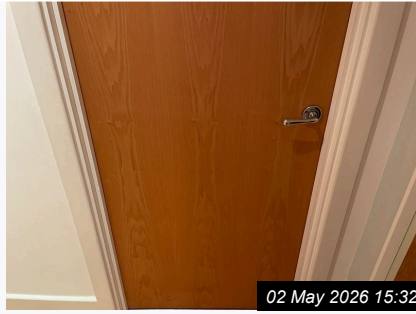
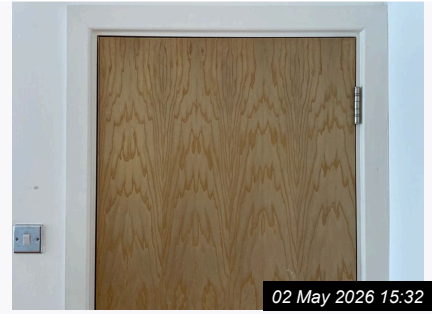
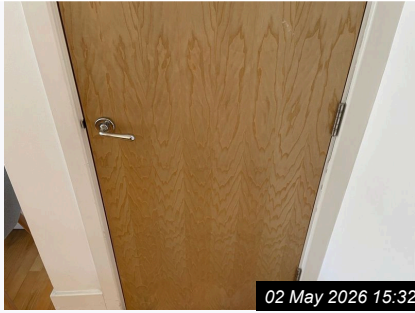
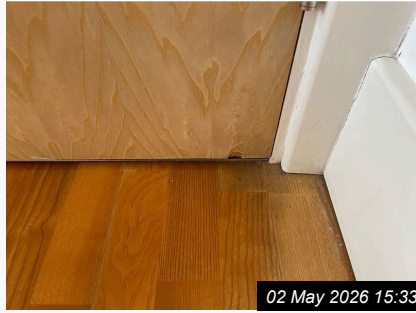
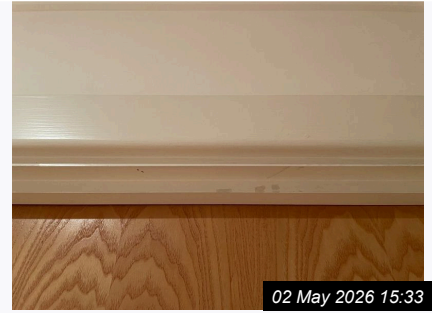
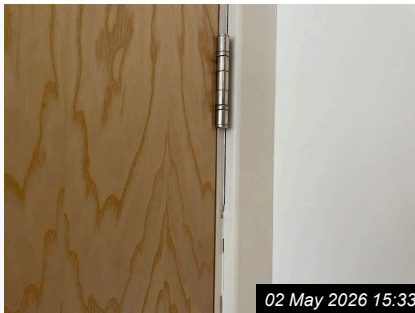
Ref #8.1

Ref	Name	Description	Condition
8.1	Door & Frame	Flush brown wood veneer door set in a white painted timber frame.	Bottom edge of door shows visible chip and wear frame has minor paint scuffs and marks hinges and handles intact and operational.

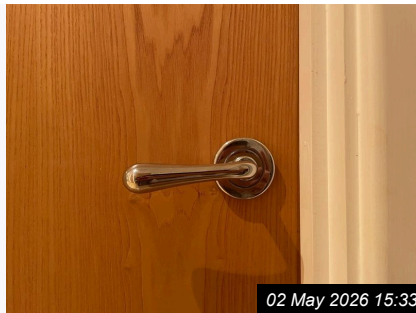
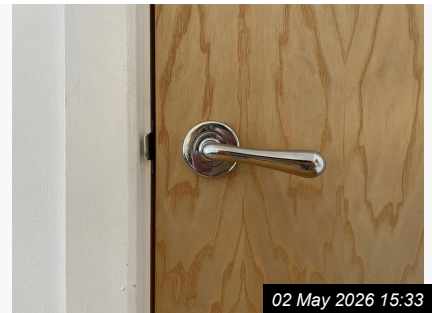
Ref #8.2

8.2	Door Fixtures	Silver metallic lever handles with circular backplates	Handles and fixtures are clean with no visible signs of wear or damage.
8.3	Ceiling	Smooth white painted plaster ceiling with coving	Ceiling is generally well maintained with some minor marks and small imperfections visible in places.

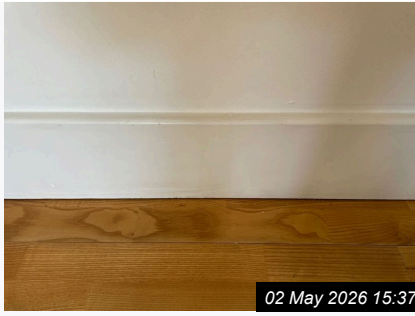
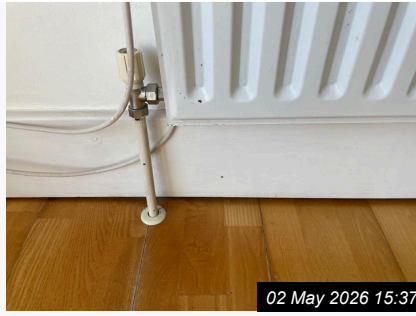
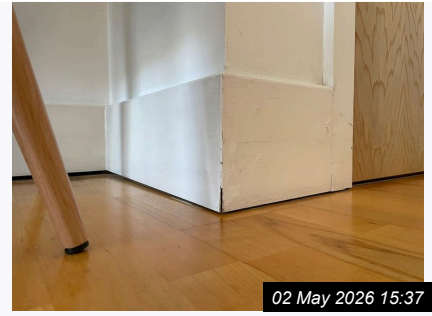
Ref #8.6

8.6	Skirting	White painted wooden	Skirting shows minor scuff marks, small chips, slight paint wear, and some visible joint gaps at corners.

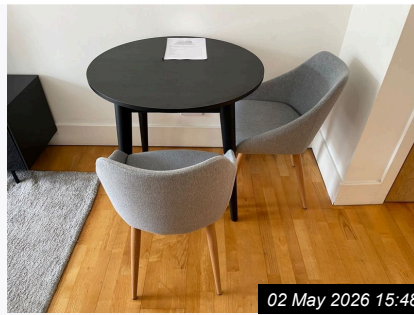
Ref #8.24

8.24	Dining Table and Chairs	Round black wooden dining table with two light grey upholstered chairs featuring angled wooden legs.	Dining table surface shows smudges and light marks chairs appear free from visible damage or wear.

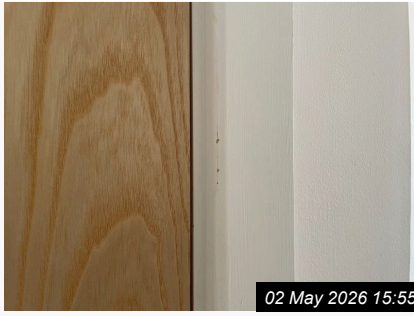
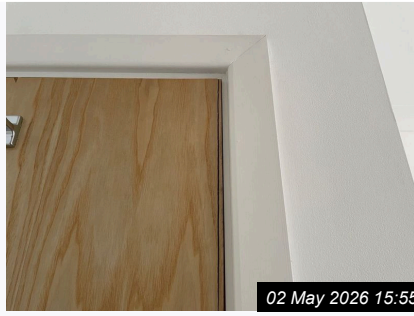
Ref #9.1

Ref	Name	Description	Condition
9.1	Door & Frame	Brown timber veneered door set within a white painted timber frame.	Door has minor scratches and light marks upper edge has a chip and there are adhesive stains around the hook frame has minor scuffs and light cracking to paint at joints and architrave.

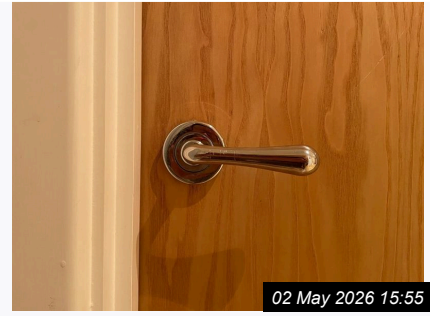
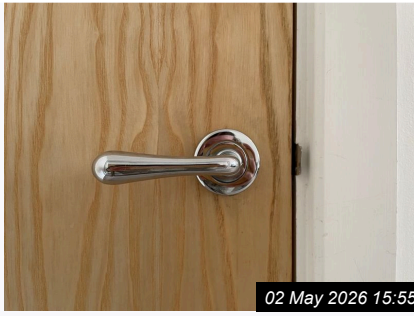
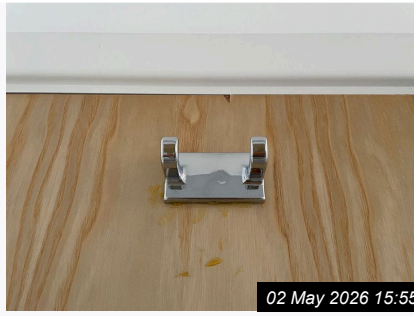
Ref #9.2

9.2	Door Fixtures	Silver chrome door handles with round rosettes double chrome coat hook	The door handles appear clean and free from noticeable damage, while the coat hook shows residue or staining beneath its base.

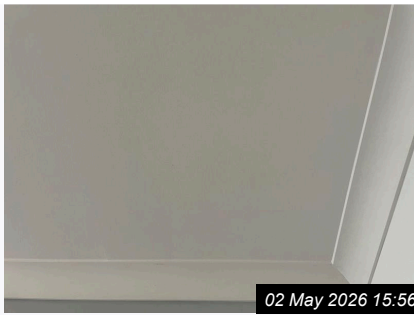
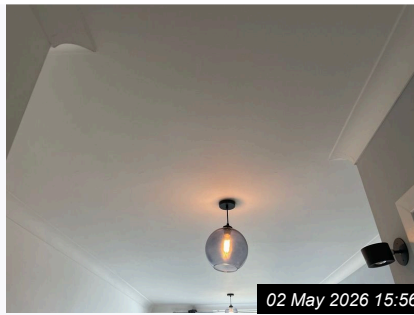
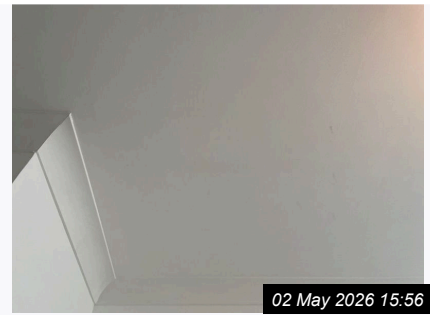
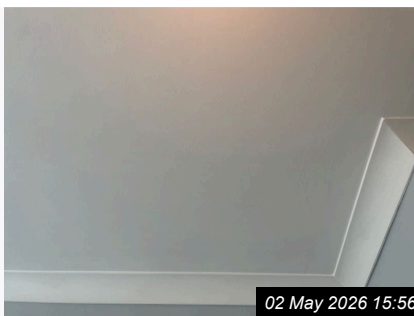
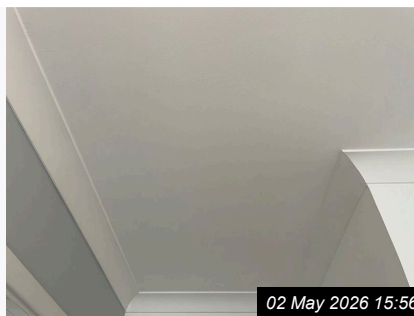
Ref #9.3

9.3	Ceiling	Smooth white painted plaster ceiling with coving	Ceiling is in good structural condition with minor surface marks some light scuffing visible in some areas.

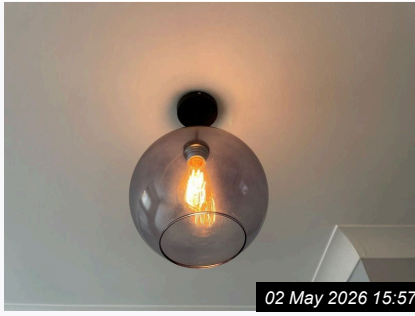
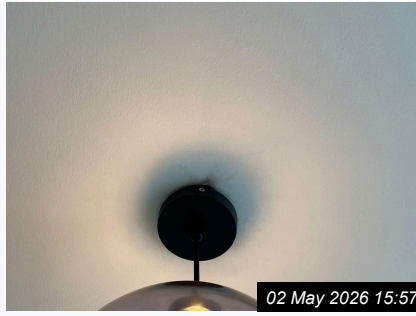
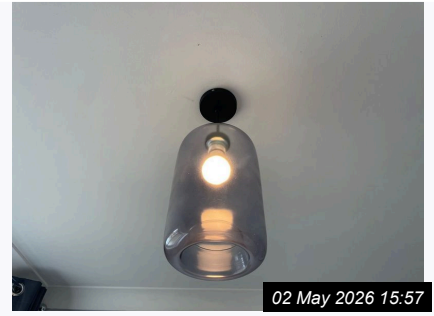
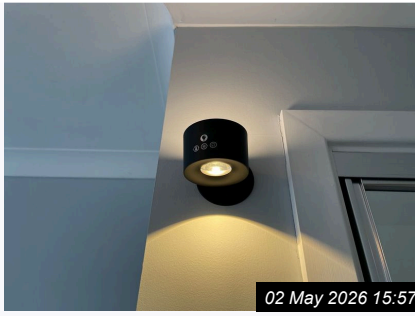
Ref #9.4

9.4	Lighting	Ceiling lights with black fittings and smoked glass shades one spherical and one cylindrical plus a black wall-mounted uplighter with touch controls.	Lights are operational Black burn-type mark to ceiling surrounding 1x lighting fixture <span style="background-color: orange; color: white; padding: 2px;">Review - Investigate</span>

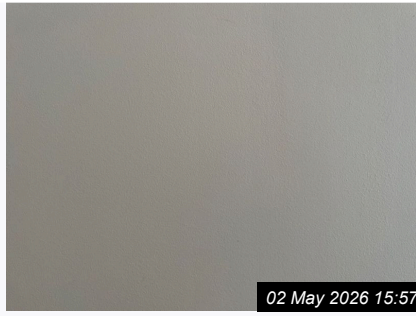
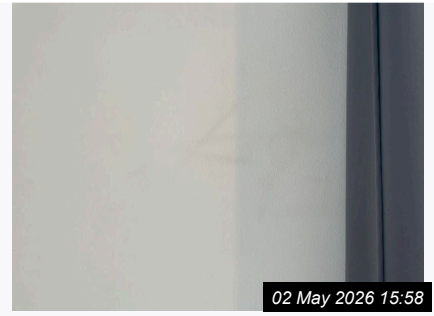
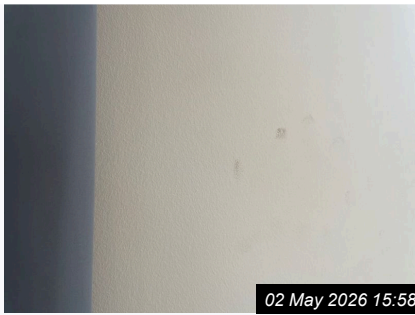
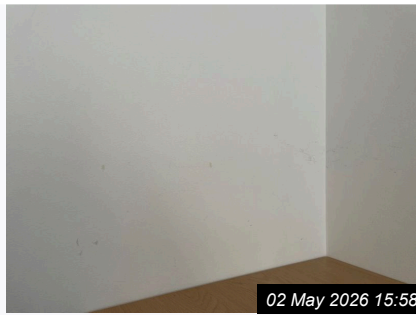
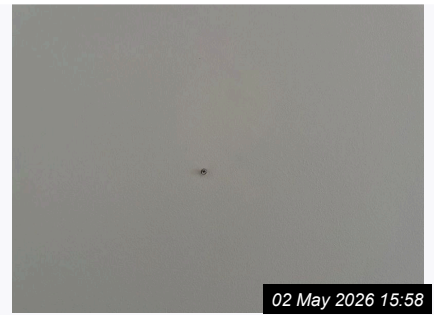
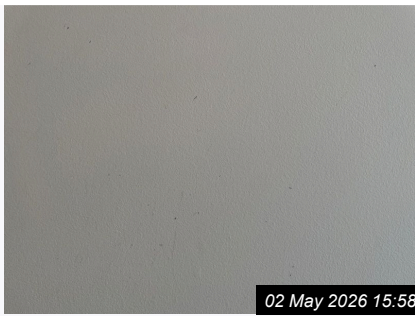
Ref #9.5

9.5	Walls	Painted plasterboard walls in light grey and white	Multiple scuff marks, minor stains, small holes, and light indents visible in several areas.

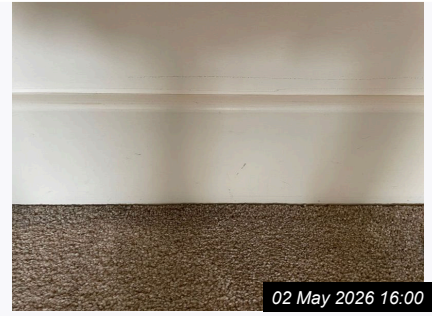
Ref #9.6

9. BEDROOM (CONT.)			
9.6	Skirting	White painted wooden	Multiple scuff marks, minor paint, discolouration and patches of touch-up paint visible generally showing signs of wear.

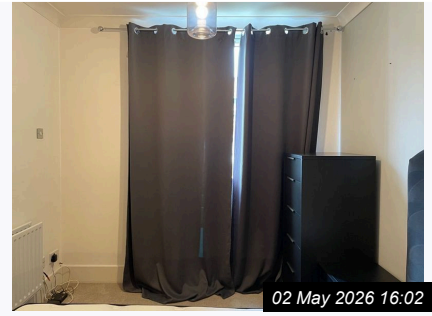
Ref #9.8

9.8	Curtains	Plain grey eyelet curtains made from a medium-weight fabric, fitted to a metal curtain pole.	Curtains show minor marks and a few loose threads small imperfections visible on the fabric; otherwise intact.

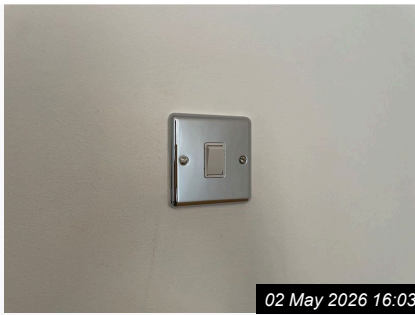
Ref #9.9

9.9	Switches/Sockets	Switches with chrome finish and white button double white plug sockets	Discolouration and some signs of use
9.10	Heating	White metal panel radiator with thermostatic valve	No visible damage or rust minor scuff marks present on surface.

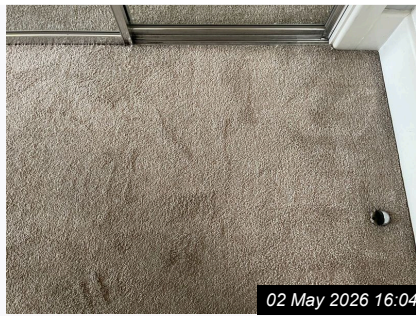
Ref #9.11

9.11	Flooring	Light beige carpet with a short pile	Carpet shows moderate wear including possibly ingrained stains, flattened areas, and marks
9.12	Built-In Storage	Storage with mirrored sliding doors chrome hanging rails internal shelving in a neutral finish.	Multiple scuff marks and scratches inside some chipped paint on the shelving general signs of use throughout visible wear to the interior walls the mirror doors and tracks appear functional.
Contents

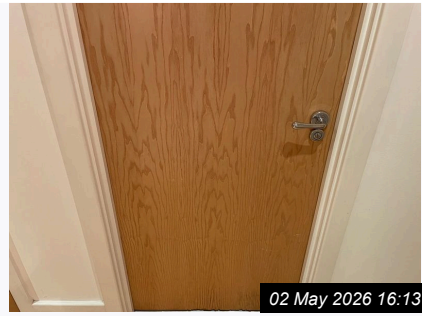
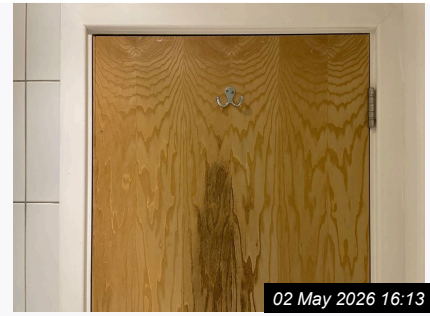
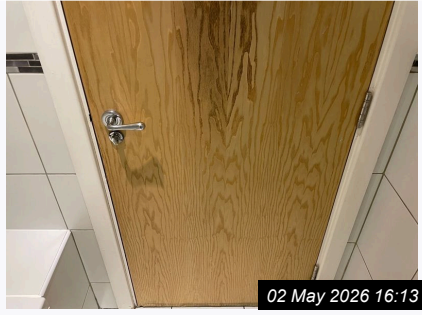
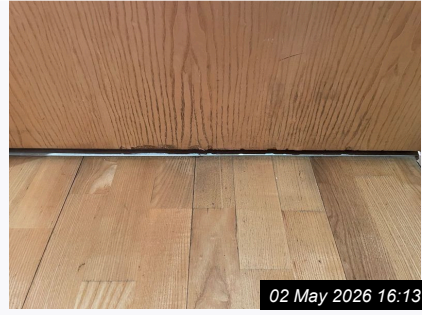
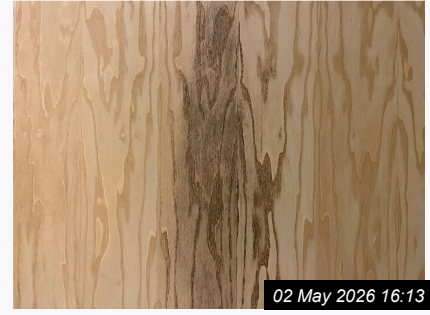
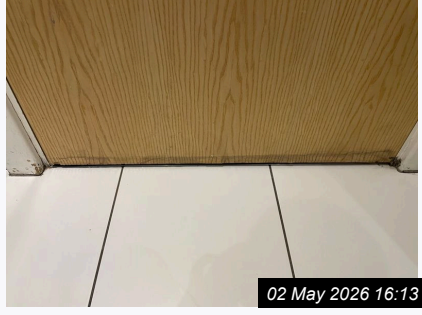
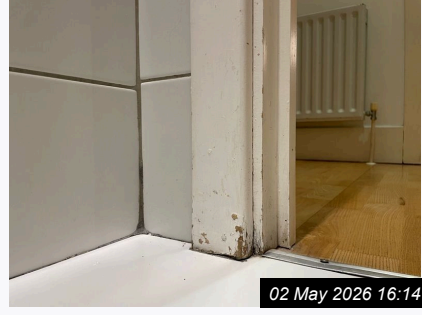
Ref	Name	Description	Condition
10.1	Door & Frame	Brown veneered timber door with a white painted wooden frame	Lower edge of door shows swelling and chipping frame has paint scuffs and damage near the base minor wear in places Door has surface staining and water damage to veneer <a href="#">Review - Investigate</a>

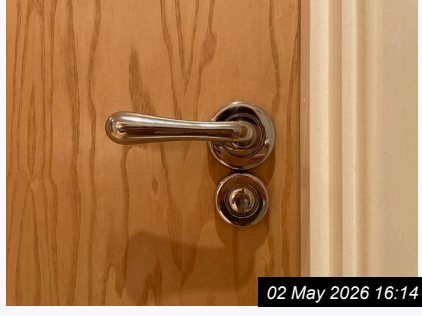
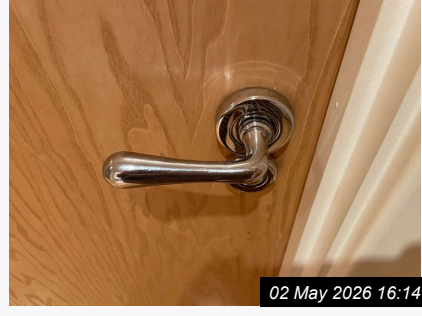
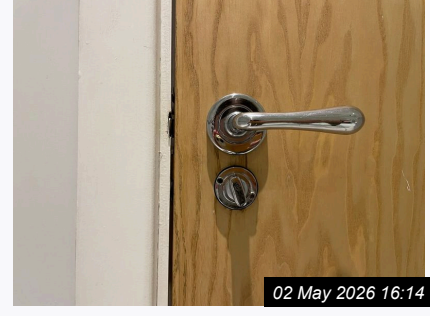
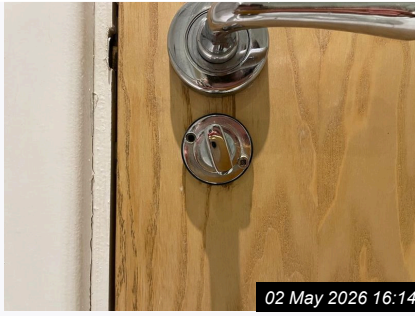
Ref #10.2

10.2	Door Fixtures	Chrome lever handle and round turn-lock fittings	Handle to exterior loose/partially detached from door Lock escutcheon to interior not seen <a href="#">Review - Investigate</a>

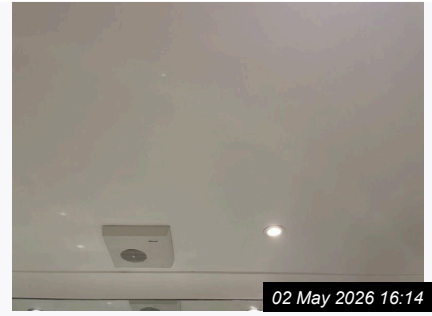
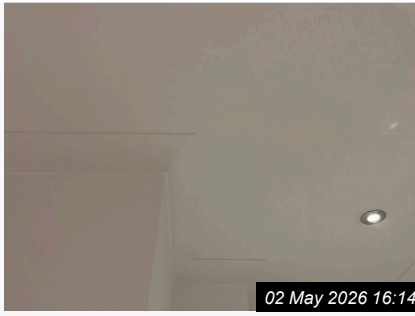
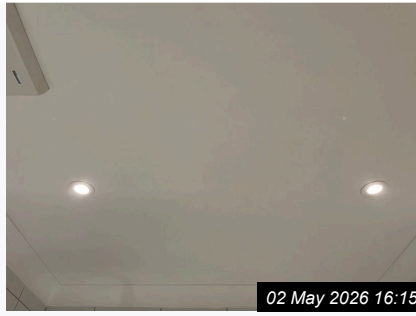
Ref #10.3

10.3	Ceiling	Smooth white painted	Ceiling is clean with no visible stains cracks or signs of water damage.
10.4	Extractor Fan	White plastic wall-mounted extractor fan branded Silavent.	Extractor fan cover appears intact with no visible cracks or damage

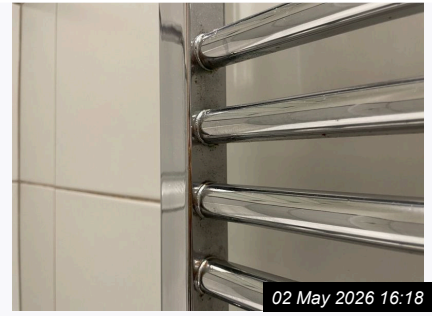
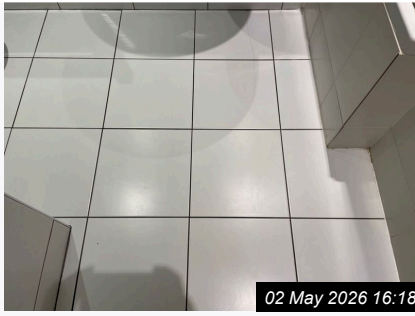
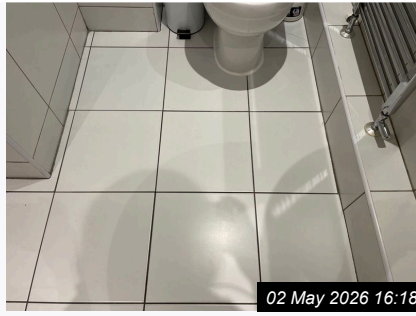
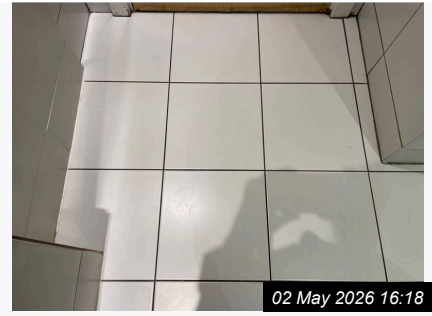
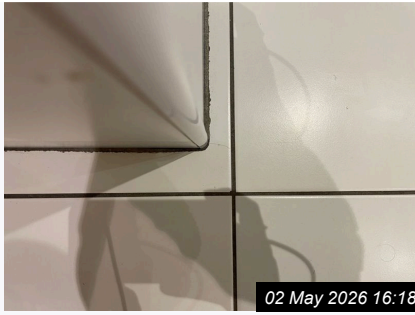
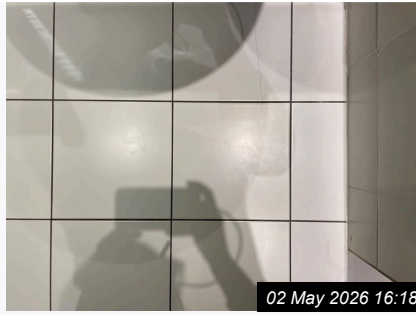
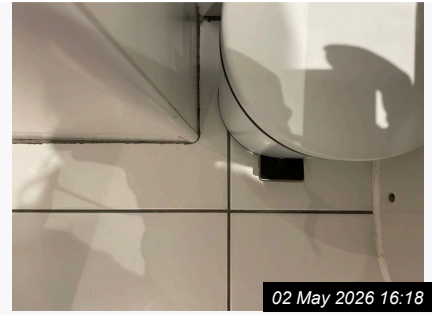
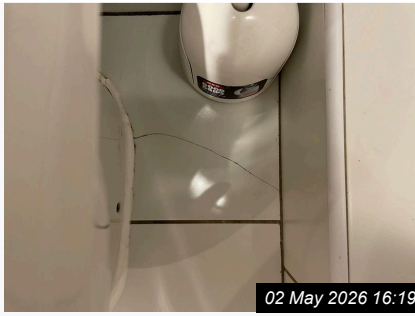
Ref #10.9

10.9	Flooring	White ceramic square floor tiles with light grey grout lines.	Some tiles exhibit visible cracks and minor grout discolouration otherwise generally intact.

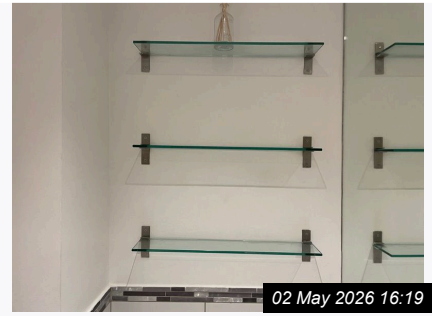
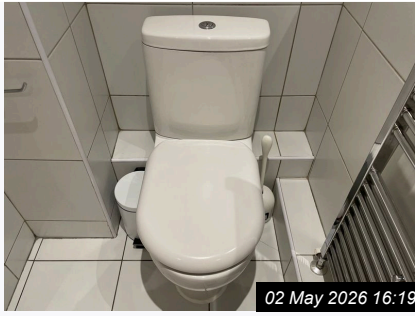
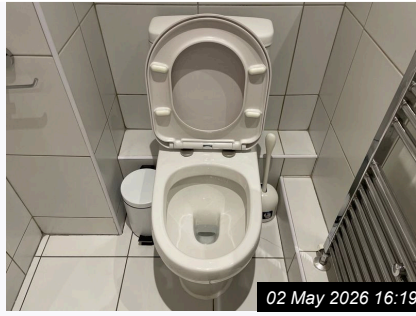
Ref #10.11

10.11	Toilet	White ceramic close-coupled toilet with dual flush button and soft-close plastic seat and lid.	No visible damage or staining toilet appears clean and in good working order.

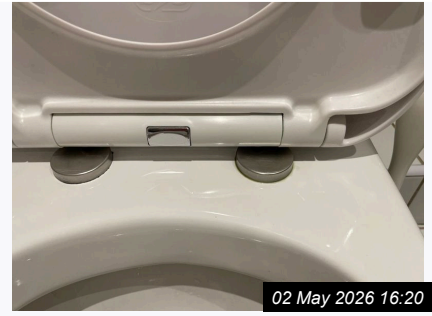
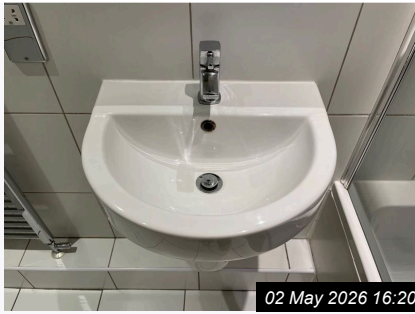
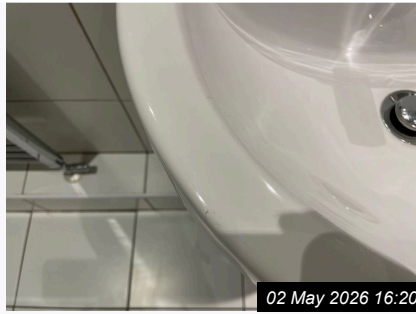
Ref #10.12

10.12	Basin	White ceramic wall-mounted basin with integrated overflow chrome single lever tap and chrome waste fitting.	Surface scratches and marks present visible rust around overflow tap and waste show wear.

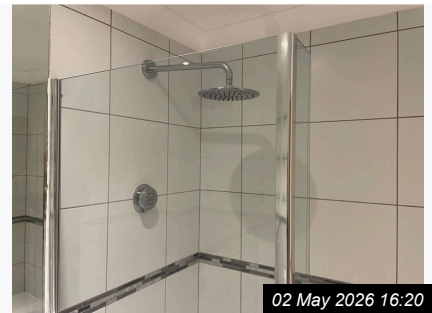
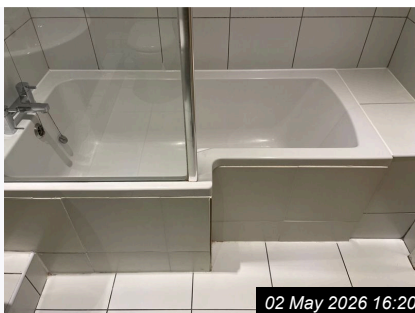
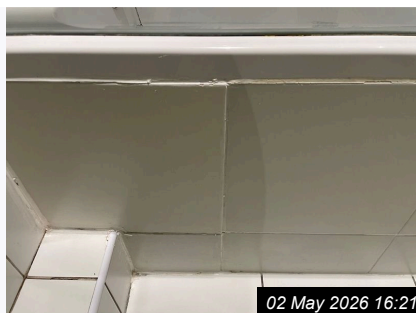
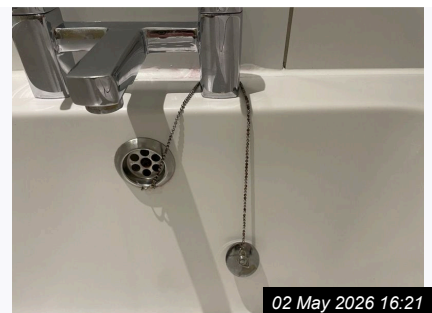
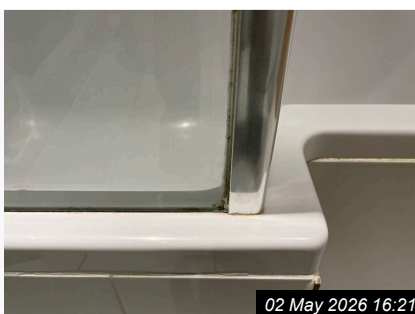
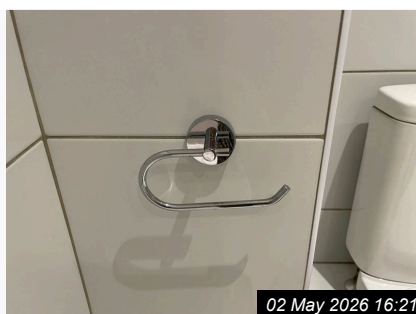
Ref #10.13

10.13	Bath, Taps & Shower	White acrylic bath with chrome mixer taps and plug glass shower screen rainfall showerhead mounted above.	Bath, taps, and showerhead all appear intact with no major damage visible discolouration and wear to sealant and grout especially around the lower bath edge and shower screen area.
Contents

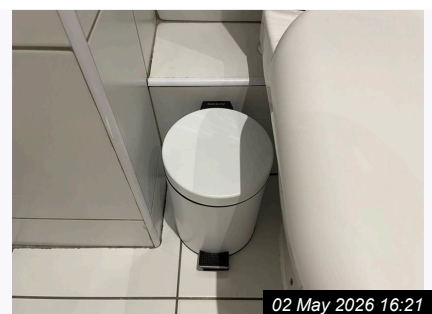
Ref #10.14

10.14	Toilet Roll Holder	Chrome-finished metal toilet roll holder	No visible signs of wear or damage.
10.15	Bin	White metal pedal-operated bathroom bin	No visible signs of damage or wear bin appears clean and well-maintained.

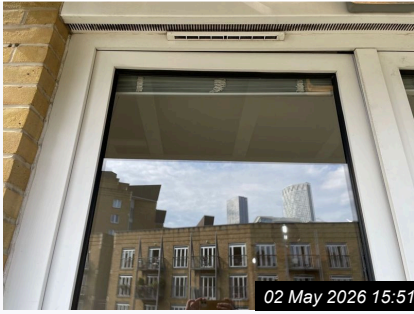
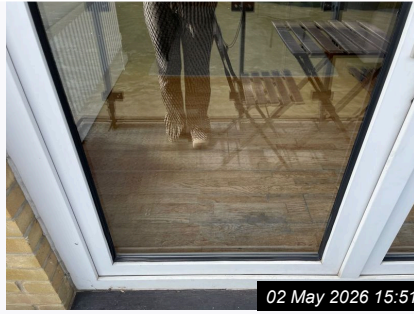
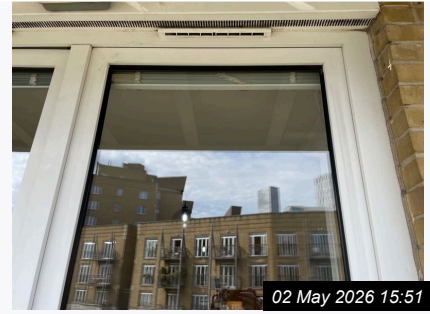
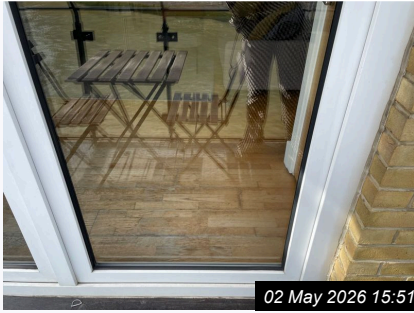
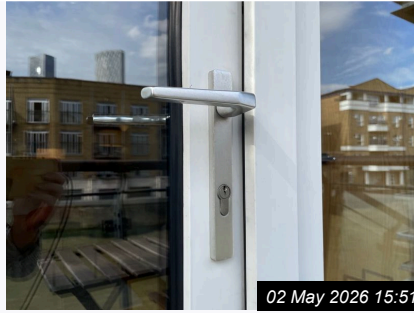
Ref #11.1

Ref	Name	Description	Condition
11.1	Door & Frame	White uPVC framed double glazed door with large glass panels and a metal handle.	Minor scuffing on the lower sections of the frame some visible paint wear near the top; glazing intact and hardware in good order.

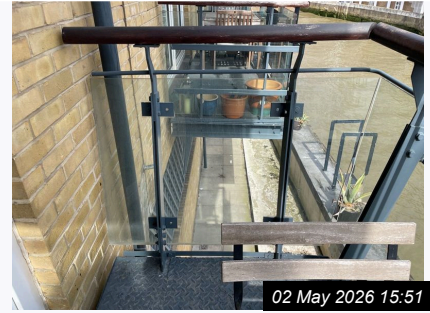
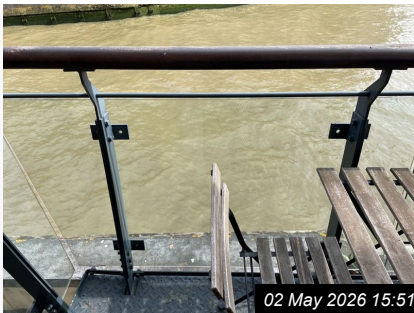
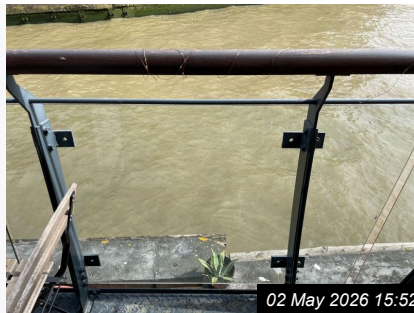
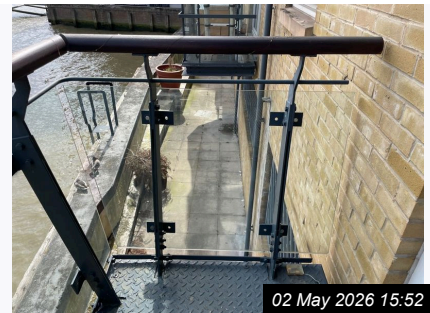
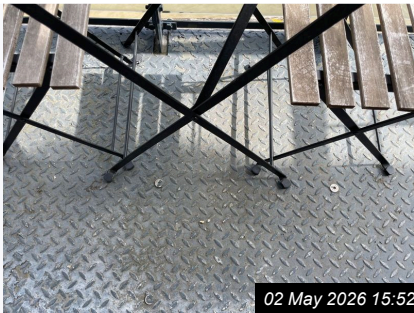
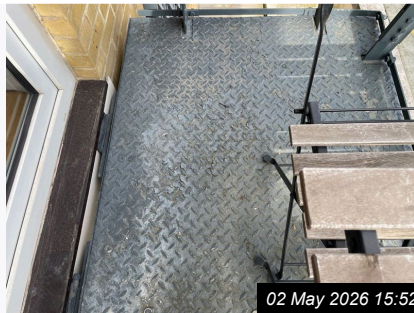
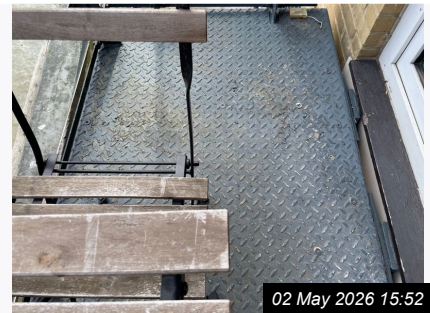
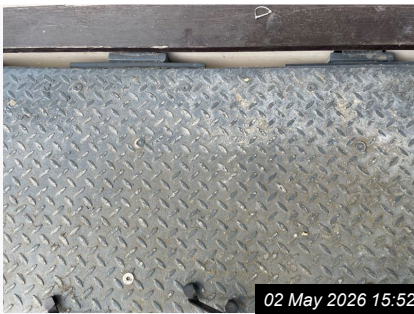
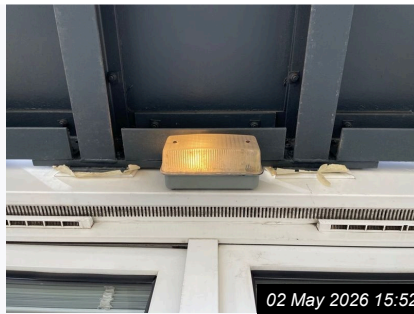
Ref #11.2

11.2	General Description	Balcony constructed with metal chequer plate flooring metal and glass balustrade wooden handrail attached outdoor lighting	Floor has patches of surface rust and some wear balustrade and handrail appear structurally sound outdoor light fitting intact

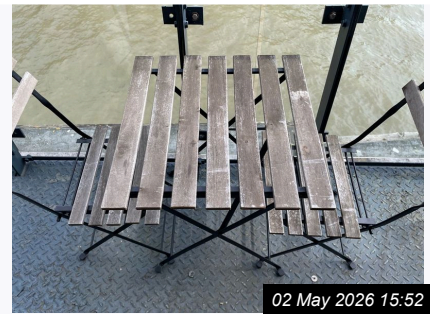
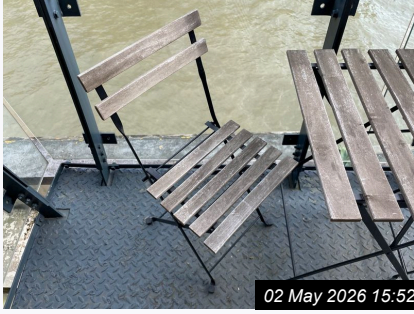
Ref #11.3

11.3	Furniture	Wooden slatted table and two matching wooden slatted chairs with black metal frames.	Visible weathering and fading on wood surfaces with some minor surface marks present no major structural damage observed.

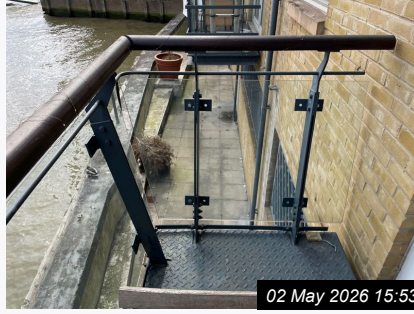
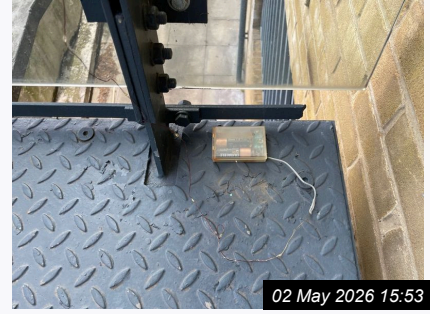
Ref #11.4

11.4	Rail	Metal and glass balcony with black metal frame, clear glass panels, and brown handrail.	Metal frame shows minor rust and wear, glass panels appear intact, metal floor has visible scrapes and surface rust, loose wires and a battery box are present on the floor.
